An Archaeological Survey of  
the Parsonage Site (38Ch1660)  
Willtown Plantation

**Archaeological Contributions 32**  
The Charleston Museum  
November 2003

# Archaeological Survey of the Parsonage Site (38Ch1660)

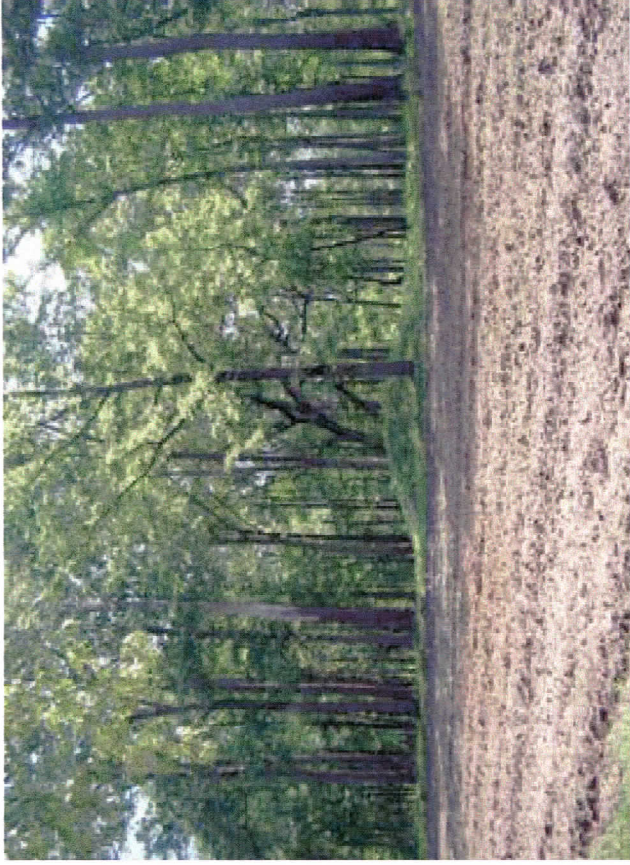
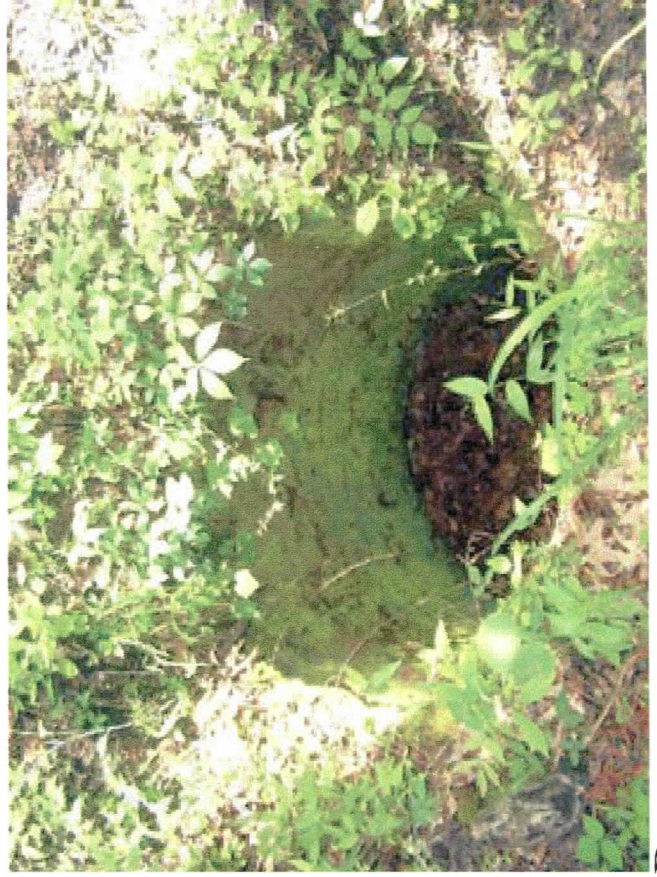
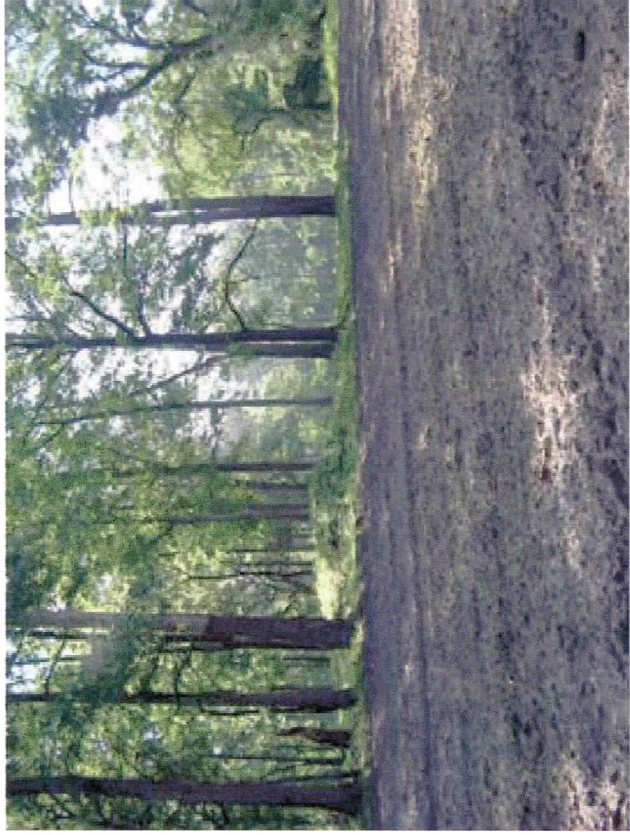
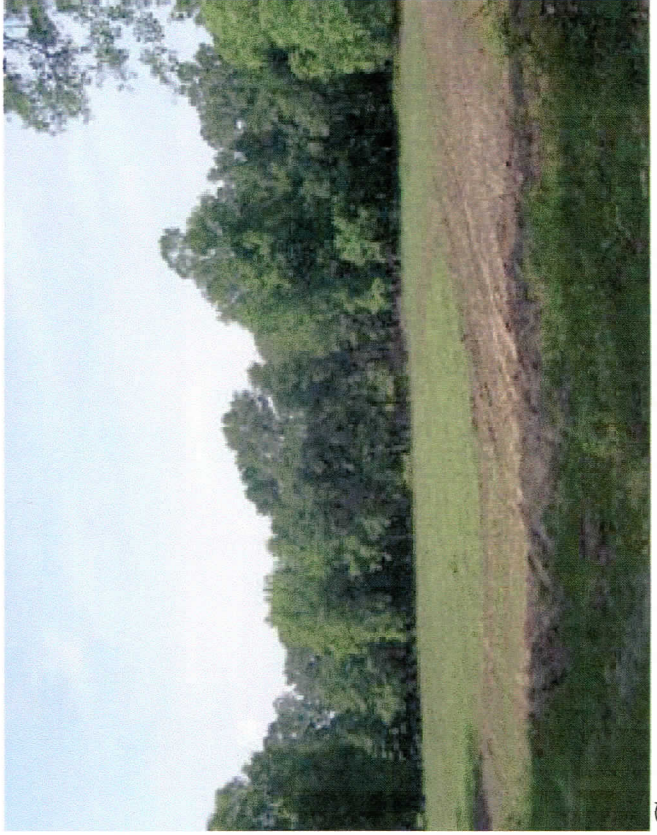
Figure 1. Site views of the Parsonage before excavation. The 'mound' covering the main house foundation is visible in the wooded area: a) facing southeast, b) the well, c) facing southeast, d) the plowed portion, facing east.

Archaeological research at the 'New Willtown Church' site by The Charleston Museum began in May 1997 when work was ongoing at the site of James Stobo's plantation on nearby Willtown Bluff, owned by Hugh Lane, Sr. Based on the description of the site by the Knox family and Mr. Dickie Godley, and research by Dr. Suzanne Linder and Mr. Jack Boineau, the sites on Willtown Plantation were presumed to be those of the church and parsonage. Artifacts were recovered from the church site (38Ch1661) and the presumed parsonage site (38Ch1660). A third site, consisting of a brick scatter and early 18<sup>th</sup> century artifacts, was located in a plowed field south of the parsonage (38Ch1662). Above-ground features and surface artifacts at both the church and the parsonage sites conformed to expectation for such structures. The open area adjacent to the cemetery yielded hand-wrought nails and window glass typical of the second half of the 18<sup>th</sup> century, though the lack of brick from piers was unexpected, and remains unexplained. The parsonage site contained more dramatic above-ground evidence, consisting of a rectangular mound obviously covering a brick foundation. A range of domestic debris, including ceramics, bottle glass, and nails were recovered from the ground surface near the mound (figure 1).

(figure 3). The site is marked by a rectangular mound of soil about 5' tall. The mound, as well as an exposed brick-lined well, are within a wooded area of mostly climax hardwood. Understory here is greatly reduced, or nearly absent, due to a carefully-executed program of prescribed burning. The wooded area containing historic remains measures approximately 200' by 300'. The northern and eastern boundary of this area is a slough, or swampy area. The site is bounded to the west by a woods road running north/south, parallel to (secondary) State highway 38. The area around the wooded section, to the west and the south, was an open field, recently plowed by Mr. Dickie Godley (figure 4). This field was freshly plowed in April, and had only moderate vegetation during the time of fieldwork. Heavy rains made portions of the field quite wet, however. Visibility in both the field and the wooded area was very good. Cultural artifacts and brick rubble were clearly visible on the ground surface, and areas of dense refuse, and sparse refuse, were easily noted.

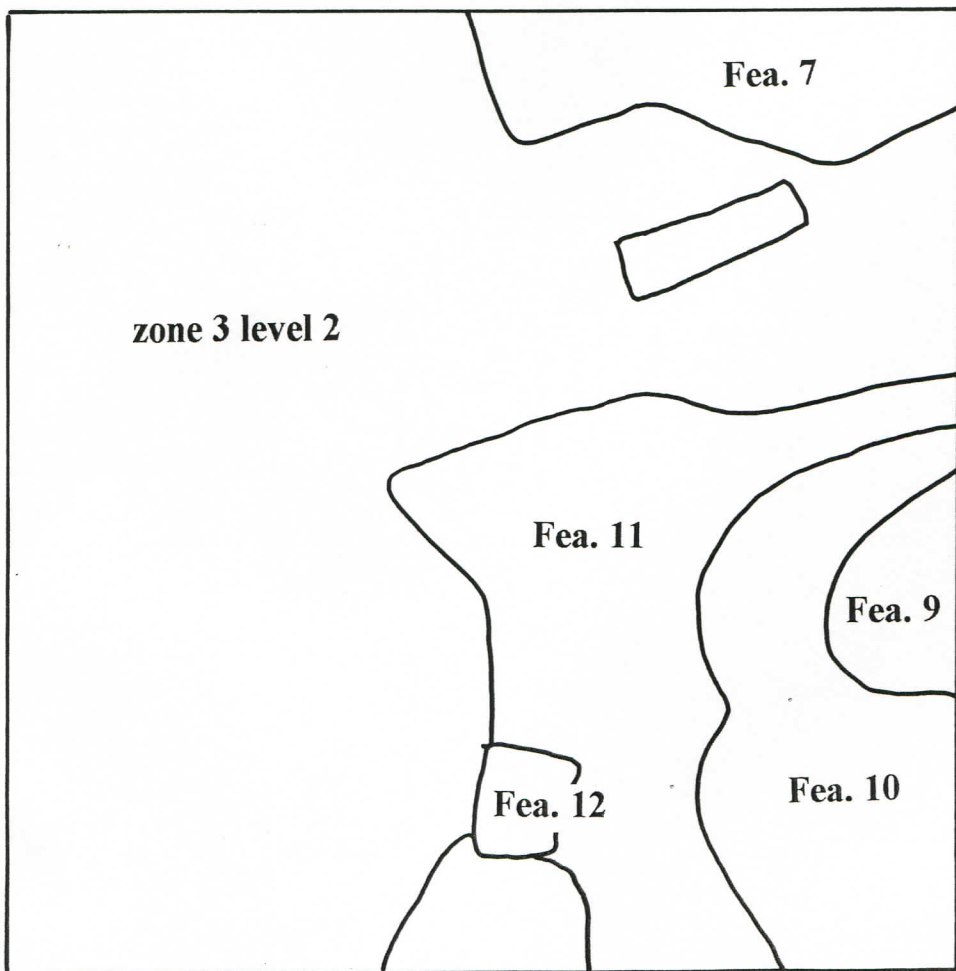
Base Zone 3

**38 Ch 1660**  
N525 E400

When the ash layer, feature 1, and the intrusive features were removed, excavation continued with zone 3. This was a loamy brown sand. Additional features were present at the base of zone 3. Feature 12, located in the center of the unit, was a shallow post hole with a flat base and a square shape. This intruded into three other defined features. The most impressive were features 9 and 10, a large double post hole 1.8' deep (figures 14 and 16). This was a mottled soil, filled with dark brown and lighter yellowish brown sand. Examination of the eastern profile of the unit after excavation of this feature revealed that the overlying layers of soil had all slumped toward the center of feature 10, suggesting some rotting of a post, or settling, after deposition. Two additional features were defined at this level, and neither were excavated; features 13 and 14 appeared to be post holes.

Due to time constraints, excavations were halted at this point. The floor at the base of zone 3, the eastern, and northern profiles were photographed and mapped. The unit was then backfilled.

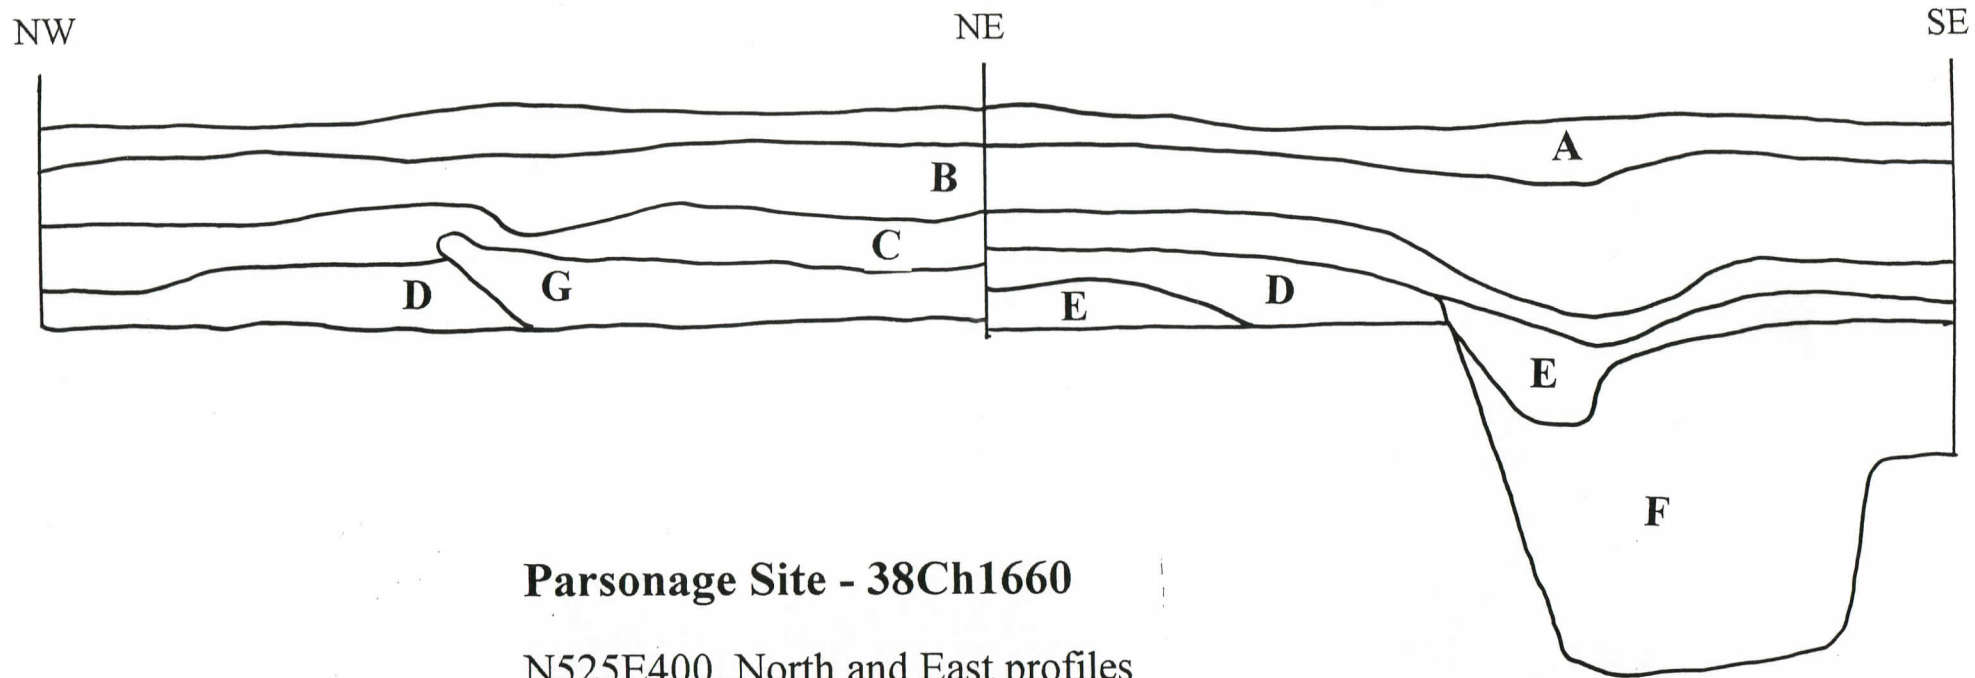
N525E400, North and East profiles

**Parsonage Site - 38Ch1660**

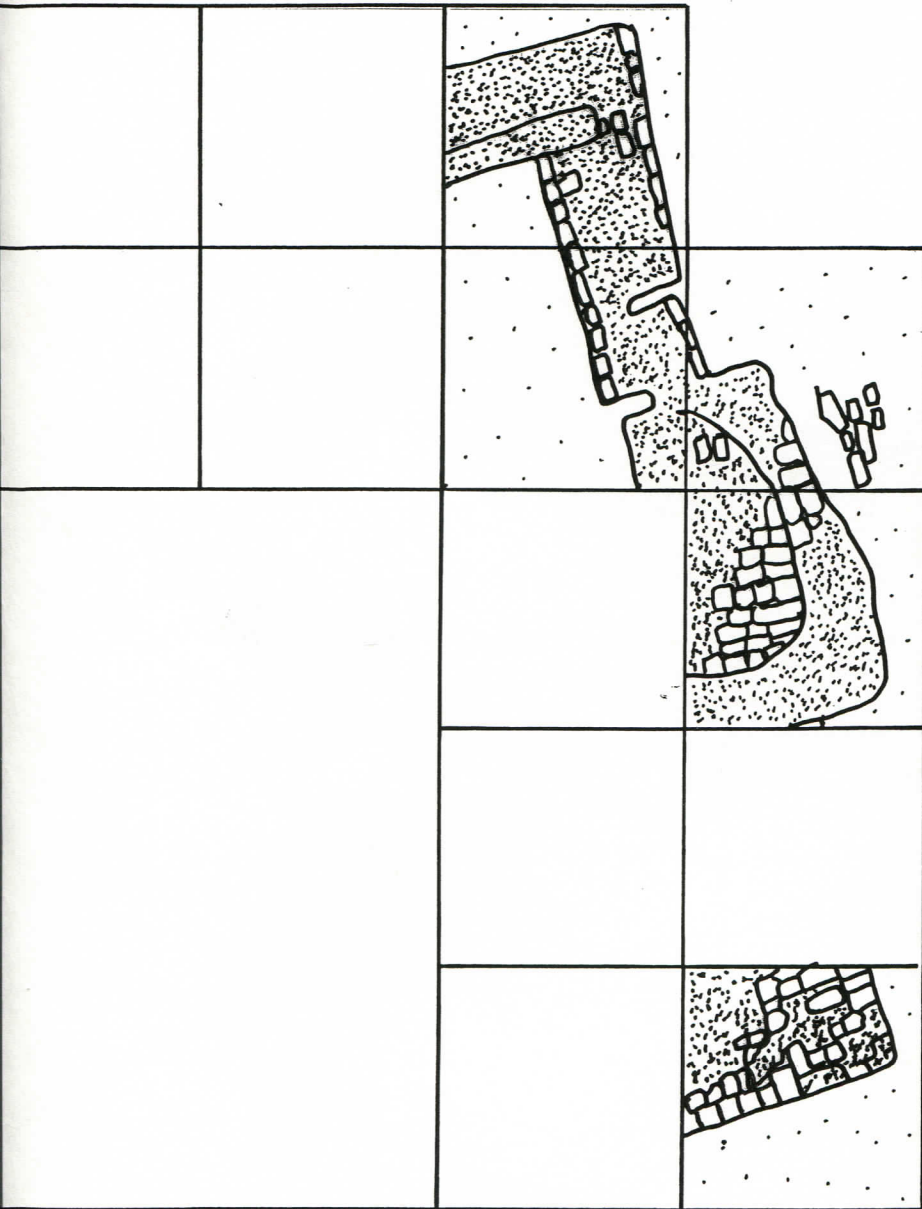
Composite Map, units  
excavated, and proposed  
for excavation to expose  
building foundation  
Scale 1:40

The eight excavation units revealed three corners, plus an exterior chimney, for a structure measuring 22' by 36' on the exterior (see figure 11). The brick foundation is well made, and is 2.4' thick, suggesting a substantial building. The mound apparently just covers the intact

Figure 11. Composite map of excavated dwelling foundation.
