# Drayton Hall: Archaeology at the Privy, 2007

Archaeological Contributions 40  
The Charleston Museum  
June 2008

1. To assess structural failures of the 18<sup>th</sup> century privy's foundation, chimney, and drainage system
2. To create a conservation work plan that specifically addresses those structural failures and mitigates the effect of that work on related underground features
3. to educate and train undergraduate students in the methodology of conducting archaeological and architectural investigations.

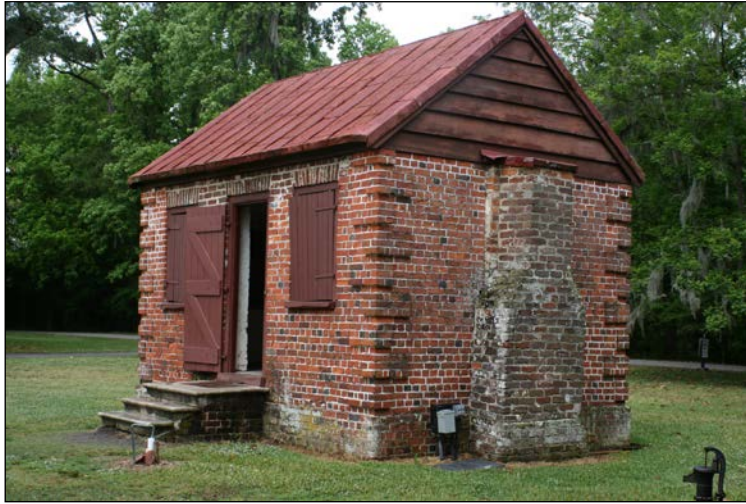
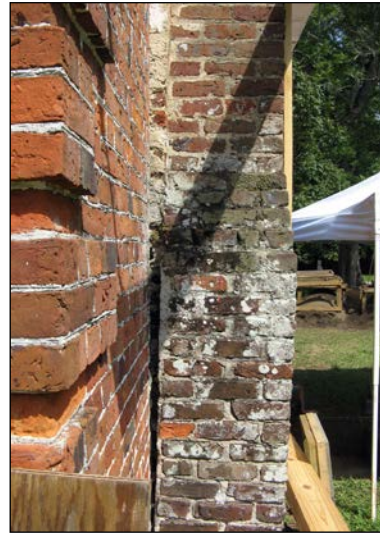
Figure 2: the privy before excavation. View shows the east side of the building. The 19<sup>th</sup> century chimney stack is visible. Note also the electrical boxes and water lines along the eastern side of the structure.

The privy faces two immediate threats. These were noted shortly after the National Trust acquired Drayton Hall, and they have worsened in recent years. The chimney on the east side

has been settling, and is close to tilting outside of its center third, presenting great probability for failure. This failure would, in turn, cause significant damage to the eastern wall and roofing system of the original building. Secondly, the structure shows signs of water infiltration, noted by collapsing soil around the foundation and biological growth on the brickwork. Hudgins and Webster suggest that the brick drainage system, which once served to flush waste from the privy, now seems to serve as a channel for water to enter the privy pit, due to changes in grade southwest of the building. Webster and Hudgins further speculate that the water infiltration may be a cause of the chimney failure, especially given the possibility of a second drain to the east. Lewis noted the problem of water infiltration during her 1980 excavation.

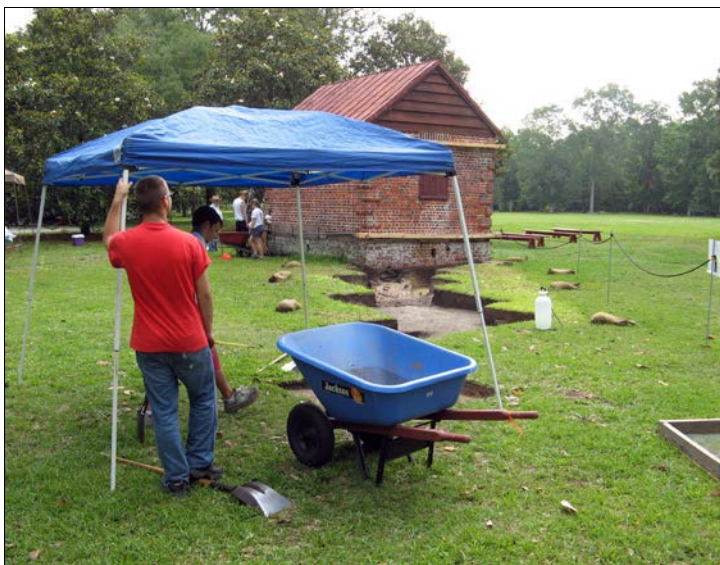
Figure 11: Beginning excavations. The structure has been secured by Richard Marks Restoration and the 1980 excavations have been reopened. The excavation area is secured with ropes.

Carter Hudgins and Drayton Hall staff prepared the site for excavation prior to our arrival. The area surrounding the privy, bordered by trees, walkways, and roadways, was secured with a rope-and-station fence and interpretive signage. The exterior fabric of the building was secured with a beam and bolt system by Richard Marks Restoration. The site grid established by Lewis in 1975 was re-established by Hudgins using a Sokkia total station. Backdirt and dry screening stations were prepared inside the roped area. A water screening station was established at the

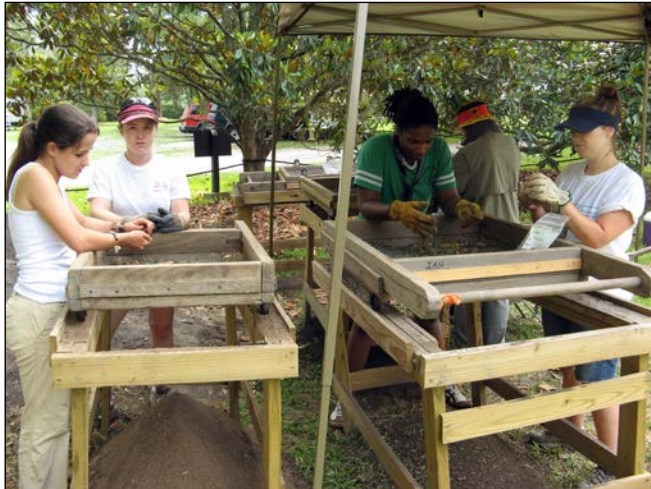
Figure 12: Screening and backdirt station.

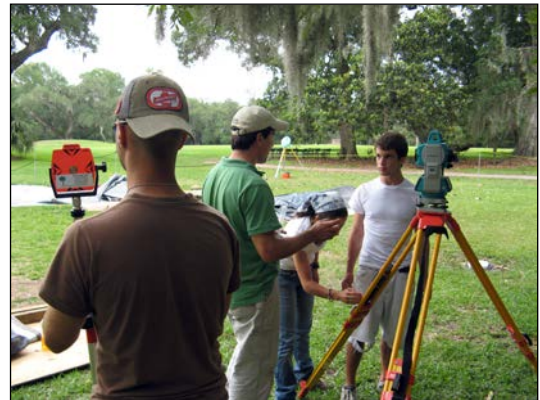
Figure 13: Training on the total station. Vertical control was maintained with the total station and with the manual transit, visible in the background

Vertical control was maintained with the total station and with a manual transit, and elevations were taken at the top and bottom of each defined provenience. A temporary datum point was established on top of the ornamental mound in front of the house. This point was used daily, and all measurements were taken relative to this point. The absolute elevation of this point is 20.448' msl.

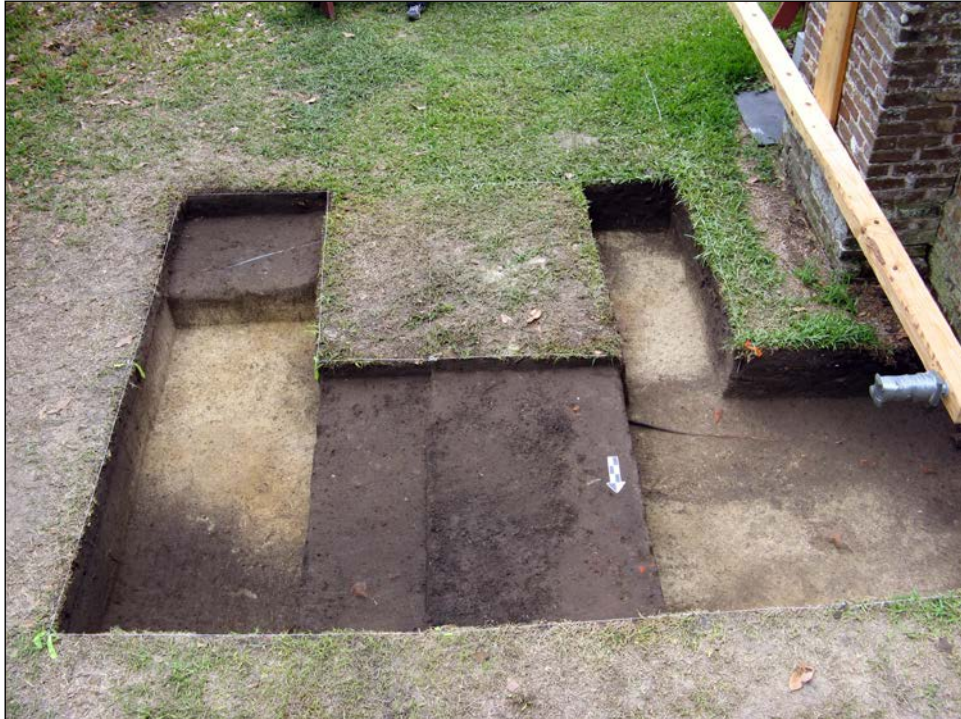
Figure 15: Features exposed on the east side of structure 2. Feature 7 is visible on the right.

Several features were noted at the base of zone 3, intruding into sterile subsoil. Most significant was a linear ditch aligned with the arched opening in the foundation (feature 7; DH 157A). This was difficult to define in upper levels, and was complicated by moisture retention around the building foundation. When upper levels were excavated, the features resolved to a narrow builders trench surrounding the structure, overlying the ditch relating to the vault. The builders trench was designated feature 2 (DH 160A), and was intruded by feature 7. Feature 7 was eventually defined as linear, with regular straight sides and a flat bottom, continuing to the interface of the building. The ditch was 2.6' wide and an unknown length; 5.8' were exposed, from the edge of the structure to edge of the conduit disturbance in units 139 and 145. [Subsequent excavation of these trenches revealed an additional foot of the feature, and suggests that the feature terminates in a narrow, relatively shallow ditch.]

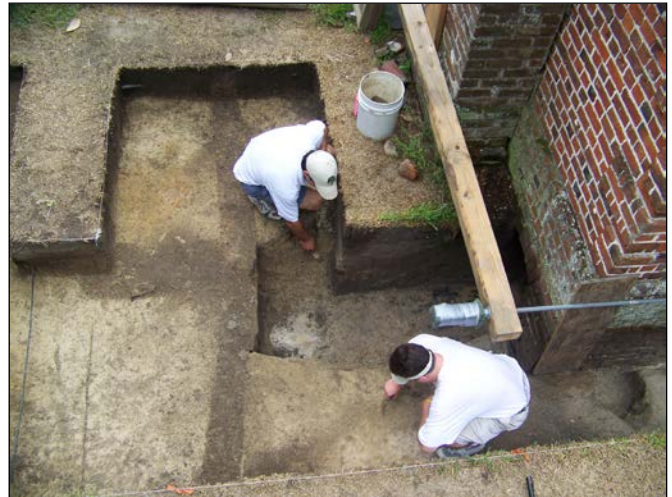
Figure 16: full exposure of feature 7 by Drayton Hall staff

Excavation of feature 7 began with a 2' wide cross-section, exposed in units 139 and 145. The feature 7a deposits were excavated first, an area 1' wide and .7' deep. This revealed a fill of homogenous brown soil, excavated as feature 7b. The excavated cross-section featured straight sides, a relatively flat bottom, and rounded corners, 1.5' deep. Based on this sample, portion of feature 7 exposed in unit 141 was excavated to the edge of the privy foundation. Following natural stratigraphy, feature 7a was segregated from feature 7b. Feature 7 was 1.9' deep at the face of the building, as measured from the point of initiation at the base of zone 3. These excavations exposed the base of the foundation and the footer course of the privy. A .3' wide section of the soil fill inside the opening was excavated separately as 7c. Excavation of the feature was halted at this point, to maintain structural stability. The remaining soils are considered associated with fill inside the structure.

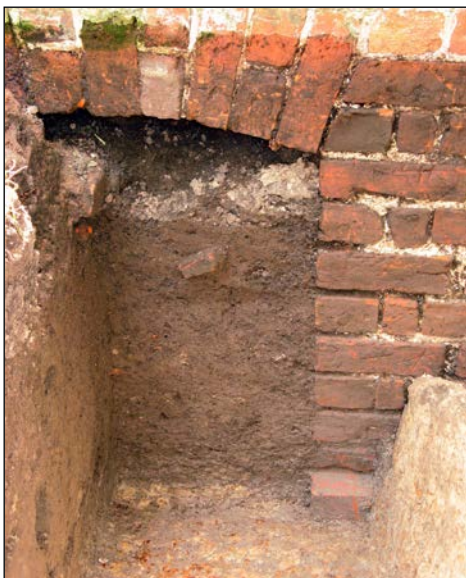
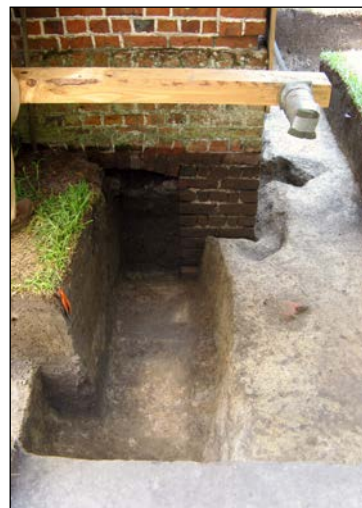
Figure 17: Excavation of feature 7; closeup of vault opening after excavation

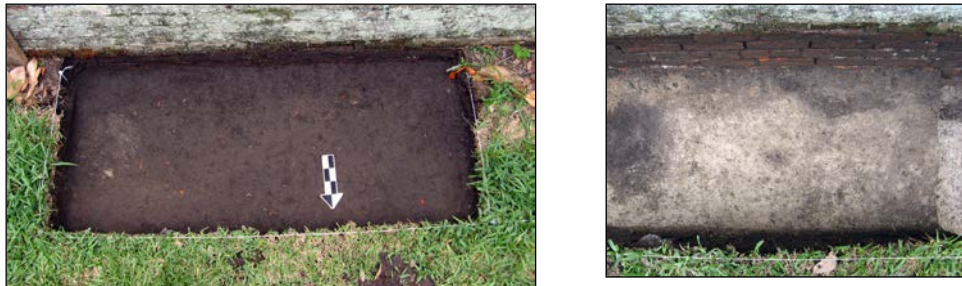
Figure 18: DH 138 at base of zone 1, showing features 1 and 2; features 1 and 2 at the base of zone 3.

Features encountered at the base of zone 1 included a construction trench for the privy (feature 2, DH 160A), the access/drainage ditch associated with opening in the north wall (feature 4), and a round post stain (feature 1, DH 159A). Feature 1 was round, .9' in diameter. Fill was mottled dark sand (10yr2/2) and light soil (10yr5/3). Feature 1 was initially excavated to a depth of .4' below point of initiation; it was eventually 1.4' deep. At the interface with sterile soil, the feature resolved into a well-defined postmold and posthole. These were excavated as feature 1a and 1b, respectively.

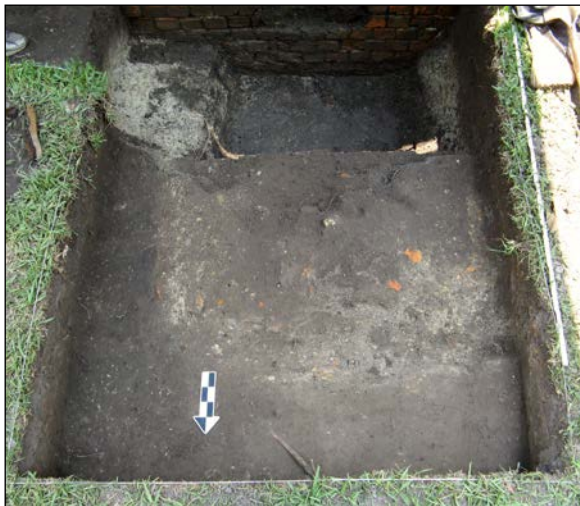
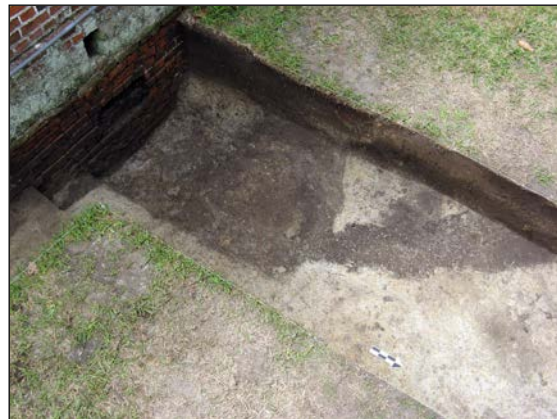
Figure 20: Feature 4 at the base of zone 1, and at the base of zone 3 (upper levels of feature 4 have been excavated).

Feature 4 was well-defined at the base of zone 3 as a large pit or trench, with straight sides and rounded corners. A more narrow ditch or trench continued from the northern terminus of feature 4, trending to the northwest. This was designated feature 16 (DH 172). Fill for the feature was similar to the above zone 3, a dark loam mottled with lighter sand (10yr3/2). A linear feature of the same fill was located along the northern profile of unit 148; this was designated feature 18 (DH 174). Feature 19 (DH 175) was an amorphous oval stain of mottled dark gray and light gray sand.

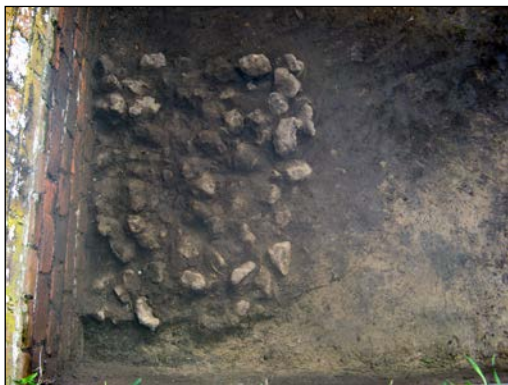
Figure 21: DH 149, feature 24 before excavation; features 2 and 25 beneath feature 24

Excavation continued with the removal of feature 24. The feature was a single layer of tennis ball-sized phosphate nodules; the function of this paved area is unknown. Feature 2 was continuous beneath it. Feature 2 was well-defined in this unit, and excavated to the base of the privy foundation, 2.4' below surface. Removal of feature 24 revealed an additional edge to the underlying feature 25, while excavation of feature 2 revealed the profile. Together, these suggest that feature 25, though amorphous in shape, may be a deep deposit of dark soil. Feature 25 was not excavated during the current project.

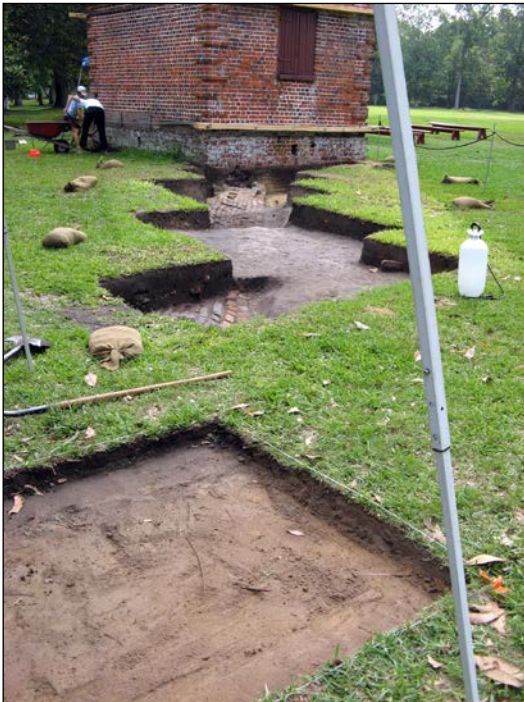
Figure 22: location of DH137 relative to 1980 excavations.

A group of three units was excavated adjacent to DH 67. Units DH 137 and DH 140 were located on the western edge of DH67, while DH 146 expanded to the east. Units 137 and 140 were excavated simultaneously, while DH 146 was a later extension. Excavation of these units revealed a stratigraphic sequence different from other areas of the site; the upper zones suggest multiple episodes of filling. Sod and root mat in a dark gray-brown matrix was excavated as zone 1, in two levels to a depth of .3 feet. At this point, an area of dark soil mottled with brick and phosphate inclusions was evident in the eastern 1.2' of the units. This was designated feature 3, and tentatively interpreted as the backfilled portion of DH 67. After sampling, these soils were excavated and discarded.

A shallow deposit of brown sand (10yr4/2) was designated zone 2; this quickly resolved to an area of hardpacked gold sand, mottled with dark soil (7.5yr5/6, 10yr7/6, 10yr3/2). These soils were removed from both units, in alternating fashion. Plastic was recovered from the zone 3 soils. At the same time, the existing profiles of the re-excavated units were compared to a photograph of the excavation in 1980. This revealed that the ground surface has accreted at least one half foot since the time of the excavation. The mottled soils encountered in units 137/140 are currently present above the old units, and this was not the case in 1980. Based on this evidence, zones 1-3 were re-designated as “overburden”.

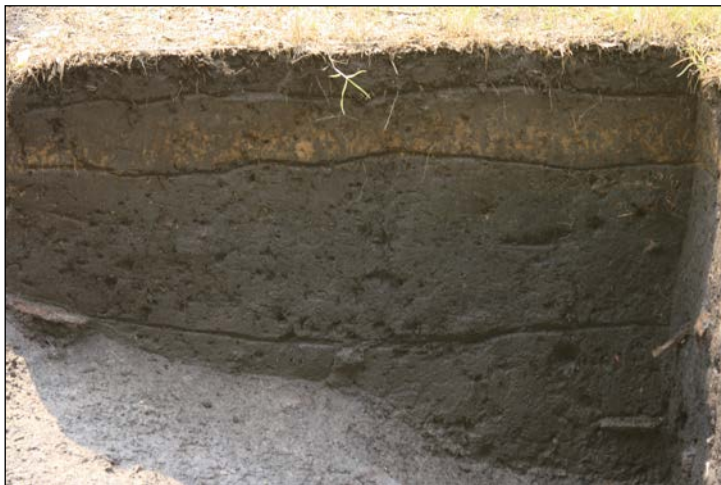
Figure 23: location of terminus of ditch 2, relative to DH 67, DH 137,140 and 146. Above; soil profile showing mottled soil overburden, deposit of zone 10, and DH 166b and 166c below.

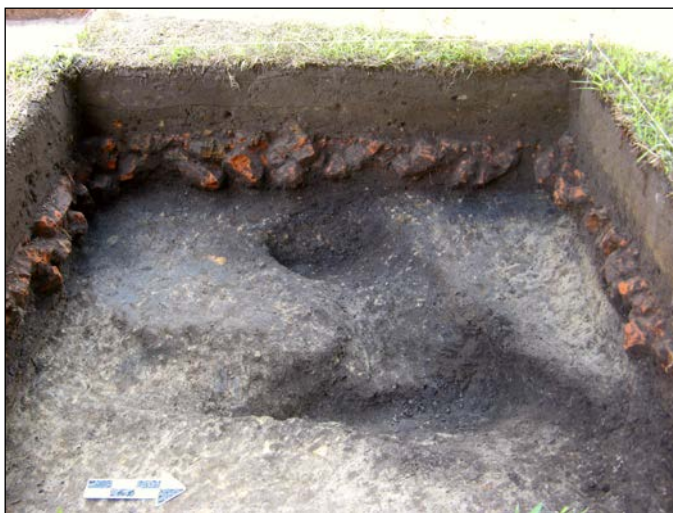
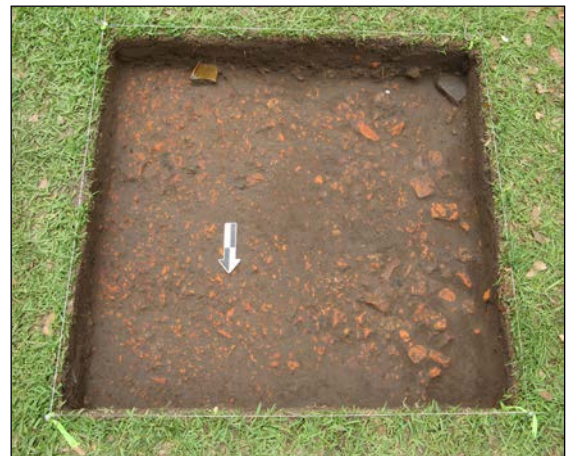
Figure 24a&b: Feature 11 in DH 147; base feature 17 in DH 150 (feature 11 in profile)

The brick of feature 11 was soft and orange/red (2.5yr4/8). The majority appeared to be bats. There was no evidence of mortar, or of use. The brick layer was relatively uniform across the two units, the thickness varying with the size of the brick fragments. Occasional 18<sup>th</sup> century artifacts were found in association with the brick, including a large fragment of North Devon Gravel Tempered Ware and a musket sideplate.

Feature 11 appears to be a paving, or filling, incident. Given the lack of structural integrity and the high stratigraphic position (below zone 2), we decided to excavate the feature and continue investigations below this level. Feature 11 ranged in thickness from .2' to .8', and was excavated as a single provenience in each unit. Samples of the brick were retained, and all brick was weighed. The discarded brick was set aside at Drayton Hall for future analysis or reuse.

The soil below feature 11 was a dark loamy sand (10yr2/1), mottled with light sand, and so was designated zone 3. The zone was relatively shallow (.3'), with an uneven bottom. Sterile soil was present beneath zone 3, except for an amorphous depression, trending northeast/southwest through the two units. This was delineated and excavated as feature 17 (DH 173). The feature ranged from .3' to 1.6' in depth. It was interpreted as a natural low area.

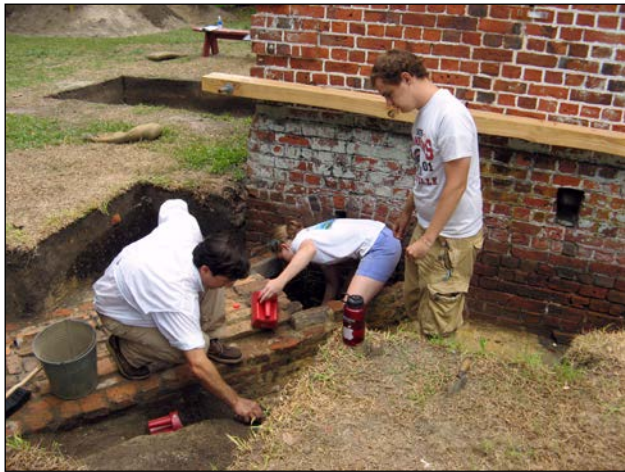
Figure 25: cleaning ditch 2; excavating sample of feature 23

The second task was retrieval of a sample of the soil filling the brick drain. At the time of initial exposure, the top of the drain had collapsed at the interface with the privy foundation, leaving an opening approximately 4' in width. Drayton Hall interns cleaned the backfill from the

drain interior, exposing original fill. A sample of this fill was excavated as Feature 23 (DH 152A). Excavating top to bottom along the fill profile, a .2' section was removed initially. This deposit contained many small bones, and a rubber button dating the deposit to the late 19<sup>th</sup> century. An additional .5' was excavated as feature 23.

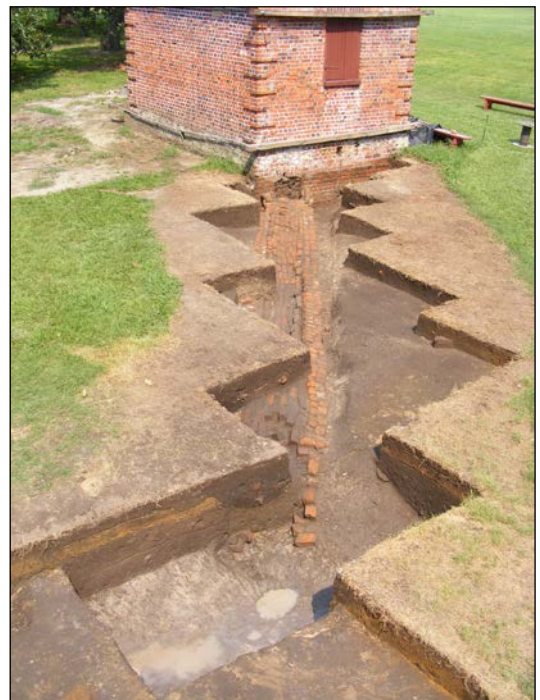
Figure 26: Excavations completed by Dr. Hudgins in August 2007

Continued excavation of the privy area, June-August 2007: Dr. Hudgins and Drayton Hall interns continued the archaeological exploration of the privy area after the Museum project was completed. Excavation of DH 67 and exploration of the terminus of ditch 2 is described above. Hudgins also excavated the soils surrounding the two conduit lines present in DH 139, 143, and 145. Soils were separated into three natural zones, following the previous designations. This exposed the terminus of feature 7, and an additional sample was retrieved. All of the additional excavations were photographed and mapped. Excavations were terminated and the project backfilled in mid-August.

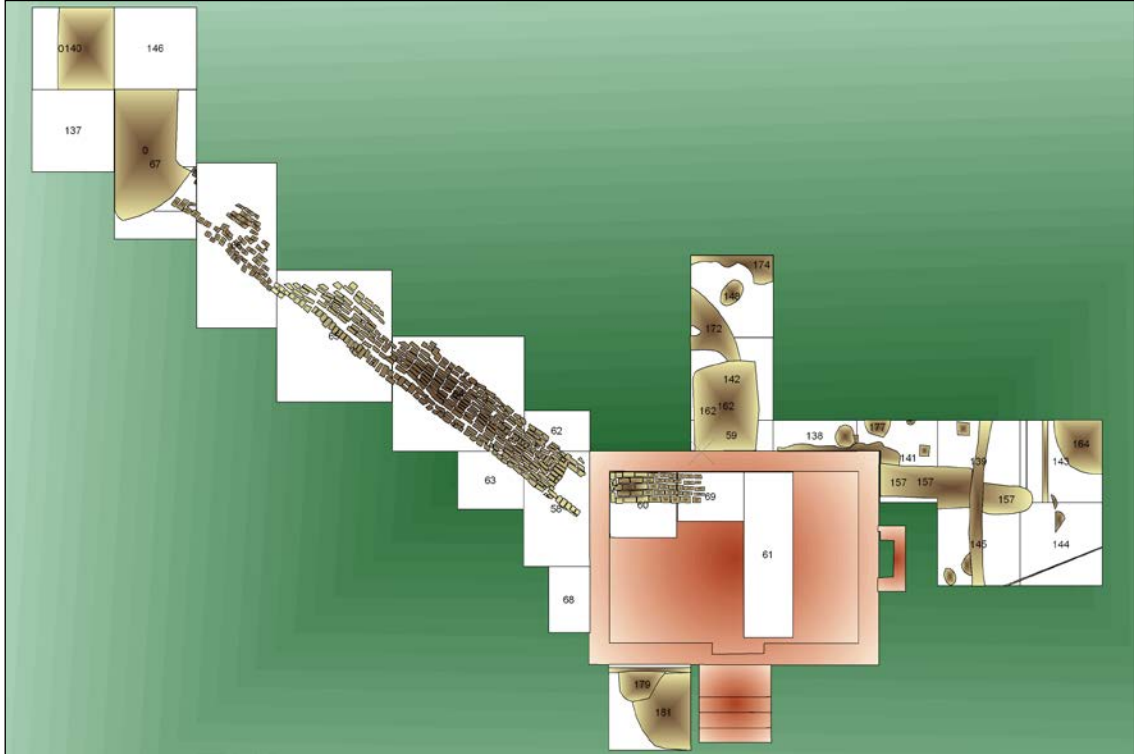
Figure 27: site map, showing units excavated and major features encountered.

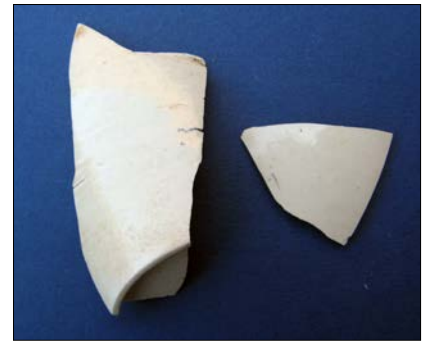
Figure 28: white saltglazed stoneware

The tin-enameled tablewares of the early 18<sup>th</sup> century (1740-1775) were replaced by dinner and tea wares of white salt-glazed stoneware, developed in the second quarter of the 18<sup>th</sup> century. The fine, molded table and tea wares were first developed in the 1740s, and these largely replaced the smaller delft vessels. Plates and soup bowls, as well as tea wares, are the most common forms recovered in Charleston, reflecting the rising importance of individual place settings and matched sets. Serving vessels are also recovered in lesser amounts. While much of the salt-glazed stoneware was undecorated, molded and sprigged examples are found, as well. Typical plate rim forms include the 'dot, diaper and basket', the bead and reel, and barley patterns (Noel Hume 1969:116). Eight fragments of these wares were recovered from the privy features.

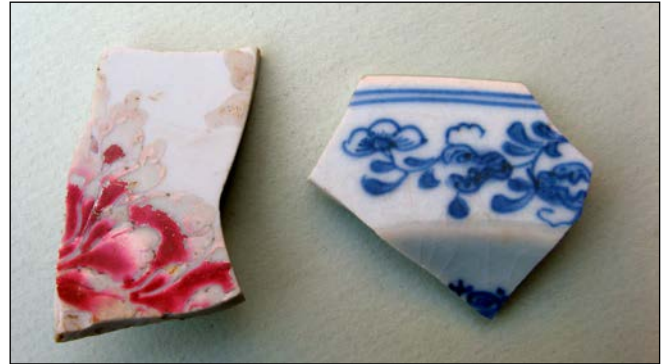
Figure 29: Examples of Chinese Export Porcelain

The privy features contained 17 fragments of blue underglaze porcelain and two enameled fragments. One fragment of 'famille rose' pattern was recovered from the lower levels of Feature 10. This fragment of a platter or large plate features a bold floral decoration in rose-pink enamel. More typical of late 18<sup>th</sup> century wares is the plate rim from Feature 23, featuring a blue underglazed floral design on the rim and a dart border. The dart border was common on wares from 1730 to 1780 (Miller et al. 2000:9).

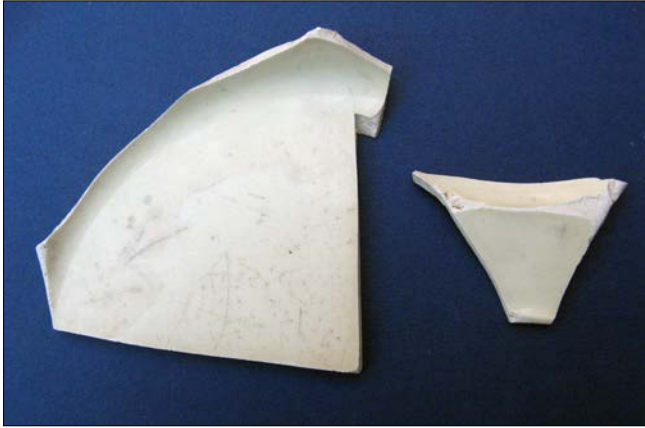
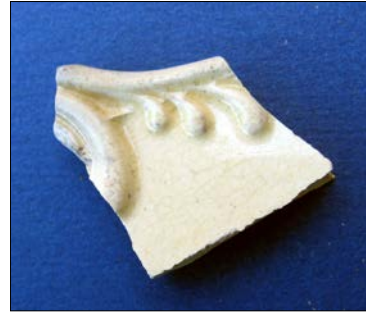
Figure 30a-b: examples of creamware. Left, Royal pattern; right, feather-edged

Creamware was the dominant ceramic of the early features, comprising 63% of all ceramics in the assemblage. Recognizable vessel forms included plates, mugs, and -not unexpected, given the association with a privy- chamber pots. This is in keeping with the almost universal popularity of cream-colored earthenware in the late 18<sup>th</sup> century. After Josiah Wedgwood ventured into business on his own in 1759, he found the green glazed ware was not so popular, and he turned his attention to refinement of the cream-colored ware, later called Queensware (after a set given the queen of England). Wedgwood appears to have perfected this ware by 1762, although diverse archaeological sites have produced nearly irrefutable evidence of earlier use (cf. Deagan 1975). Regardless of the initial manufacture date, by the 1770s these wares could be found in the four corners of the colonial world, and are ubiquitous on archaeological sites of the period. In her study of 18<sup>th</sup> -century consumerism, Ann Smart Martin (1994b:169-185) has commented that Wedgwood himself marveled at how quickly creamware “spread over the whole Globe and how universally it is liked.” What is remarkable in Martin’s view is that Wedgwood managed to compress the cycle of luxury-to-common consumption into a very short period. By continually bringing out new styles, Wedgwood satisfied both the middle class consumer eager to display their knowledge of manners and the fashionably wealthy who sought to distance themselves from the middling sort (Martin 1994a, 1994b, 1996). Creamware came in highly decorated and expensive styles, and in relatively plain and affordable patterns. Like other colonial residents, Charlestonians flocked to the new ware, and

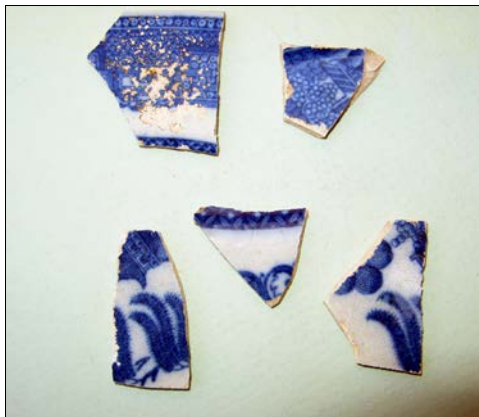
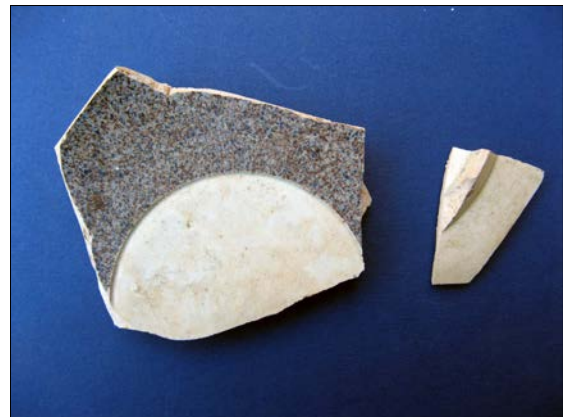
Figure 31: Examples of pearlware: Transfer printed (left), spattered (right)

Two additional decorative styles were applied to pearlware after 1795, and they dominate early 19<sup>th</sup>-century ceramics. Transfer or bat printing involved the creation of detailed designs in a myriad of patterns. The North Staffordshire potters, led by Josiah Spode, successfully produced this blue-on-white ware in 1784. This development, coupled with a significant reduction in the importation of porcelains from Canton after 1793, resulted in a large market for the new wares (Copeland 1994:7; Miller 1991). Transfer-printed wares, the most expensive of all the decorated refined earthenwares, are usually recovered in a wide variety of forms; plates of all sizes, bowls of all sizes, tea cups and coffee cups, with or without handles, mugs and saucers. The list of service pieces is equally lengthy, including platters, tureens, and tea wares. Four fragments were recovered here. The feature assemblage also included two fragments of a saucer featuring a spattered pattern.

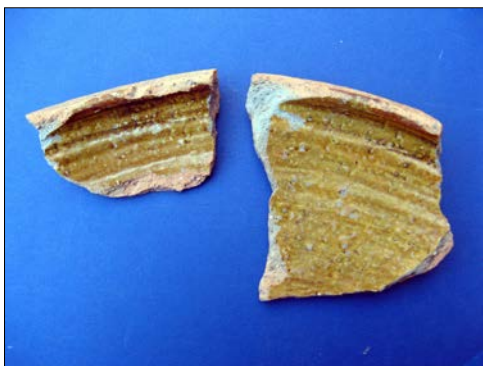
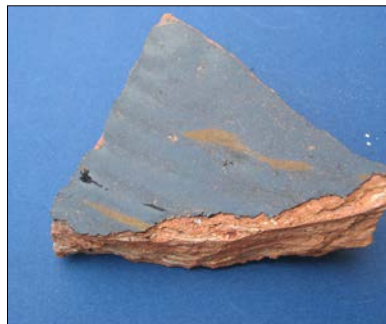
Figure 32: (above) North Devon Gravel Tempered Ware  
Figure 33: (right) Buckley earthenware

The early 19<sup>th</sup> century proveniences also yielded a small number fragments from utilitarian ceramics. European earthenwares comprised 6% of the ceramic assemblage, while stonewares contributed another 2%. Each type was represented by a few sherds. North Devon gravel tempered ware consists of smooth red and gray clay with heavy quartz inclusions, hence its name. The interior of the vessel is coated with a thick apple-green lead glaze. The lowcountry examples are usually cream pans or one-gallon pots. Feature 11 contained two large fragments

from pans. Buckley ware features an agate-like body of red and yellow clays, but the heavy vessels are ribbed on the interior and/or exterior and covered with a thick, black lead glaze. A single fragment was recovered. forms include cream pans and bowls, glazed only on one side and large storage jars glazed on both sides (Noel 1969:135).

with a thick, black lead glaze on the interior, as seen in the fragment from Charleston (Hume 1969:135).

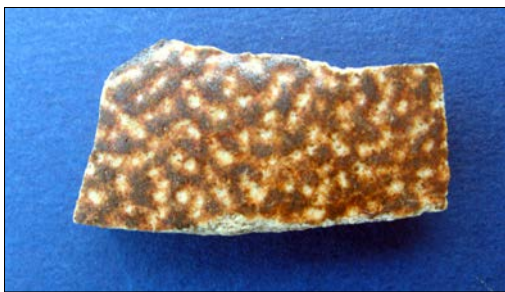
Figure 34: Brown saltglazed stoneware

Other utilitarian ceramics were stonewares. Noel Hume suggests that these wares were manufactured in the Rhineland and imported into England; they were then shipped to the colonies in large numbers in the 17<sup>th</sup> and first half of the 18<sup>th</sup> centuries. After 1760, the Rhineland's virtual monopoly was broken by the potters of Staffordshire (Noel Hume 1969:276). The most common ware was brown saltglazed stoneware. While the 17<sup>th</sup> -century "bellarmine" jugs decorated with a bearded face are the best-known, the undecorated bottles of the 18<sup>th</sup> century are the most common in Charleston. Two fragments were recovered from the privy features.

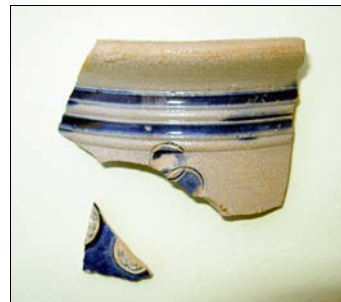
Figure 35: Westerwald stoneware

Somewhat less common were fragments of Westerwald stoneware. This ceramic is gray-bodied and decorated in blue. Vessel forms for the mid-18<sup>th</sup> century include chamber pots, small crocks, and mugs of various sizes; earlier 18<sup>th</sup> century sites contain jugs with bulbous bodies and reed necks, and porringers. A single fragment was recovered in the privy features.

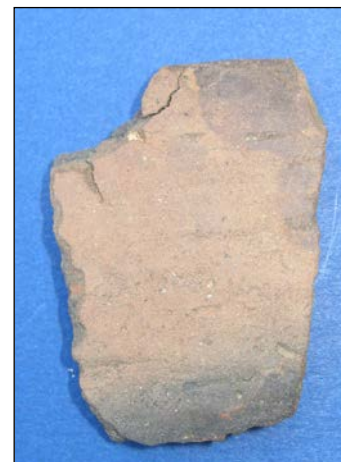
Figure 36: example of colono ware

The 2007 excavations yielded a broad range of European ceramics associated with the 18<sup>th</sup> century, but locally made colonowares are a significant portion of the assemblage. Taken together, the varieties of colonoware comprise 7% of the ceramics recovered from the early 19<sup>th</sup> century features, and this pottery is found throughout the later deposits. This assemblage includes a number of wares produced by Native Americans of the historic period, as well as the more commonly-defined wares associated with African American sites in the lowcountry. The Drayton Hall colonowares were subjected to detailed analysis by Ronald Anthony, and are discussed in depth in Chapter V; thus they are not discussed further here.

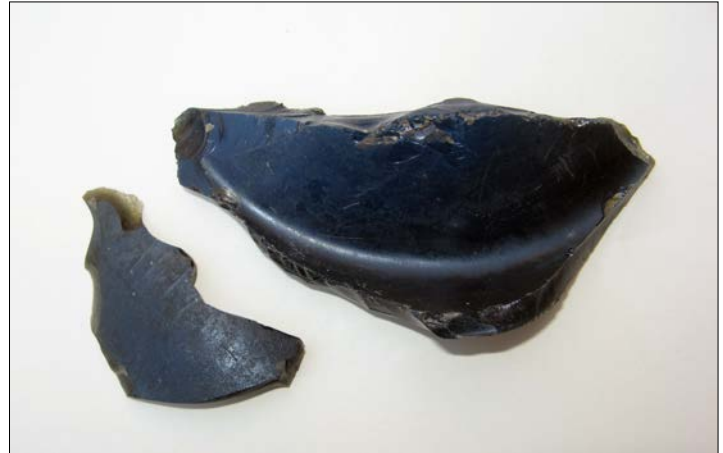
Figure 37: Examples of olive green glass bottles. The fragment appears to have a worked edge.

Another fragment of green glass appears to have been worked on the edge, possibly creating a shaving or scraping tool.

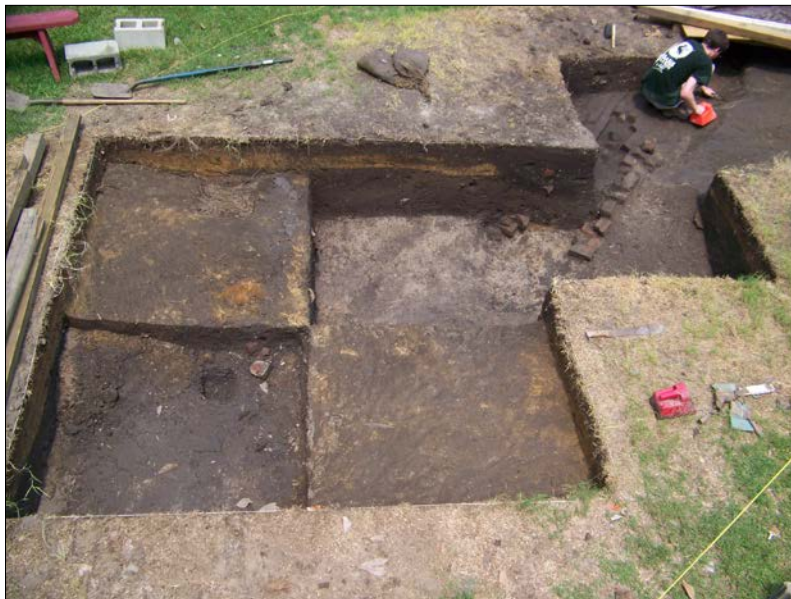
Figure 55: Soil profile above the drain in 2007. Yellow sand fill is visible in the upper portions of the profile. These soils remain unexcavated in the northeast and southwest units. The southeastern unit has been excavated to the top of the drain. The northwest unit has exposed the artifacts concentrated in Feature 10, overlying Ditch 5. North is to the left of the image.

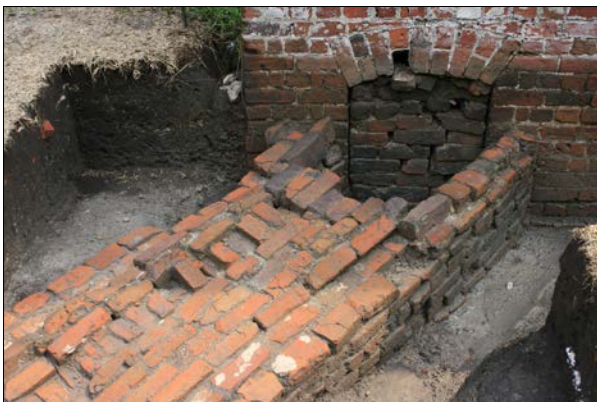
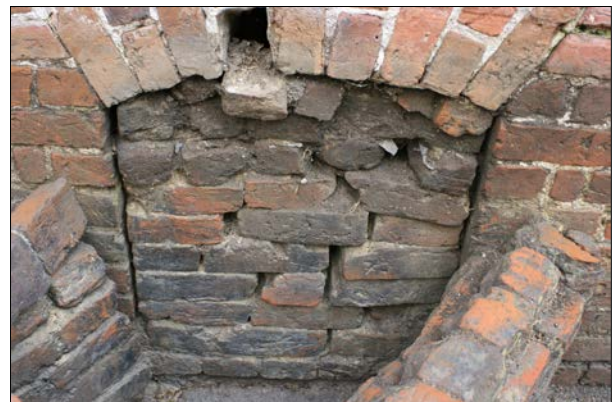
Figure 56: Views of interface of vault opening and drain. The opening was bricked after the 1980 excavations to stabilize the building and soils inside

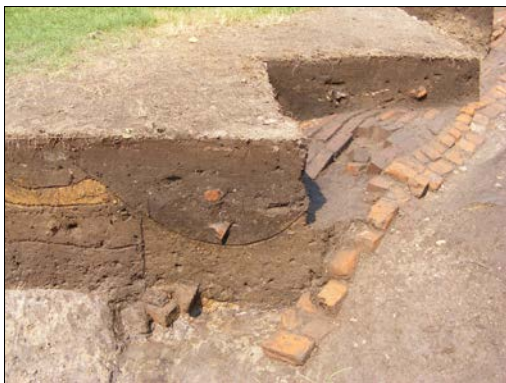
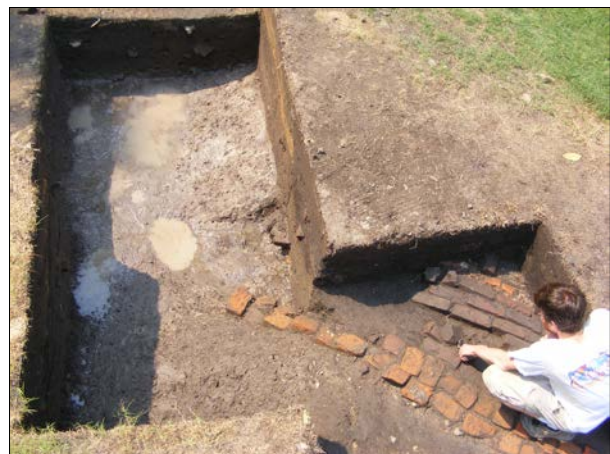
Figure 58: Terminus of drain; depression at end of drain

The brick drain continued to the northwest 32 feet and terminated abruptly, without additional architectural features. Lewis exposed the terminus in unit DH 67. She noted the end was irregular, possibly indicating disturbance or removal of remaining sections. She did observe that a large area at the terminus appeared to have been dug out and filled with slag and gravel, possibly to create a leaching field. Based on this description, it was anticipated that the drain continued beyond this point, and 2007 excavations were located to search for an extension. None was found. Instead, re-exposure of the terminus suggested a finished edge, with some slight disturbance of the upper courses. The brick terminated in a depression of dark soil, filled with artifacts from the turn of the 19<sup>th</sup> century (DH 166C). The deposits also contained quantities of slag and phosphate, possibly the materials observed by Lewis and interpreted as a leach field.

Based on the current excavations, the brick drain appears to have terminated in a natural, or enhanced, low area. This area was filled with refuse in the early 19<sup>th</sup> century, at a time when owner Charles Drayton was making extensive changes to the property. His map of the early 19<sup>th</sup> century shows a water feature in this vicinity, running north/south from the flanker building to a large drain. It is possible that the ditch indicated on the map was an adjustment to a natural low area, adjusted to enhance drainage of the living area. Curiously, the privy building is not present on this map. The archaeological evidence indicates that the privy drain connected to this drainage feature. Evidently, the drainage ditch was eventually filled and abandoned. Feature 10 (DH 166A-B) may be part of this effort. As indicated by the present structural problems with the privy, drainage of this area remains an issue.

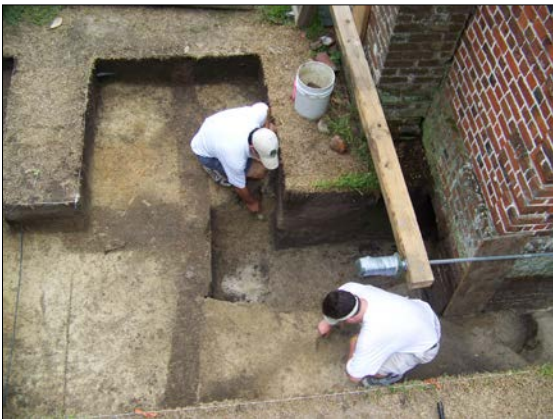
Figure 60: Views of Feature 7 on east side of structure

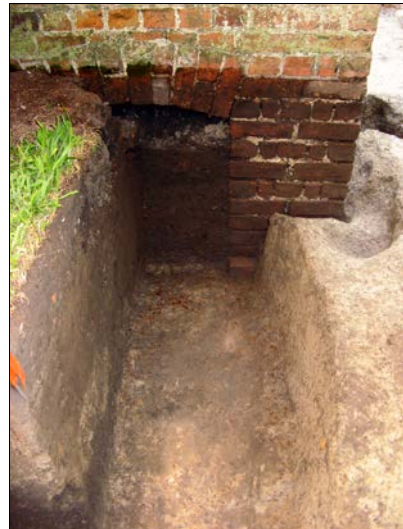
in length and 2.5' in width. From its point of definition at sterile subsoil, the feature was nearly 2' deep at the face of the building, the bottom parallel with the base of the arch. The pit exhibited straight sides and a slightly rounded bottom. The feature evidenced two fill episodes. Though the lower levels exhibited no obvious lensing, it is possible that this reflects a pit that remained open for some time. Feature 7 (DH 157A) terminated in a smaller, shallower feature. The feature was clearly excavated for access to the vaulted opening, but was not used for drainage. A near absence of cultural materials suggests that it was not used for refuse disposal, either. Likely, high ground on the east side of the structure made drainage here impractical. It is possible that the pit allowed access for flushing the vault.

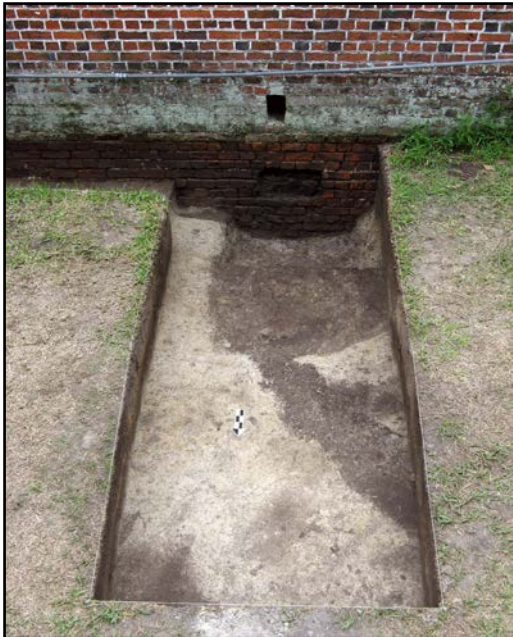
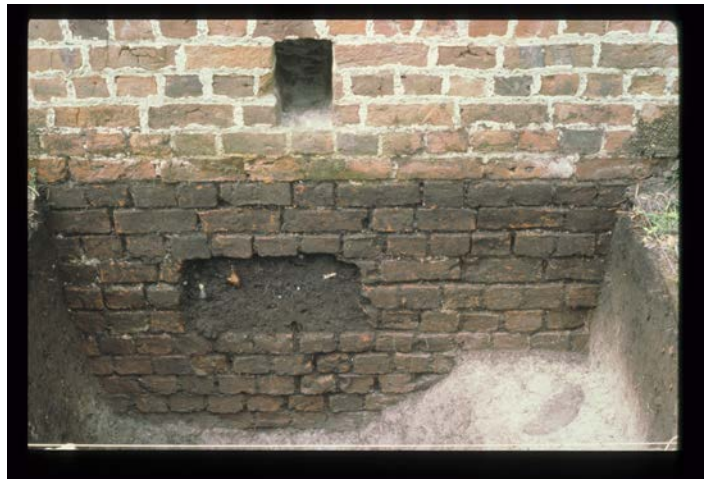
Figure 61: Views of opening in north foundation as excavated by Lewis in 1980 (right); Expanded excavation in 2007 and associated Feature 4.

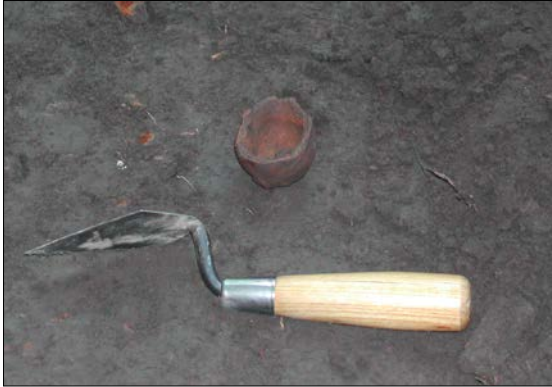
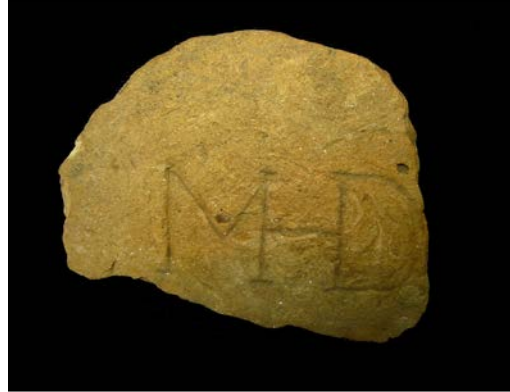
Figure 62: small hand-modeled pot from locus 22; colono ware with incised initials

Further support for on-site manufacture of colono ware within plantation settings was discovered at Drayton Hall plantation where Lewis (1978) recovered a basal fragment of a colono ware bowl, near the planter residence, with the initials “MHD” incised into the bowl before it had been fired. The initials may stand for Mary Henrietta Drayton who resided at Drayton Hall plantation from the 1780s to the 1840s (Lewis n.d.; Ferguson 1992). Additionally, in 2003, a very small crudely made bowl was recovered from Locus 22 at Drayton Hall plantation (Zierden and Anthony 2004). Based on its physical attributes, this vessel does not appear to be a market ware nor does it seem functionally viable. It is quite possible that this petite colono ware vessel represents a container made by a child, perhaps evidencing enculturation. This scenario further supports the on-site manufacture of colono ware within a plantation setting.

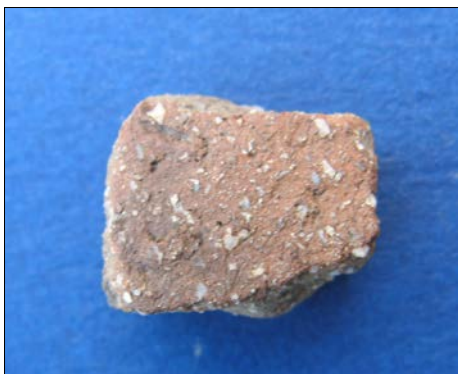
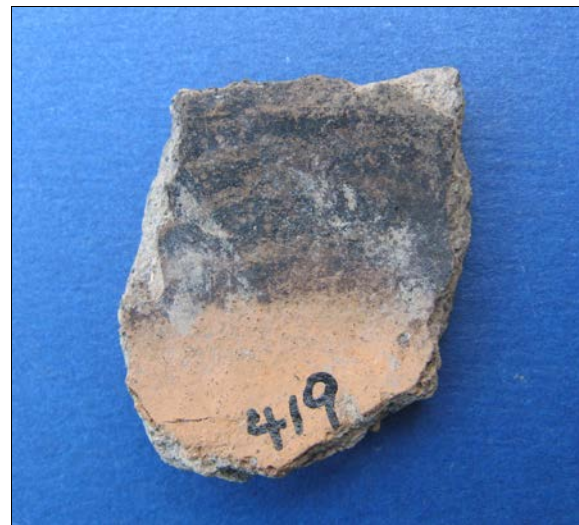
Figure 63: Examples of historic period Native American ceramics: shell tempered (left) and burnished (right)

produced and used by those interacting with Native American, as groups or individuals (Anthony 1986, 2002; Ferguson 1989; Wheaton et al 1983; Garrow and Wheaton 1989). This colono ware category includes earthenware whose surfaces have been complicated stamped and/or red filmed, as well as those whose surfaces have simply been burnished. Those vessels whose surfaces have been burnished and stamped usually exhibit a relatively coarse paste and medium to coarse sand temper (Anthony 2002). Less frequently, a crushed shell temper is observed. The red filmed vessels may or may not exhibit a medium to coarse paste. If not, then often they exhibit a laminar paste (Anthony 2005). This “red filming” seems to be a slip rather than a painted design like those associated with some River Burnished vessels. The burnished medium to coarse sand tempered ceramics may very well be the same pottery referred to as Colonial Burnished by Hamby and Joseph (2004) in their study of the Charleston County Judicial Center site. Table 9 depicts the frequency of colono ware by category recovered in 2003 and 2005 in locus 22, and in 2007 from the privy area.

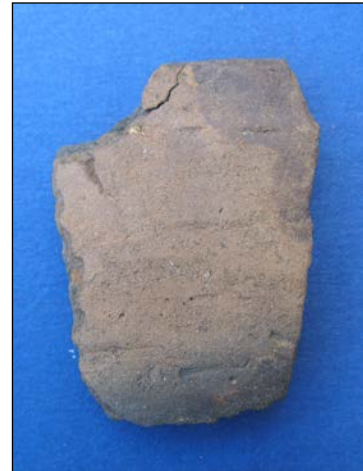
Figure 64: Lesesne lustered rim

As depicted in Table 9, Yaughan continues to be the most common variety of colono ware at Drayton Hall since 2003. Yaughan has been found most frequently in slave occupation areas, particularly residential loci. In rural contexts, Lesesne lustered colono ware occurs most frequently in planter occupation areas (Anthony 1986, 2002). Additionally, Lesesne appears to be the most abundant colono ware from downtown Charleston (Hamby and Joseph 2004; Isenbarger 2006; Zierden 2001). Lesesne lustered ware quite likely represents a market ware (cf. Anthony 1986; Hamby and Joseph 2004; Isenbarger 2001, 2006). River Burnished colono ware (Ferguson 1989) likely is another, though probably a later example.

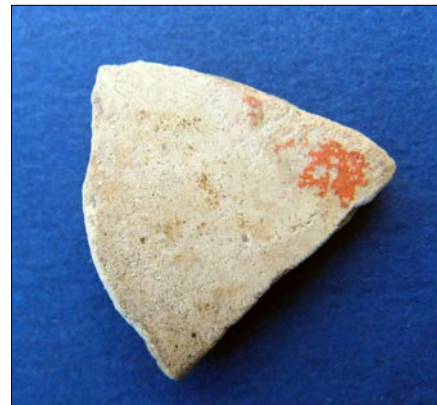
Figure 65: River burnished sherd with red pigment

River Burnished pottery (Ferguson 1989) is thin, well made earthenware, which at times exhibits burnished and painted surfaces that are most frequently decorated in black and/or luminescent red. Wares of this description are most common in late 18<sup>th</sup> to early 19<sup>th</sup>-century contexts. Designs observed on archaeologically recovered examples, from both rural and urban locales, include dots, lines, and floral motifs (Lewis n.d.; Zierden and Anthony 2004, 2006). River Burnished sherds recovered during the present investigation exhibited remnants of a red pigment (10R4/8). Since the 1980s, many researchers in South Carolina have suggested that River Burnished colono ware was initially produced and exchanged by Native Americans known since the late 18<sup>th</sup> century as the Catawba.

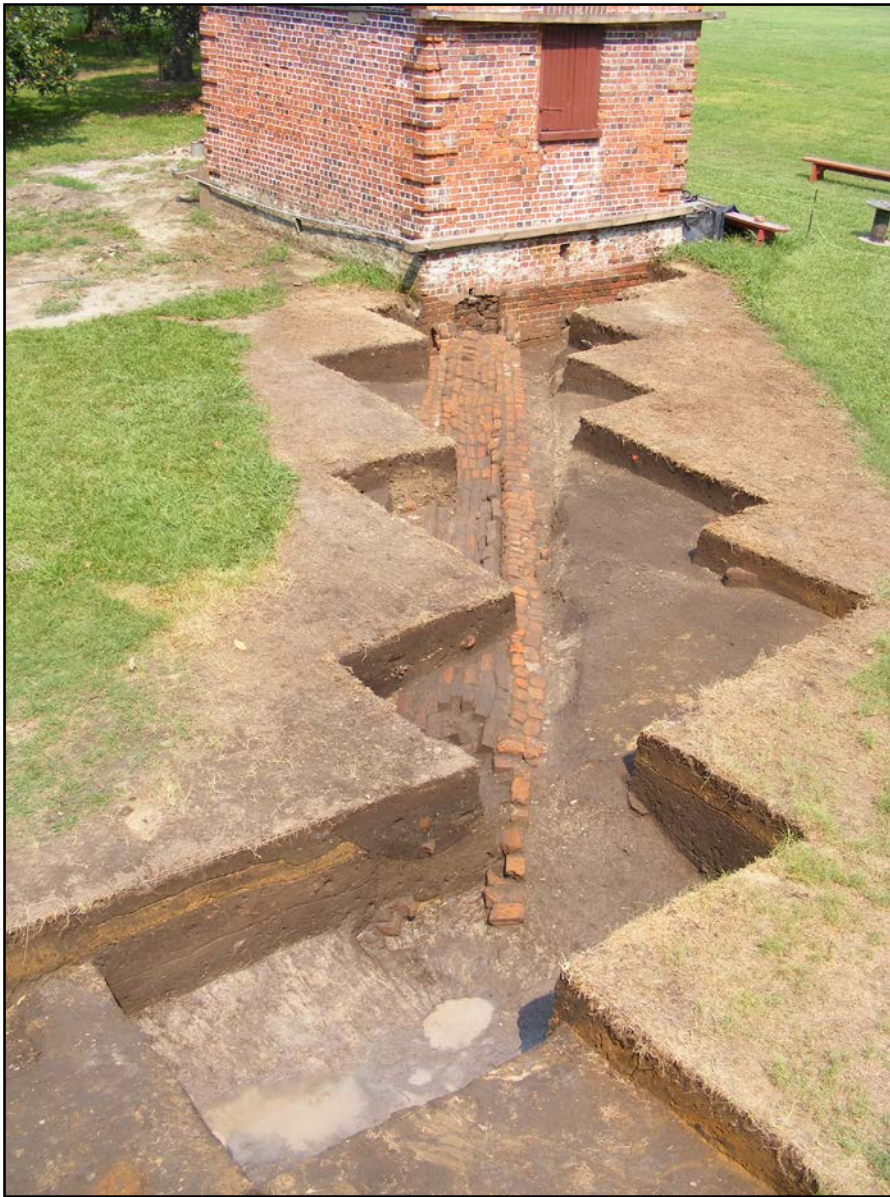
Figure 66: Drain and privy, facing southeast. Units on north, east, and south sides of building have been backfilled.
