ARCHAEOLOGICAL RESEARCH AT THE EXCHANGE BUILDING,
CHARLESTON, S.C.: 1979-80

Elaine B. Herold, Ph.D.
Research Associate

THE CHARLESTON MUSEUM
360 Meeting Street
Charleston, SC 29403
March 1, 1981

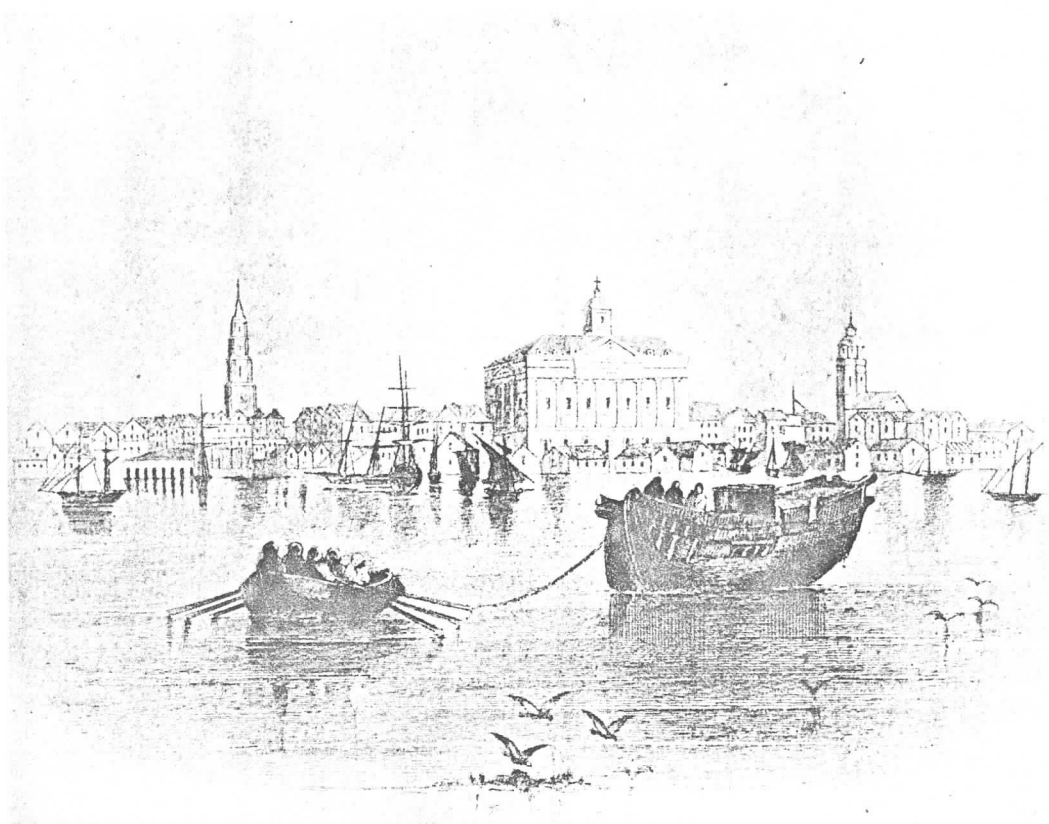
CHARLESTOWN IN 1780, SHOWING THE EXCHANGE BEFORE ALTERATION
From an Old Print

Figure 1. An old print showing the east side of the Exchange Building in 1780. From the *Dwelling Houses of Charleston* by Alice R. Huger Smith and D. E. Huger Smith, p. 265.

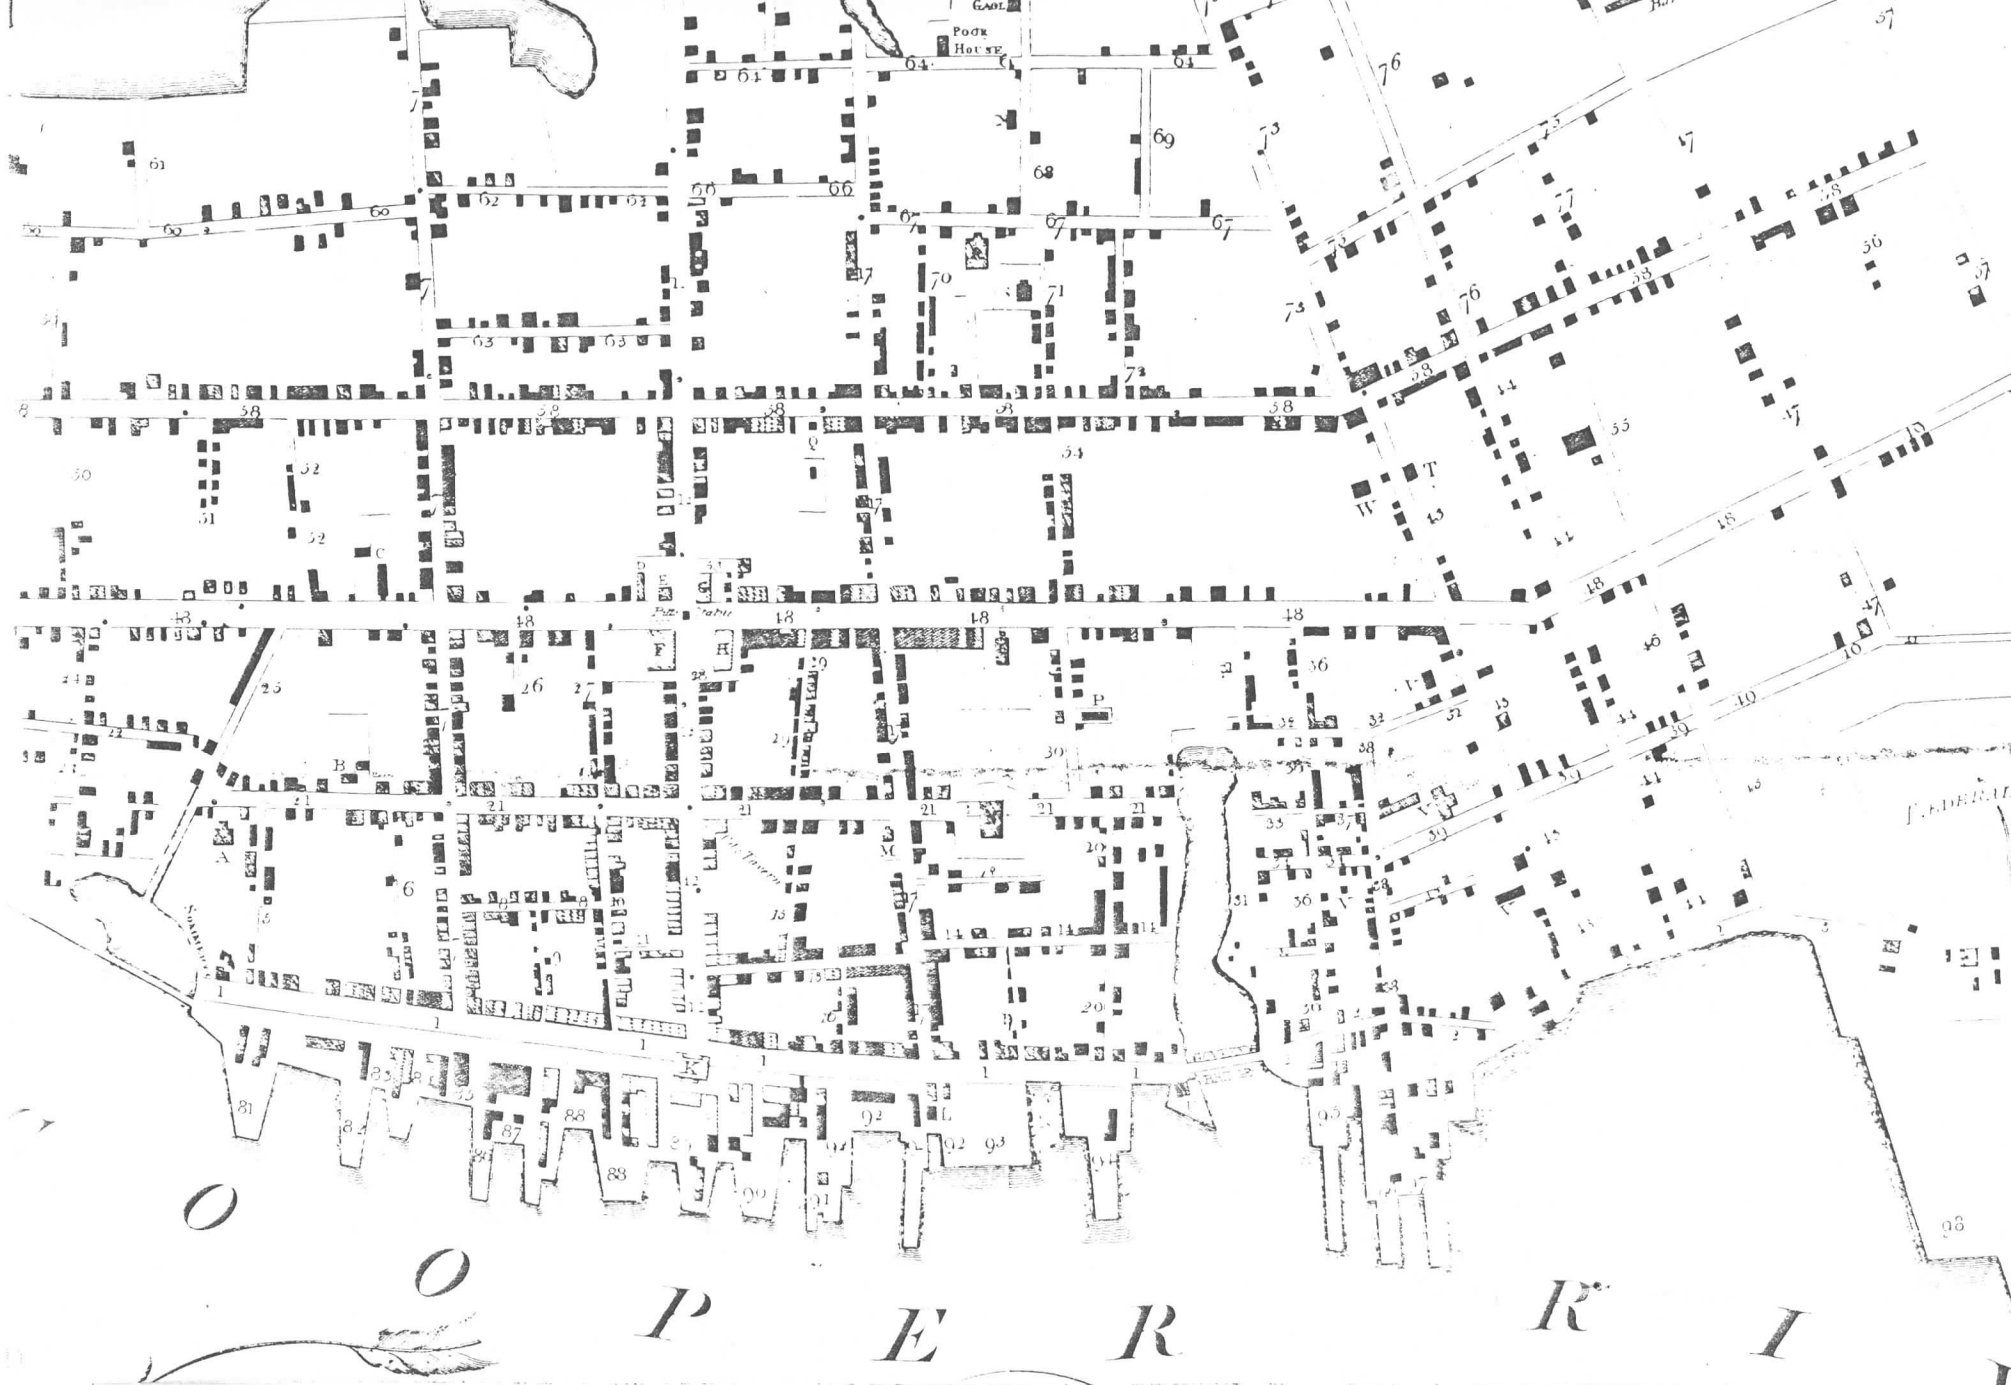
Figure 3. A portion of the 1788 map of Charleston made for the use of the Phoenix Fire-Company of London. The Exchange Building (K) occupies the area at the foot of Broad Street. From the reproduction of an engraving in the Library of Congress.

At the time of the original grant, much of the land east of the street was low. The 1739 map of Charleston (Figure 2) shows no construction directly east of the Half Moon Battery. By 1788, however, buildings extended about 230 feet east of the Exchange and beyond that for another 160 feet or so there were wharves (Figure 3).

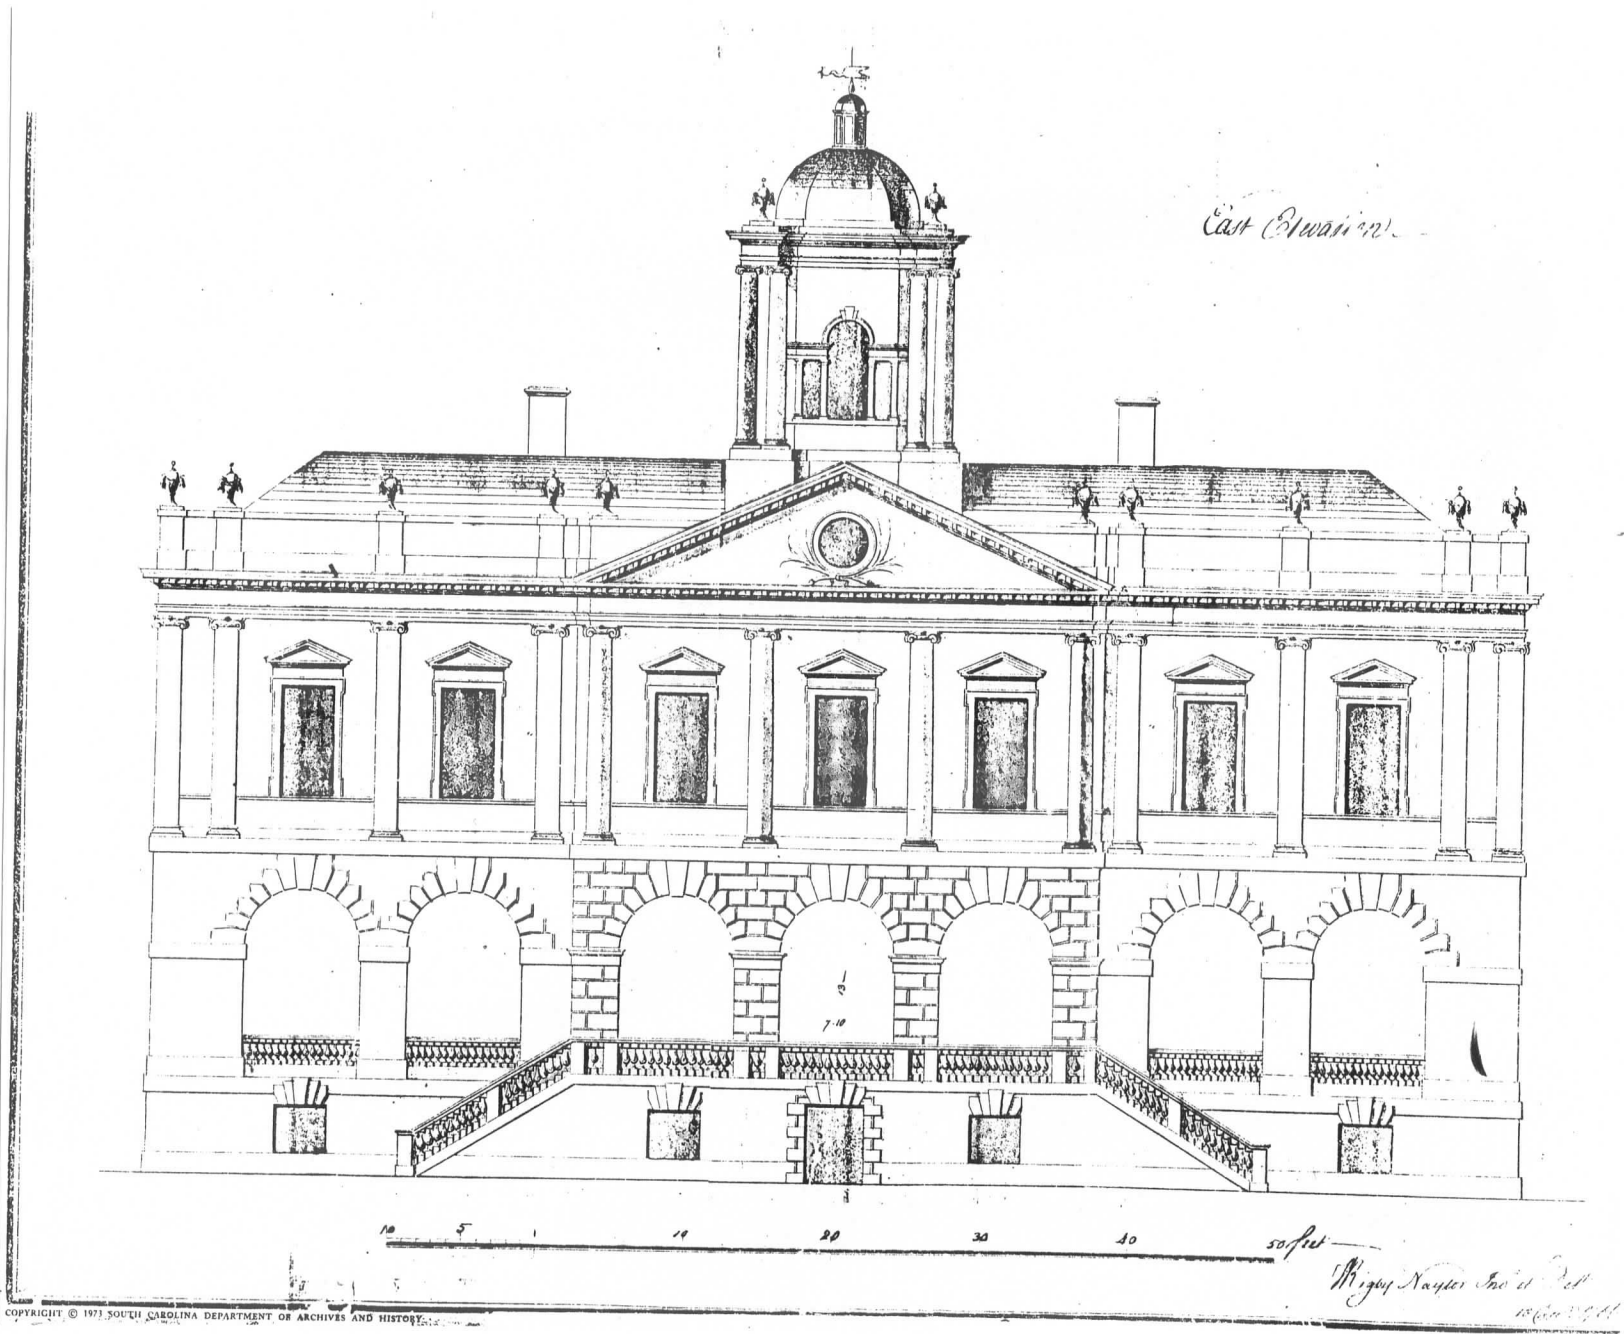
Figure 4. William Rigby Naylor's plan for the east side of the Exchange Building, 1766. From a 1973 reproduction by the South Carolina Department of Archives and History.

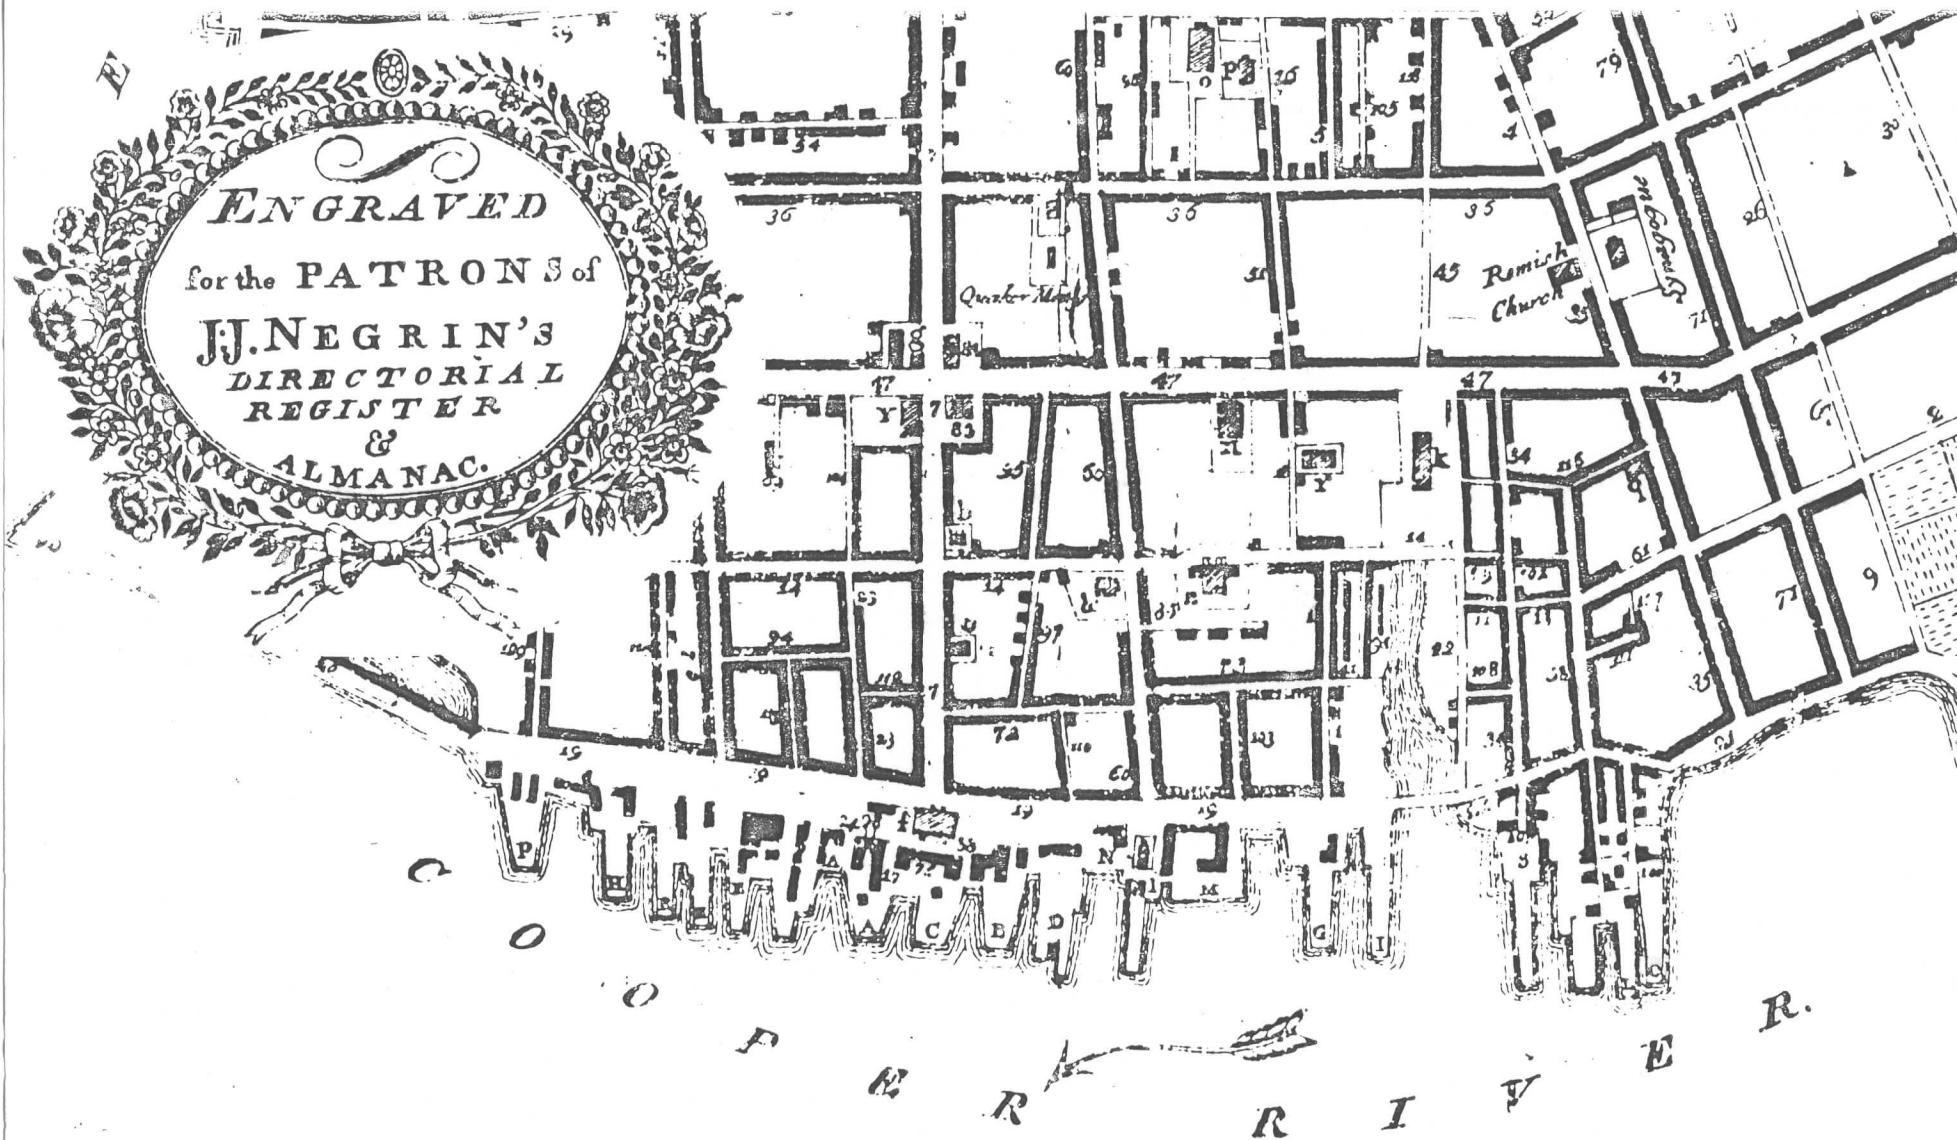
Figure 7. A portion of the 1802 map of Charleston engraved for the patrons of J. J. Negrin's Directorial Register and Almanac showing the Exchange Building at the foot of Broad Street. In this map the towers on the west side appear to have been removed and replaced by stairs. The original of the map is at the South Carolina Historical Society.

Not too long after the completion of the building, it became necessary to modify it. As the city grew and traffic increased, East Bay Street was widened. Califf (1873, p. 4) reports that although plans were made for the widening of the street in 1787, the towers or stair bays on the west side probably were not removed until some time between 1805 and November 1817, when another plat shows they were gone (Figure 8). A recently discovered advertisement in the *City Gazette and Daily Advertiser* requested bids for the removal of the towers and replacement of the stairs on August 16, 1800. The appearance of the building on a map of Charleston at the South Carolina Historical Society suggests that the towers had been removed by 1802 (Figure 7).

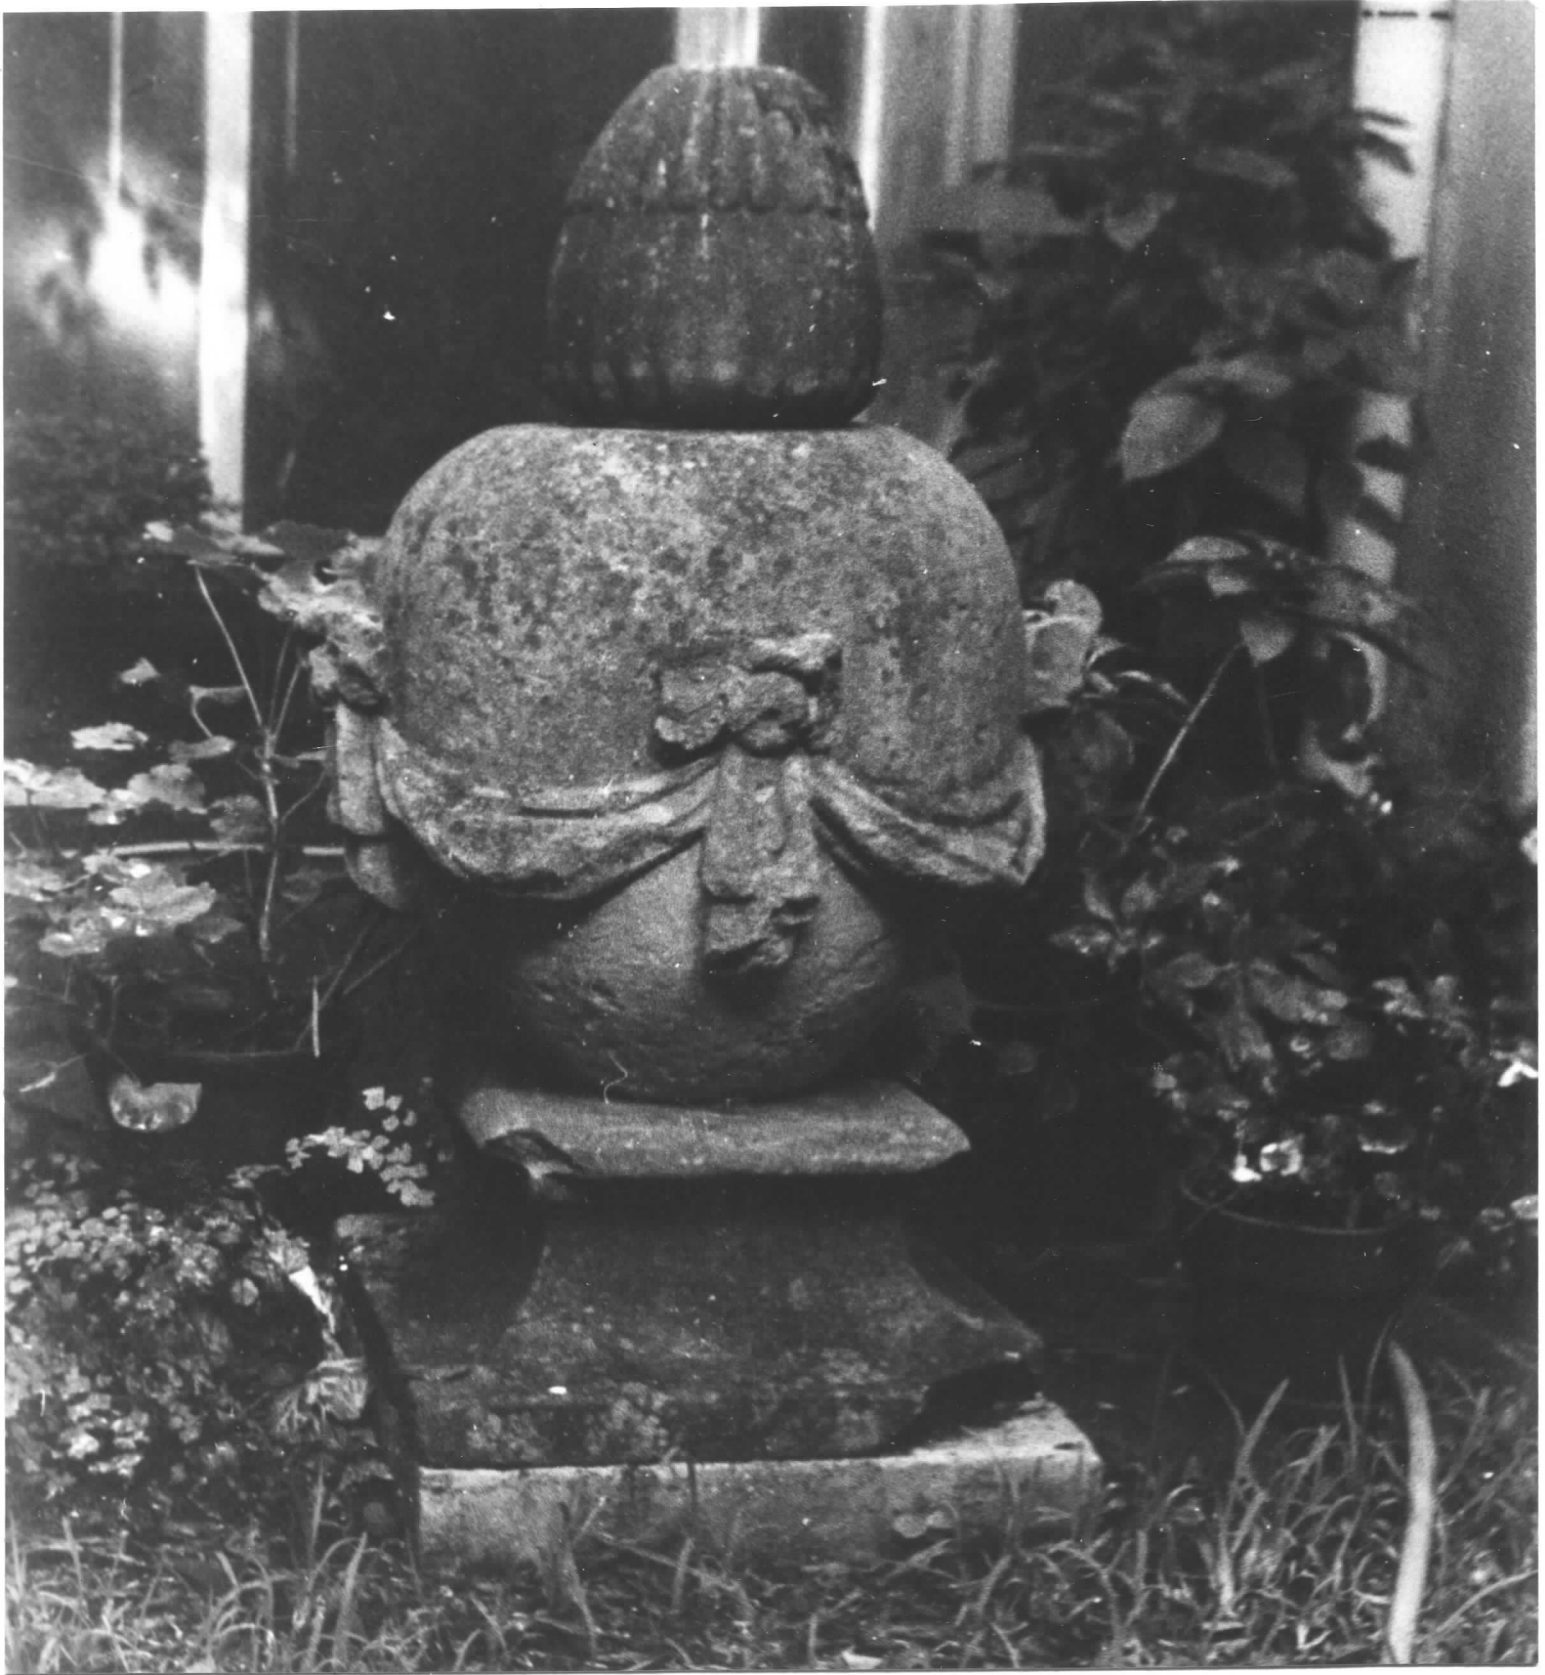
Figure 12. A stone urn reported to have come from the top of the Exchange Building, now in the garden of Mrs. Robert N. S. Whitelaw, Charleston.

The other most visible change in the building concerns the cupola on top. The original one was removed before 1817. Its replacement, designed by Charles Fraser, was put up in 1835 and remained in place until the 1886 earthquake damaged the building, when it, too, was taken down. At this time the parapet and the urns which ornamented it also were removed (Bryan 1973, p. 29). Two of the urns remain today in a garden in Charleston (Figure 12).

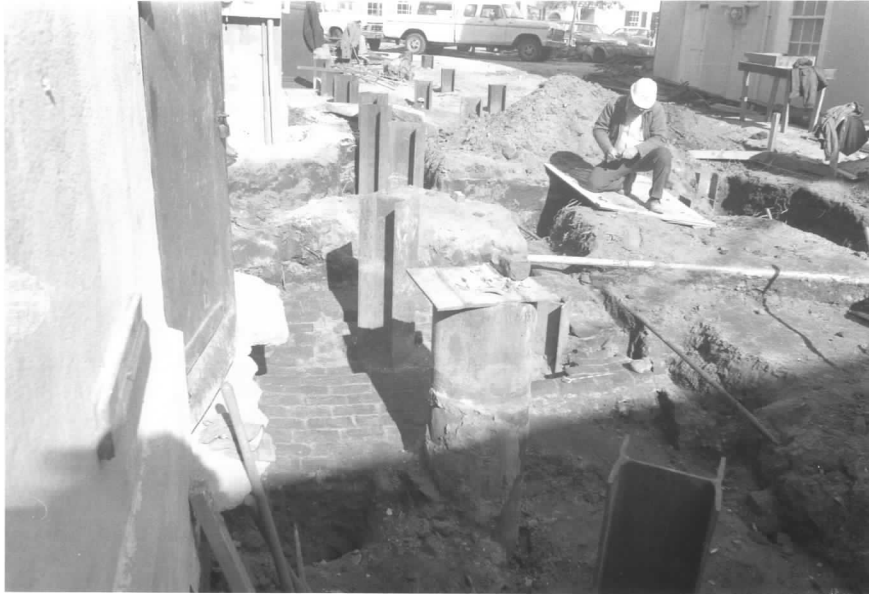
Figure 23. Photograph looking north on the east side of the Exchange Building, showing the paving in front of the south cellar door in the area of the Elevator Pit.

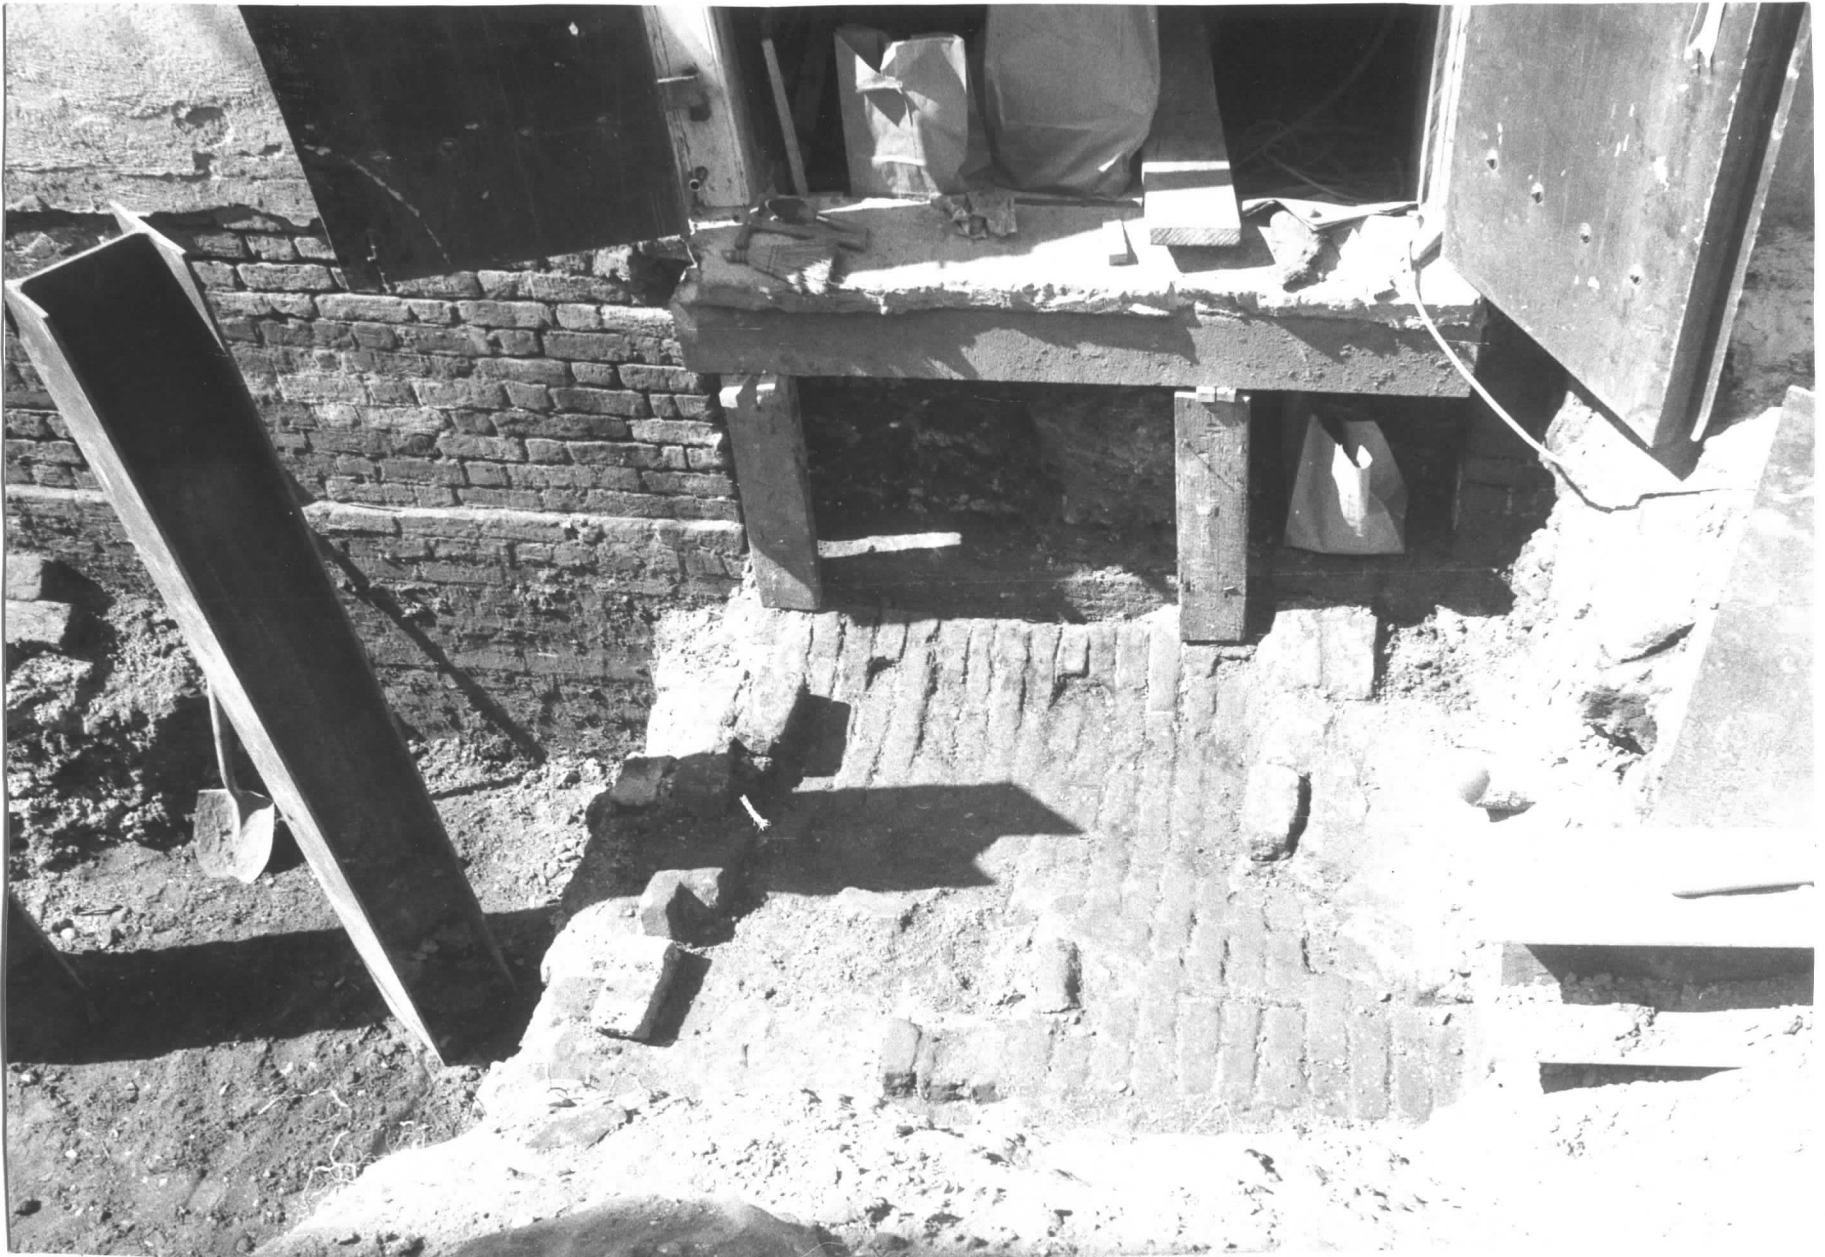
Figure 24. The original paving in front of the central cellar door on the east side of the Exchange Building.

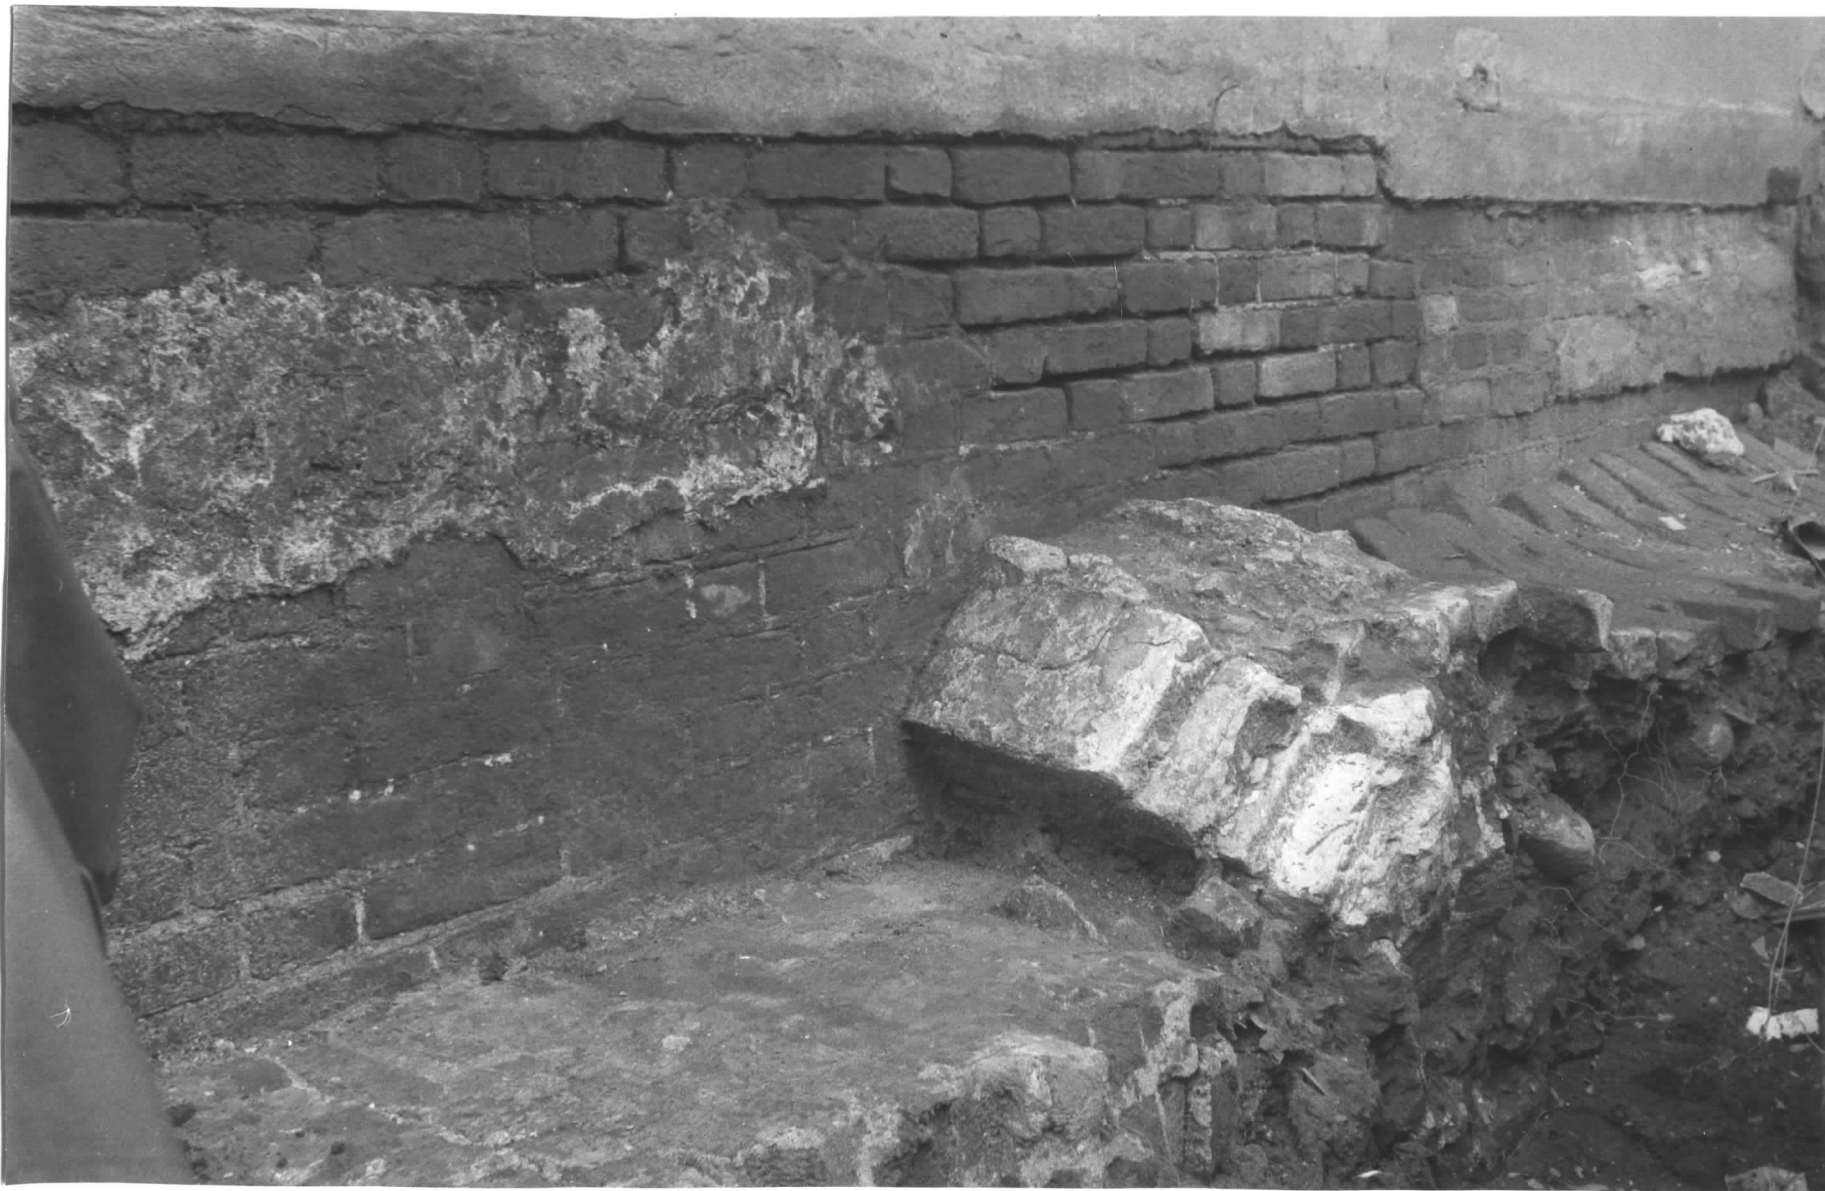
Figure 25. The north section of the east wall of the Exchange Building showing (left) remains of the plaster once on the wall of the room under the stairs, (center) the part of the wall which supported the foot of the stairs, and (right) the patched section of wall where the north cellar door was located and the paving in front of it.

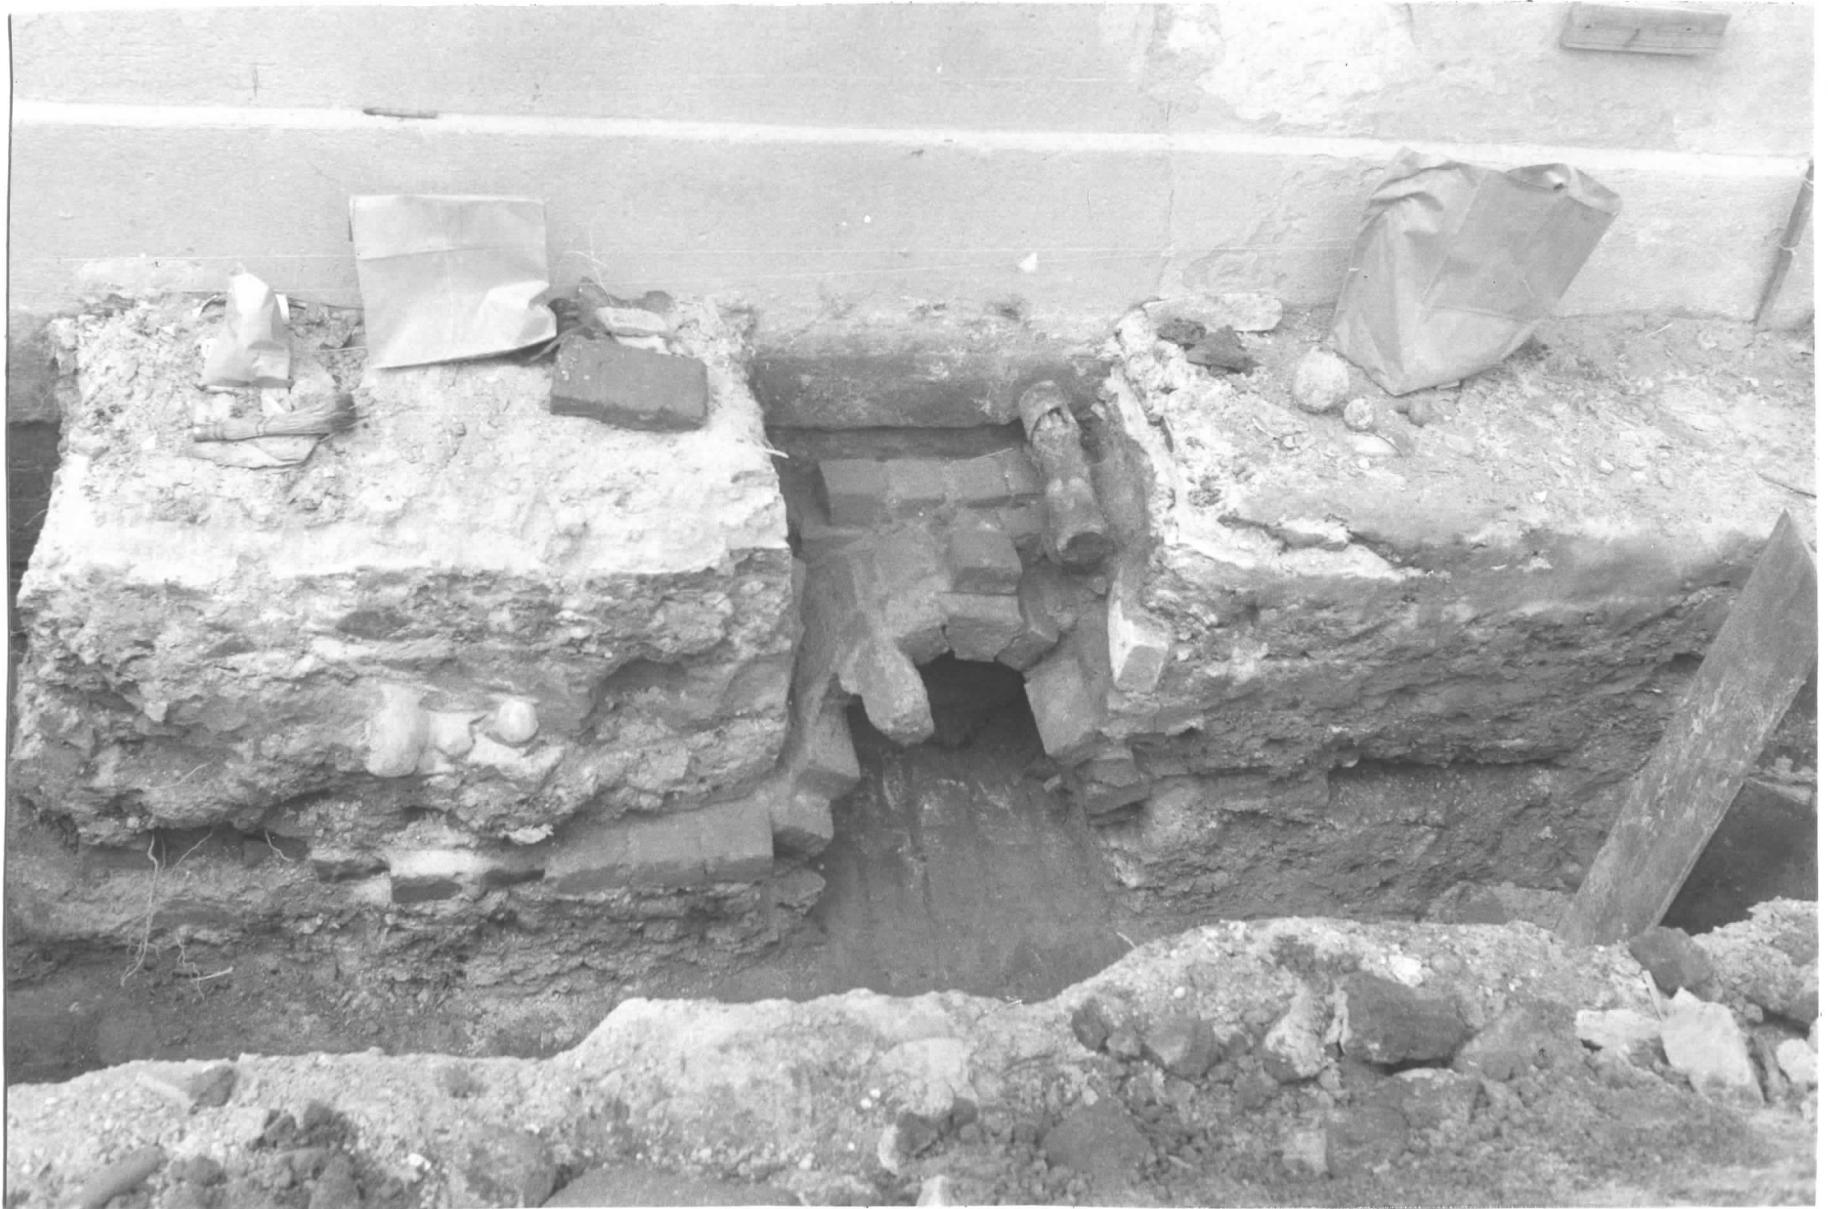
Figure 26. Photograph of the nineteenth century brick drain along the east wall of the Exchange Building in Section V. Note the iron drain pipe above it which goes into the wall.

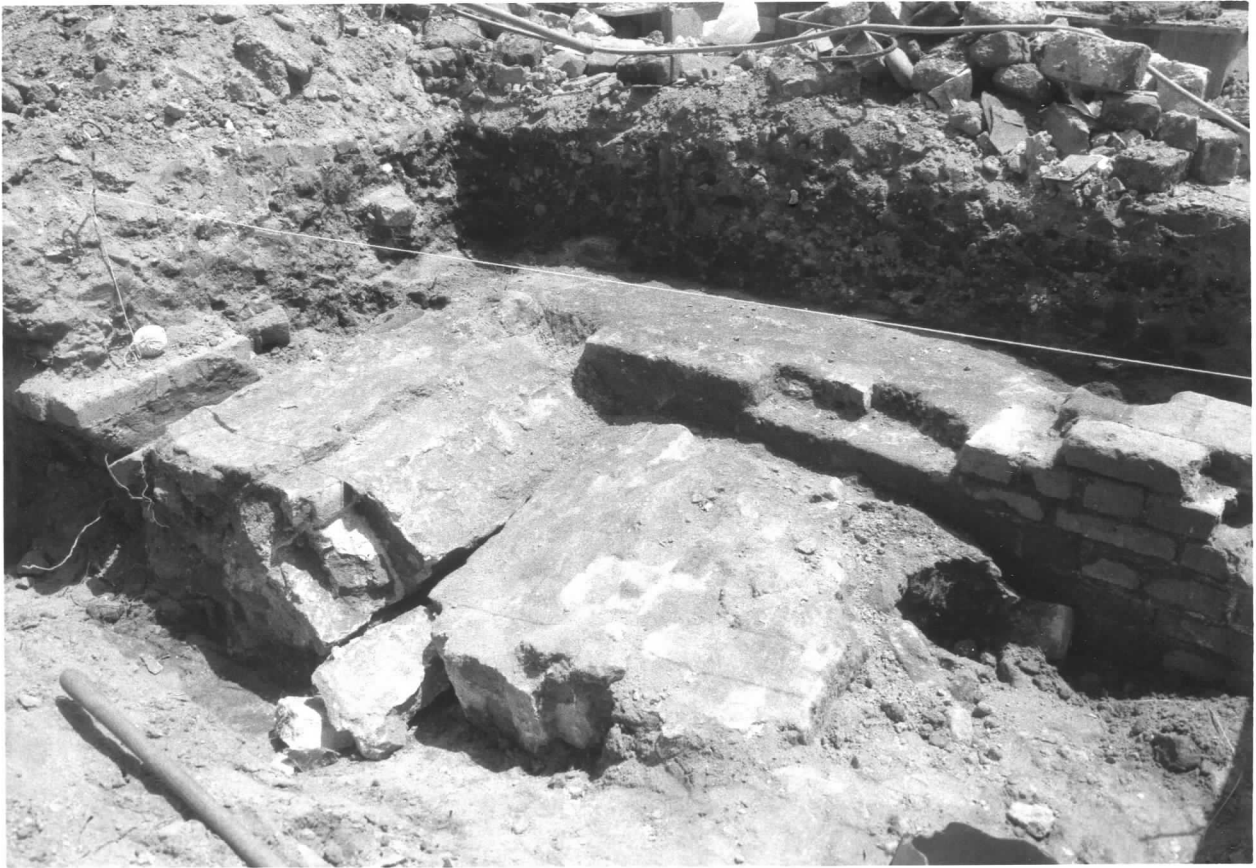
Figure 27. Photograph of the remaining part of the wall which supported the northeastern corner of the north stairs on the east side of the Exchange Building. The block in the center is the fallen wall from under the staircase.

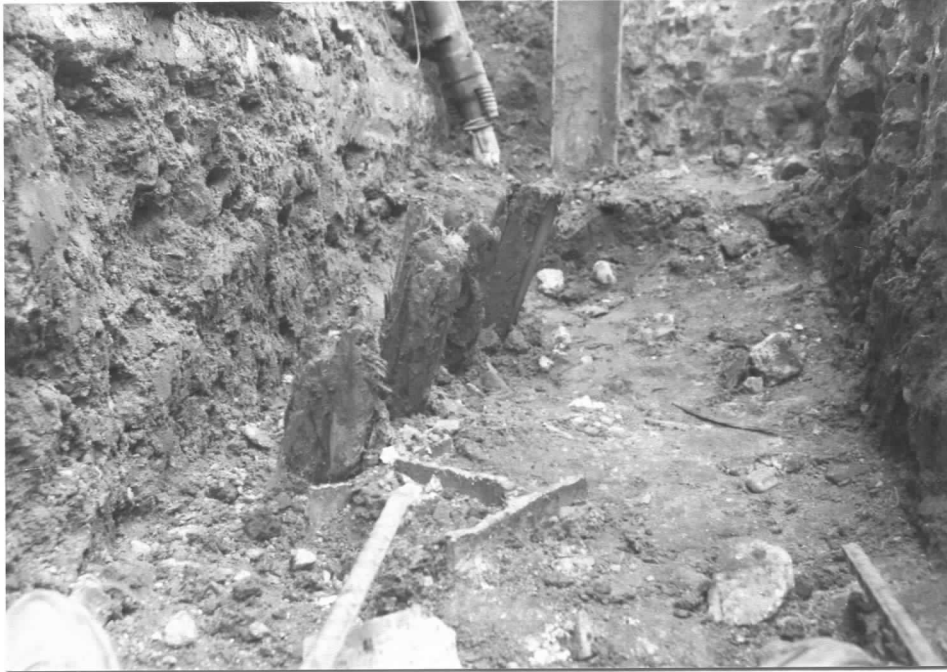
Figure 28. Photograph of the row of pilings put just inside the builder's trench to stabilize the bank at the time of construction of the Exchange Building.

A row of twelve pilings was found set just inside the edge of the builder's trench in the east side of the building, north of the central cellar door (Figure 20). The pilings were 0.2 to 0.45 feet in diameter, and the two that were recovered from the excavation were 7.5 feet long. Presumably they were placed there to stabilize the bank during construction, or the remains of an earlier barrier. Miller found evidence of a "coffer dam" in his excavation just east of the Half Moon Battery wall (Exchange File, Charleston Museum; see Appendix II).

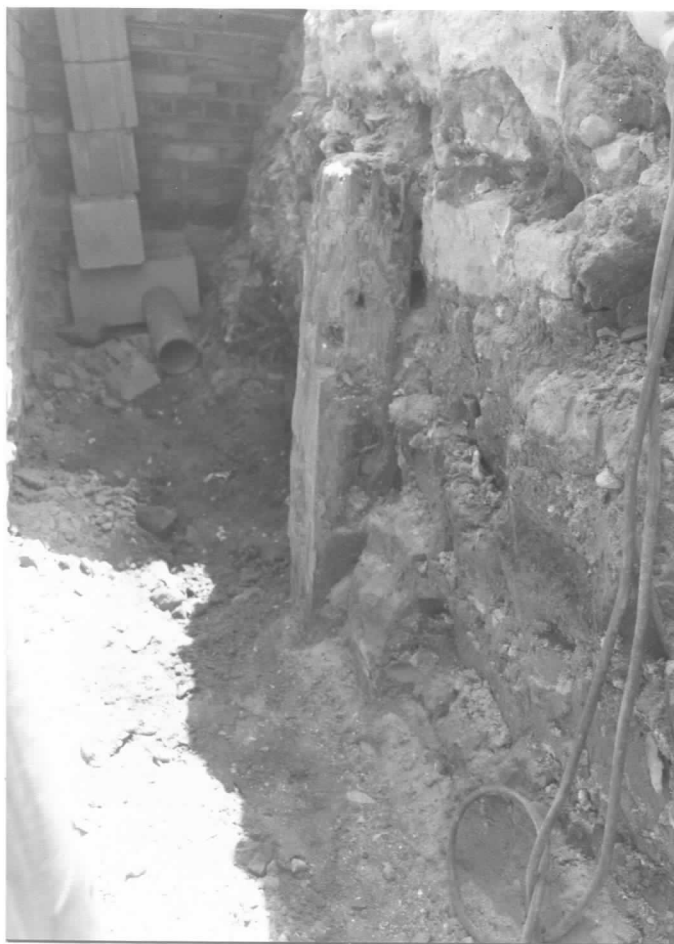
Figure 29. Photograph of post which was found at the edge of the paving north of the north stairs.

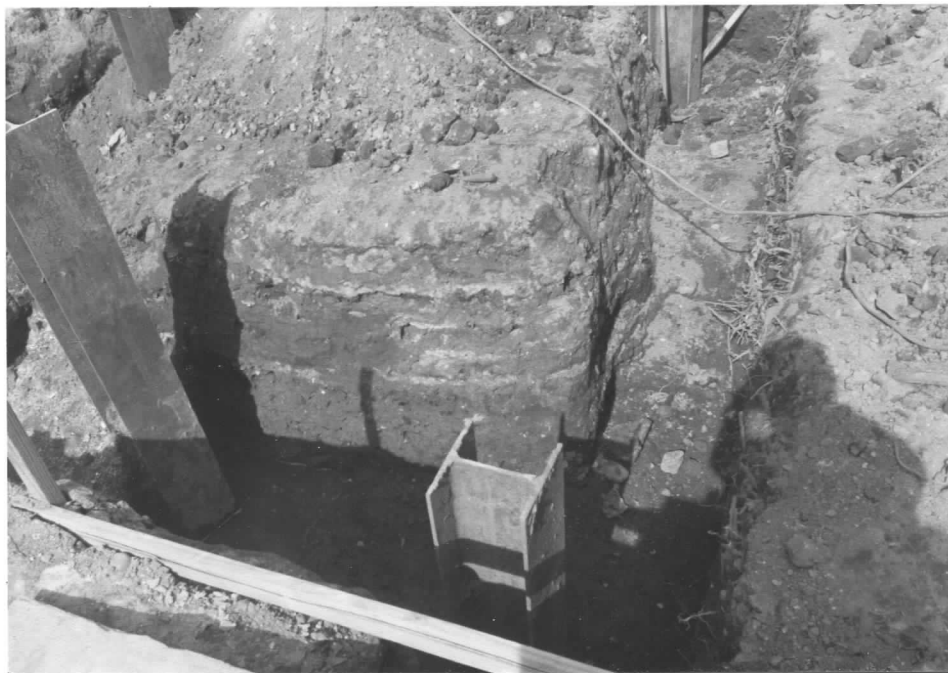
Figure 30. Photograph of the stratified layers of paving east of the building. The lowest layer shown was put down when the building was completed in 1771.
