ARCHAEOLOGICAL RESEARCH AT THE EXCHANGE BUILDING,
CHARLESTON, S.C.: 1979-80

Elaine B. Herold, Ph.D.
Research Associate

THE CHARLESTON MUSEUM
360 Meeting Street
Charleston, SC 29403
March 1, 1981

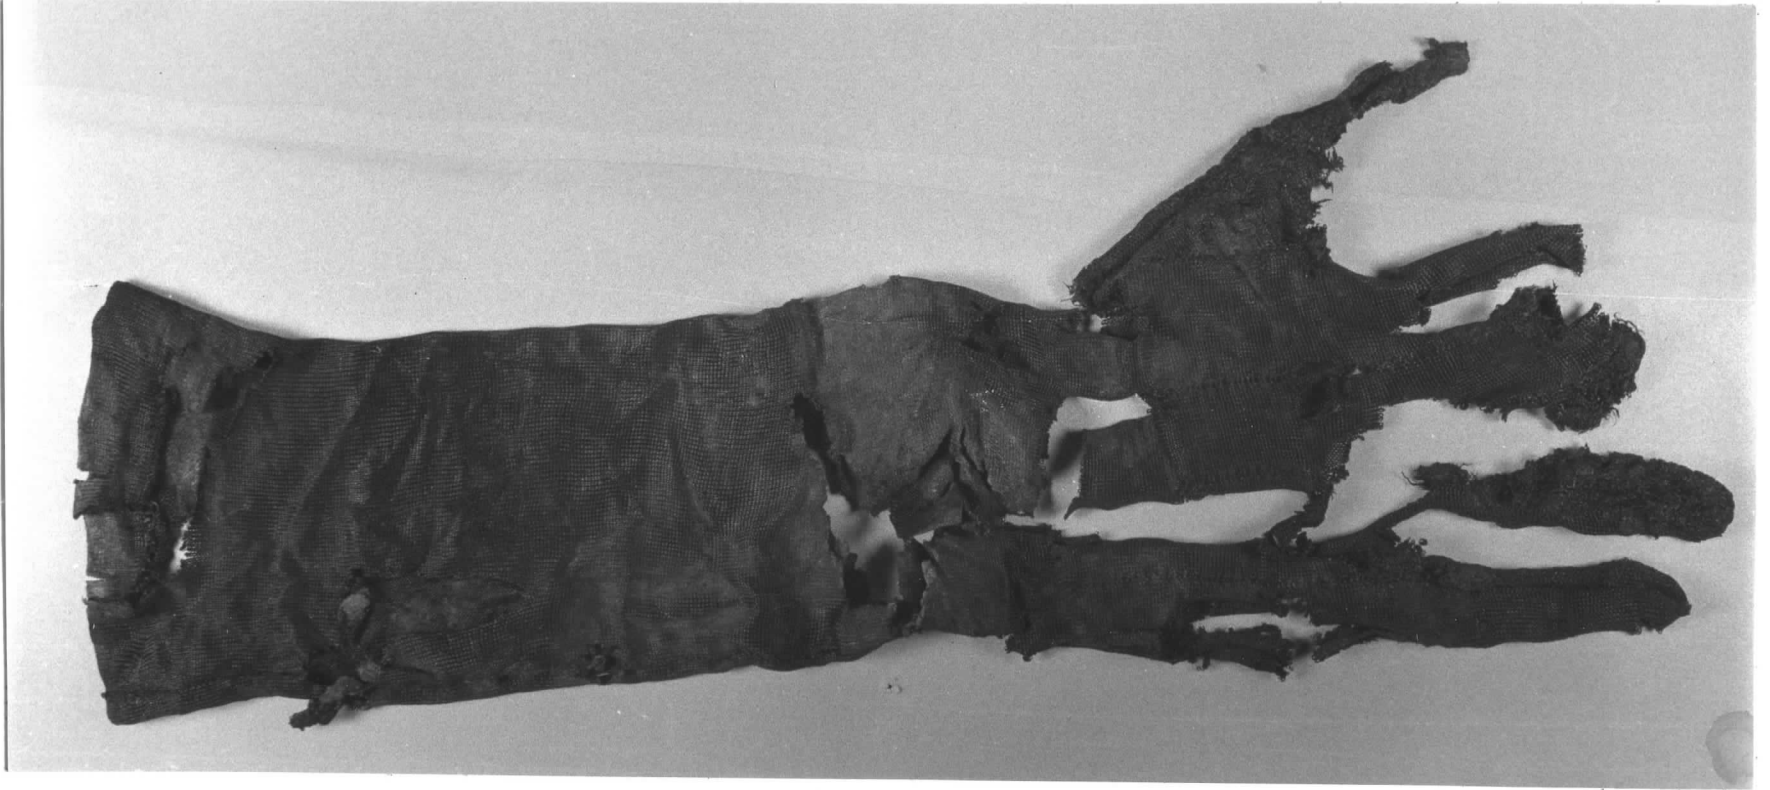
Figure 32. The worn glove found in the northeast corner of Section II, in the level predating the building. Length: 30.5cm.

The most complete specimen recovered was a lady's glove (Figure 32), which may be of silk. The fabric is knitted; the glove was elbow length, hemmed at the base and had been worn long enough to have required rather extensive repair of the fingers. When last worn, it had been removed by turning it and peeling it off so that all of it was inside out except the tips of the fingers. It comes from a level dating about 1767.

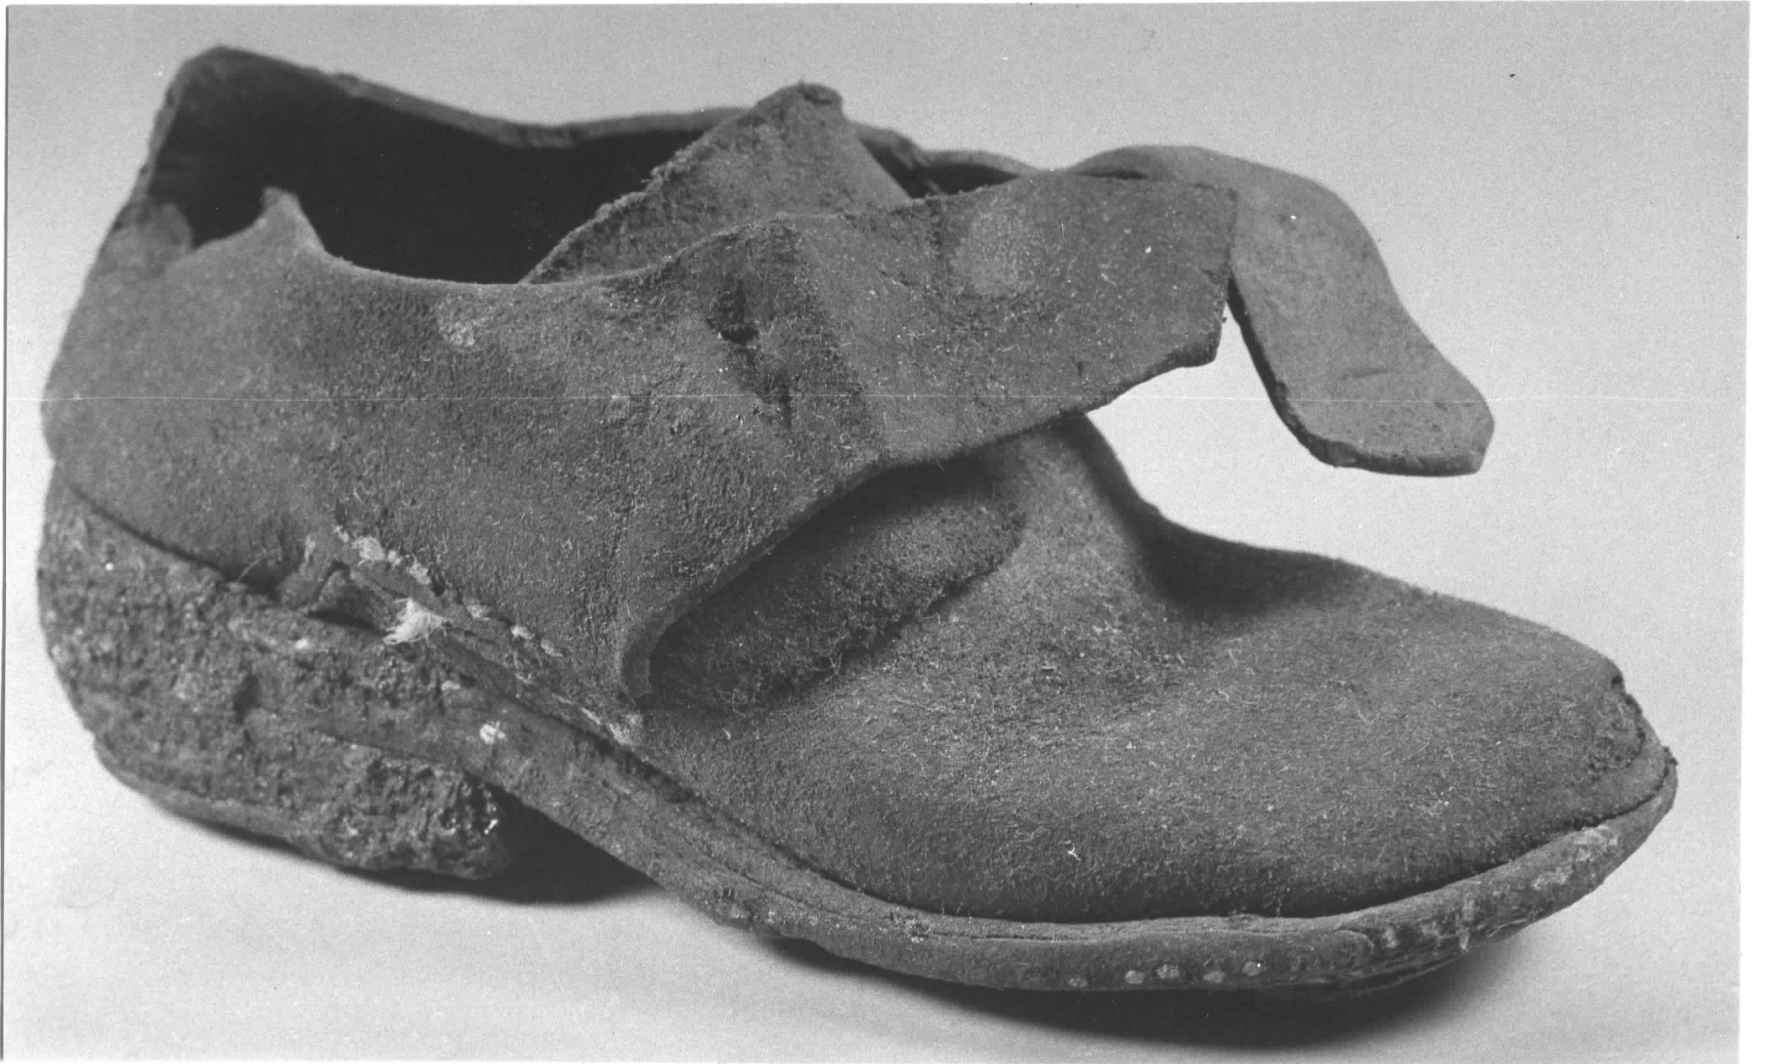
Figure 33. Child's leather shoe which was preserved in the pine pitch in the lowest level of excavation at the Exchange Building.

A total of 99 leather objects and trimmings were recovered from the excavations, and the majority of them predate the building, most of them coming from the level with the pine pitch. Forty-one of the specimens recovered are parts of shoes, the remainder are scraps and leather trimmings. Most interesting, perhaps, is the complete child's shoe (Figure 33) without a buckle. Both the toe and heel show evidence of hard wear. Other toe and heel fragments of shoes were included in the collection. Toes are pointed, as shoes were made for either foot. Heels were made of layers of leather sewed together. The entire shoe was fastened together by stitching.

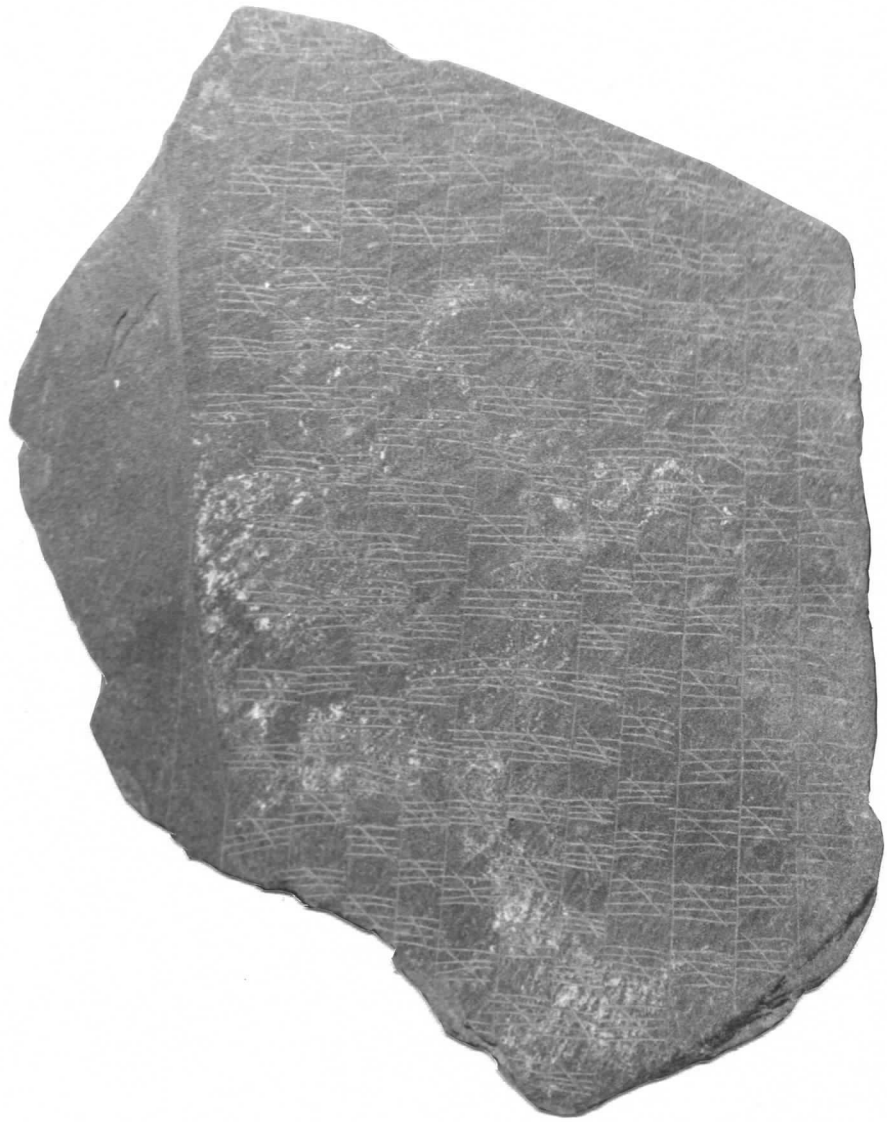
Figure 36. A piece of slate used to record a count of something in the past. Length: 15.7cm

Two pieces of slate are of special interest. One consists of a piece which evidently was used to keep a record, for both sides are covered with rows of groups of five straight lines, four arranged vertically and one cutting across them at a diagonal (Figure 36) -- the same procedure used in counting today. The other piece was decorated with what appear to be arcs from a pair of dividers and a possible capital "M" scratched in one side. This one was found in the layer predating the building.

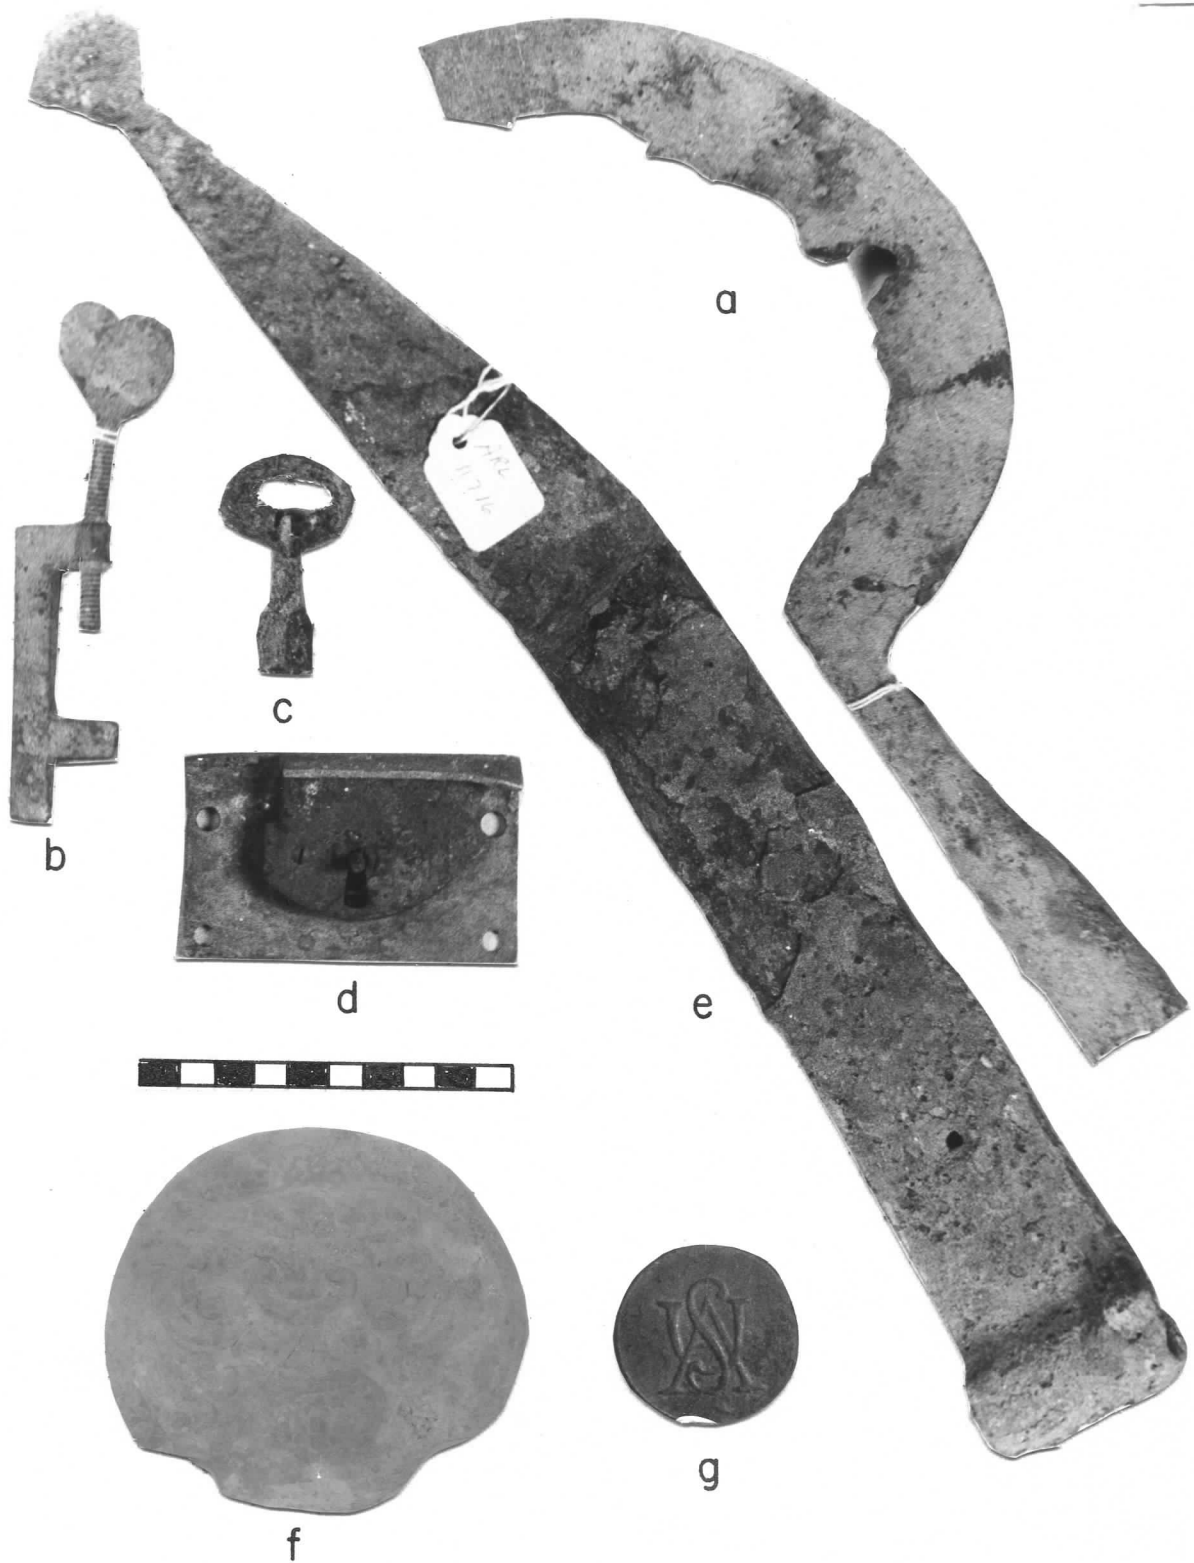
Figure 38. Metal artifacts from the Exchange Building excavations. a) sickle b) quilting frame clamp c) key d) brass lock e) hinge f) brass ornamental piece with molded leaf design, possibly from a piece of military equipment g) a button. Scale in centimeters applies to a-e, f is 5.5cm wide.

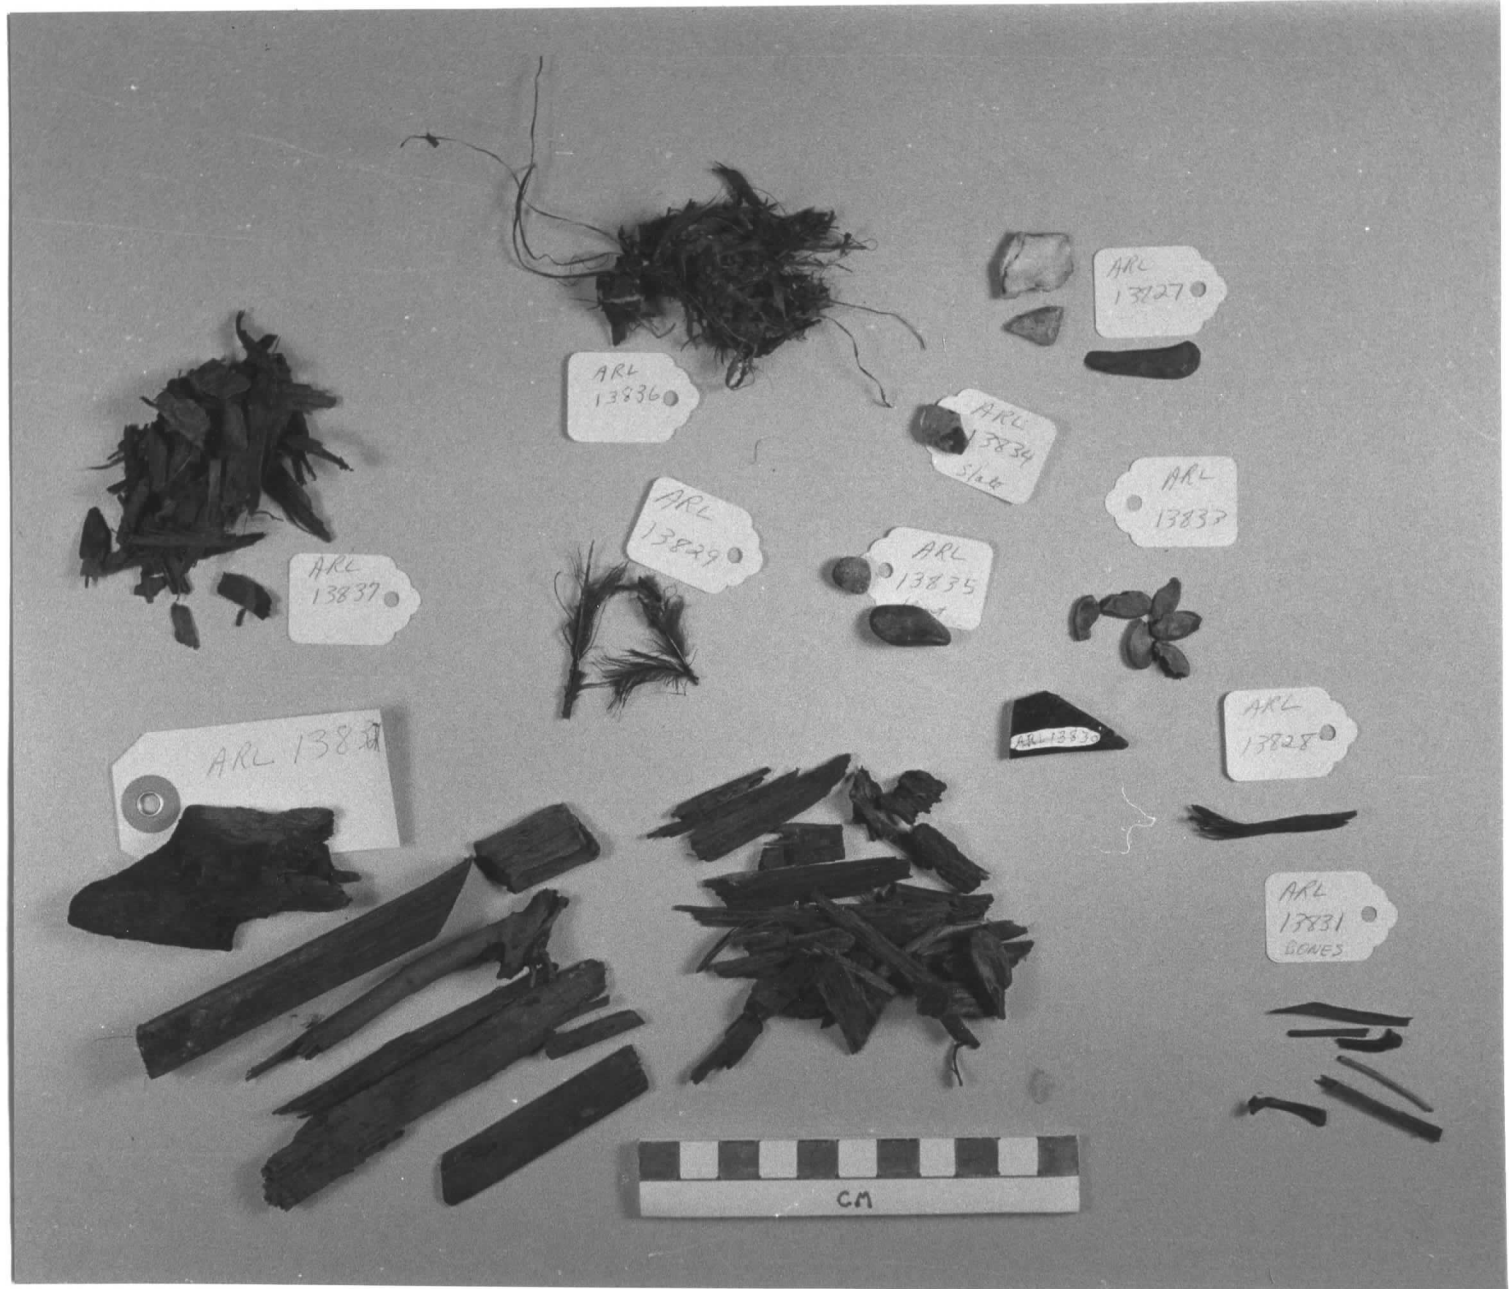
Figure 39. Small items recovered from the pine pitch in the lowest level of the excavation. Included are small pieces of wood, wood chips and shavings, feathers, fiber, watermelon seeds, shell, slate, glass and small animal bone.

Included in the matrix of the pine pitch in the lowest levels of the site were several interesting things relating to the environment of Charleston at that time. Remnants of diet are represented by eleven peach pits, nine watermelon seeds, a fragment of gourd and peanut shells recovered, as well as animal bone and fish scales. Samples of pine pitch also included fragments of large and small bird feathers, small pieces of fiber, wood shavings, and wood chips. The animal bones from this and later levels have not been analyzed as yet, but will provide data on the diet of that time.

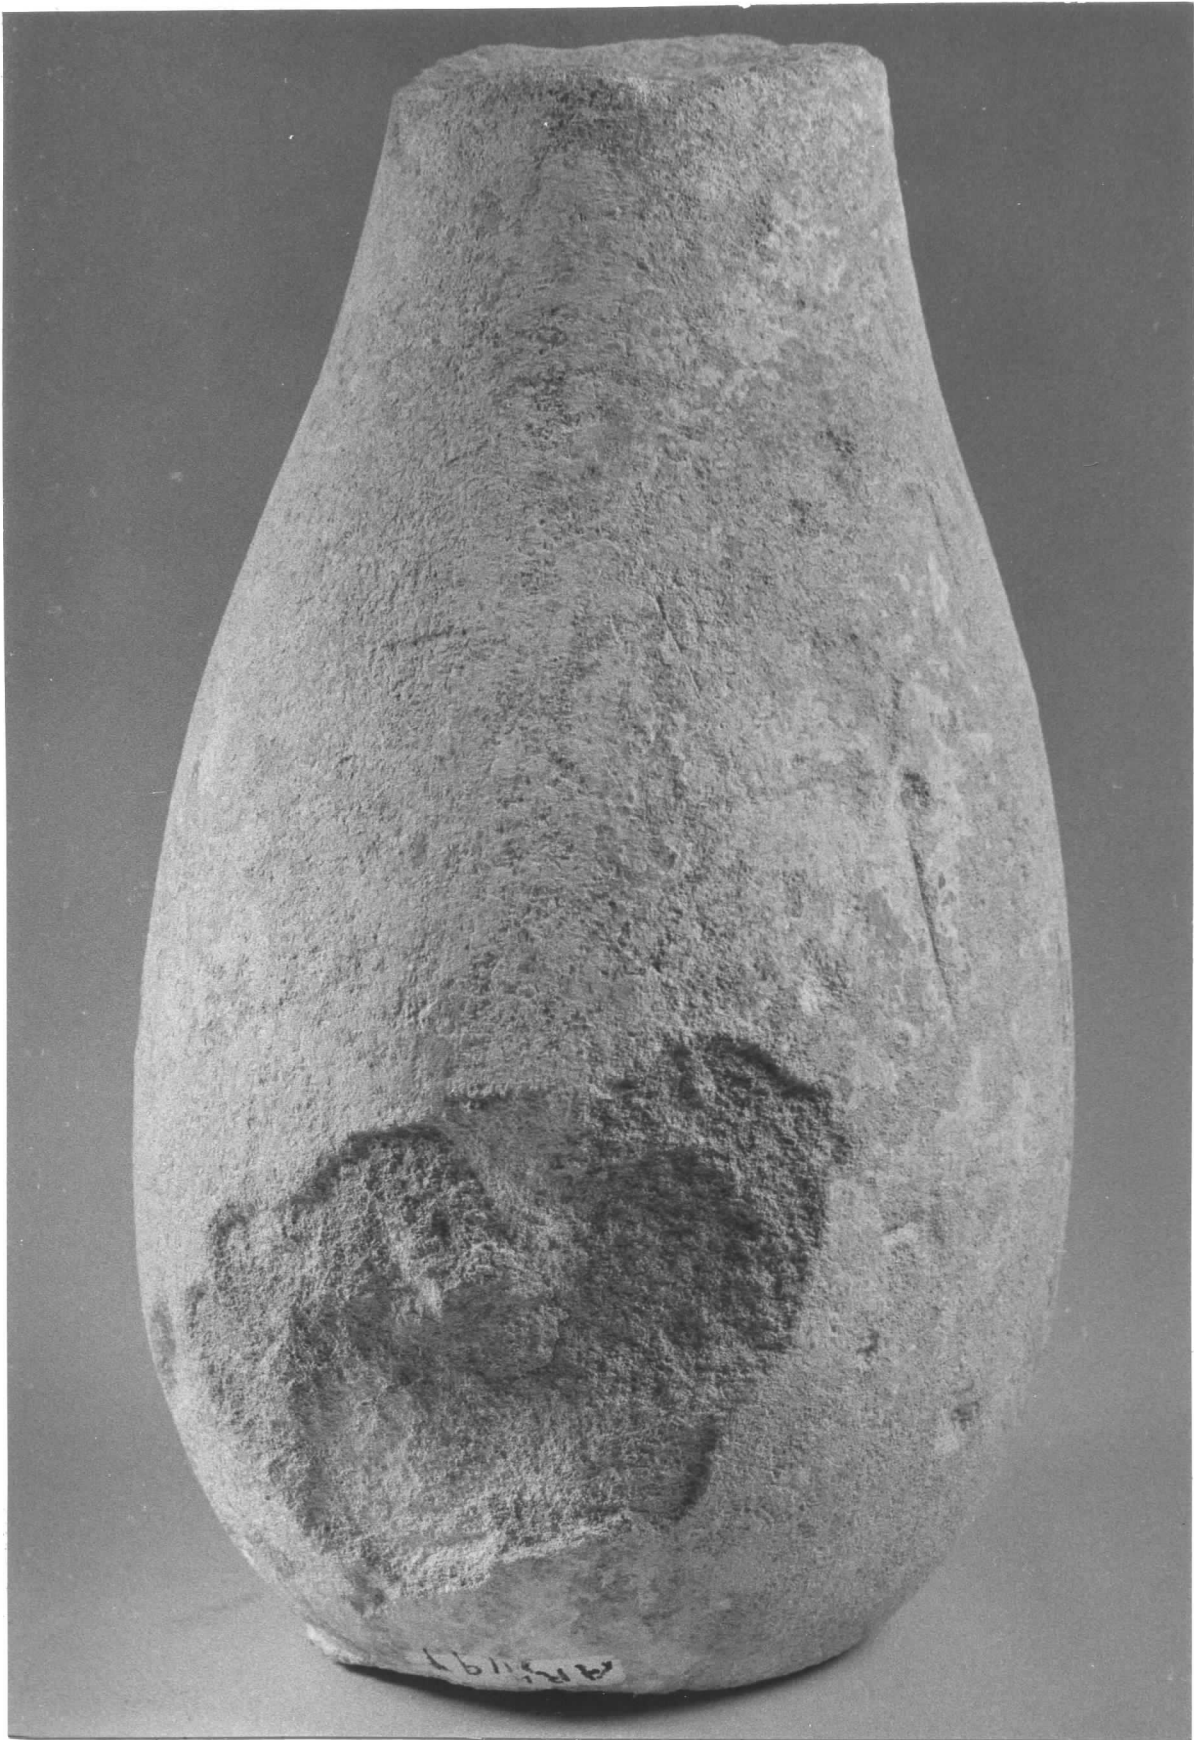
Figure 40. A fragment of what may be part of a stone balluster from the railing at the Exchange Building.

The railings were also to be of portland stone, and Naylor's drawing shows stone(?) railings not only on the stairs and platform, but also across the arches of the arcade on the first floor. Ravenel (1945, p. 43) suggests the wooden railings in the arches may have been replaced with iron in 1801, and we believe there may have been an iron railing on the porch as well. The amount of iron staining in Feature 2, under the porch projection, suggests that there was an iron railing on the end of the platform. The only evidence of stone railing was part of a stone baluster found in the excavation which looks like those shown on the Naylor plan (Figure 40).

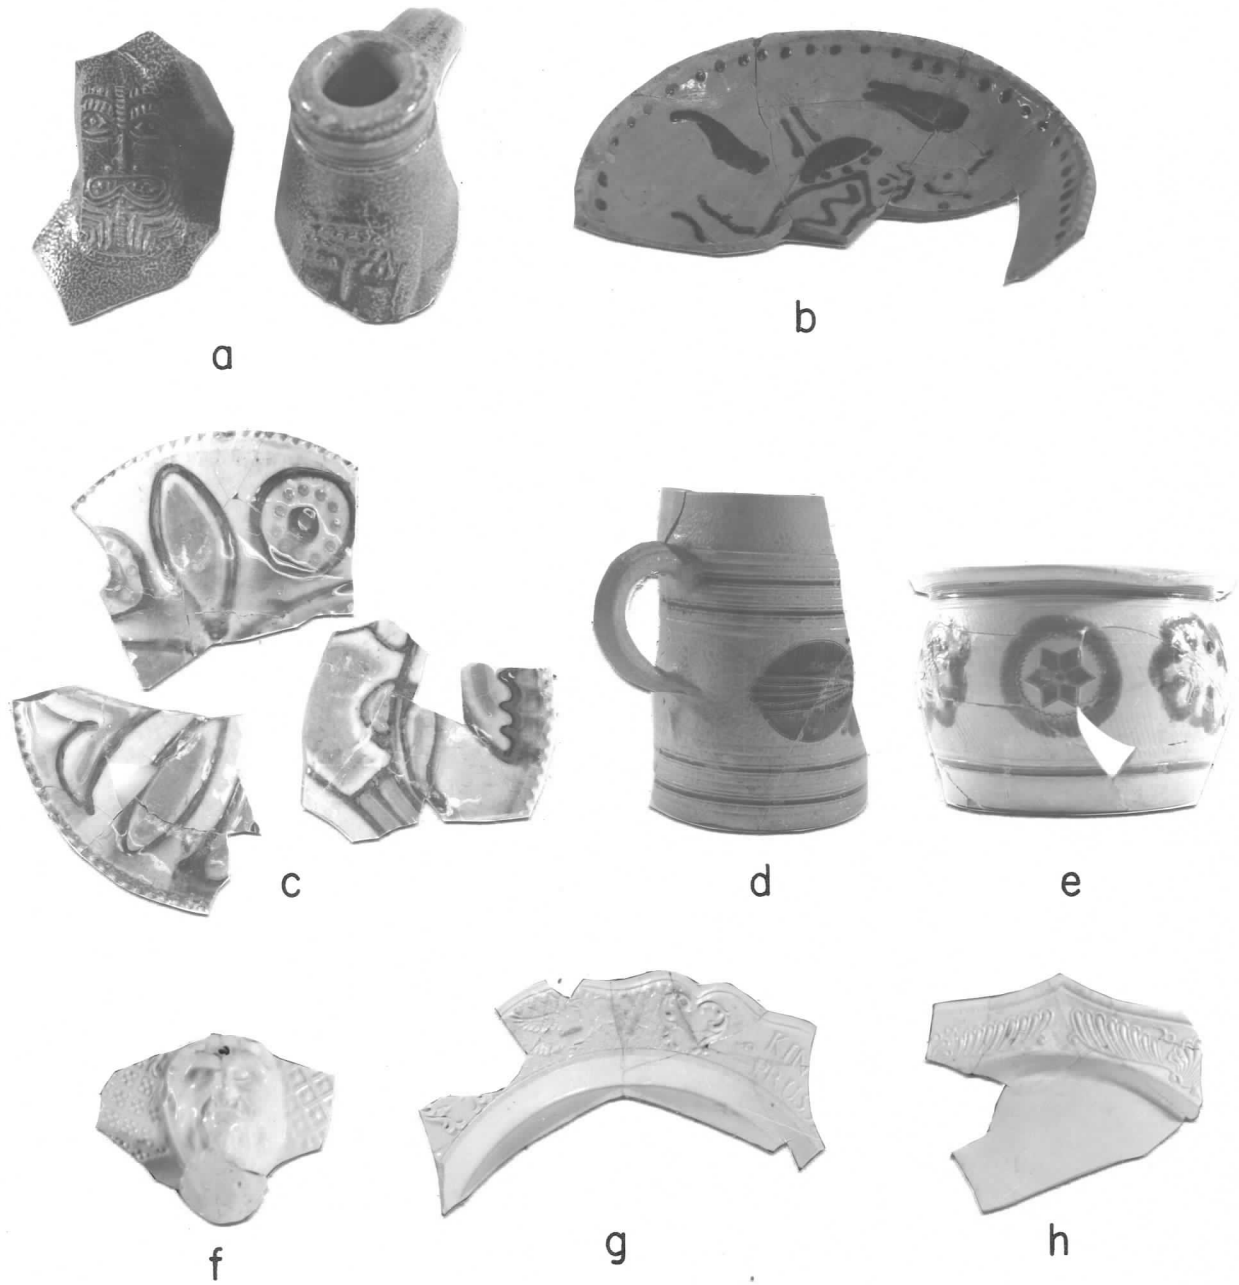
Figure 45. Ceramics from the Miller excavations inside the Exchange Building. a) Bellarmine jar fragments b-c) yellow Staffordshire slipped ware bowls d) Westerwald mug e) Westerwald chamber pot f) white salt glaze vessel foot with face molded in it g-h) King of Prussia white salt glaze plate fragments.

The yellow Staffordshire slipped ware sherds were most abundant in the levels below the floor. Sherds indicate the vessel forms include bowls, post-set pots and jars. Several good examples of bowls were found (Figure 45).

Another numerically important ceramic type was the white salt glazed ware. Not only did the collections include the familiar dot and diaper and barley patterned plates, but also a King of Prussia pattern plate with an eagle molded on the border (Figure 45) dated 1756 (Mountford 1971, plate 144) and fragments of one or more serving dishes with molded feet with heads on them (Figure 45) dated 1730 (Mountford 1971, plate 64).

Westerwald pottery was represented in the collection by sherds from the usual chamber pots (Figure 45). There was also a tall restorable mug with an unusual design (Figure 45).

Other ceramic types were present. Fragments of Bellarmine jars with masks (Figure 45) were found along with some examples of British grey and brown stoneware utilitarian vessels. There was a large number of large milk pan fragments of reddish ware with greenish to orange glaze on the inside.
