**Archaeological Investigations of
the Parsonage Site (38Ch1660):
2005 season**

August 2006

Archaeological Investigations of
the Parsonage Site (38Ch1660):
2005 Season

by
Martha A. Zierden and Ronald W. Anthony
The Charleston Museum

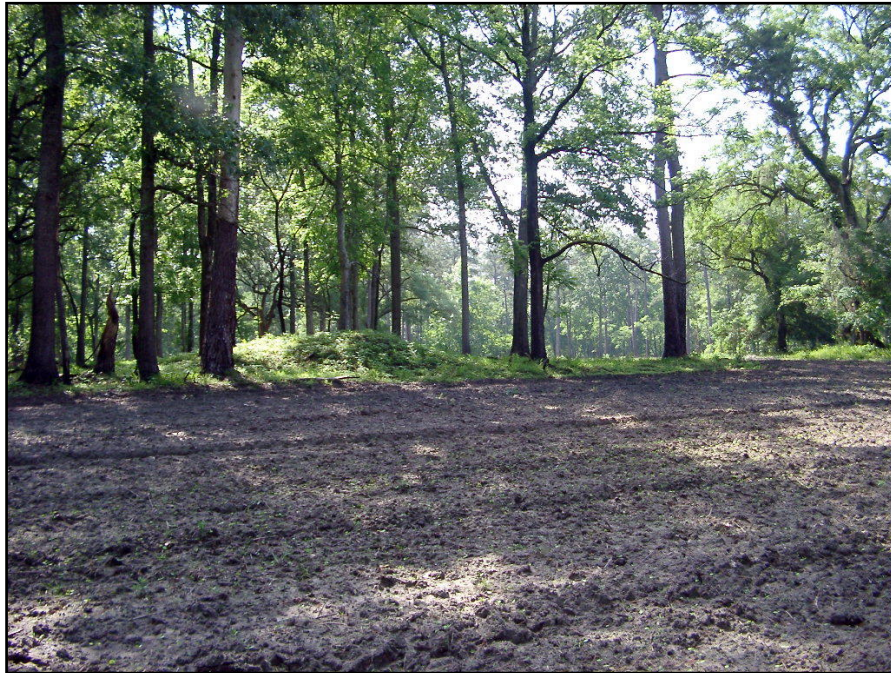
Figure 1: View of parsonage site, facing southeast. Photo taken in 2003, prior to excavation of the house foundation mound.

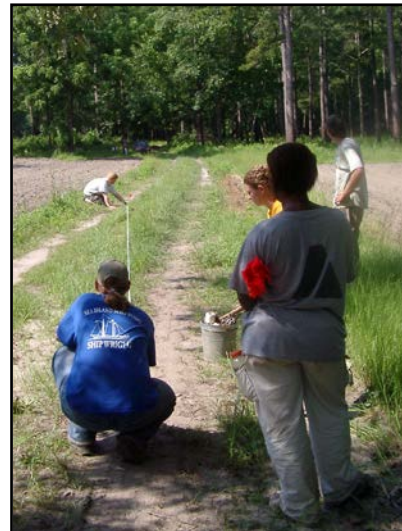
Figure 4: re-establishing the grid

The base points at N200E200 and N700E200 were intact when we returned in 2005. The transit was set up over the N200E200 point and grid points placed at 50' intervals. Points were then placed at closer intervals in the vicinity of the mound (N500 to N550). The transit was then set over the N510 and N530 points, and lines established to the east. These proved to be .4' north of those from the 2003 dig, which were still in place. The 2005 points were used for all excavations on the west and south sides of the foundation. Points from the 2003 excavation were used for the two remaining units on the eastern wall. The discrepancy was adjusted in mapping. Grid points from both seasons were left in place at the end of the project.

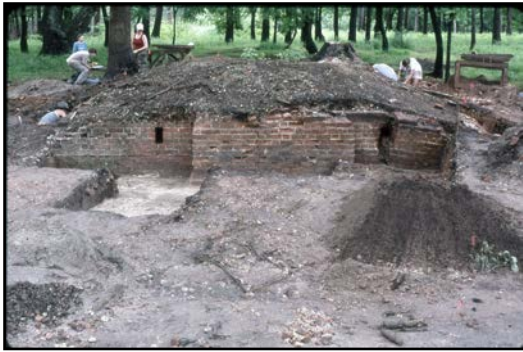
Figure 6: west wall of parsonage, before and after backfilling to grade.

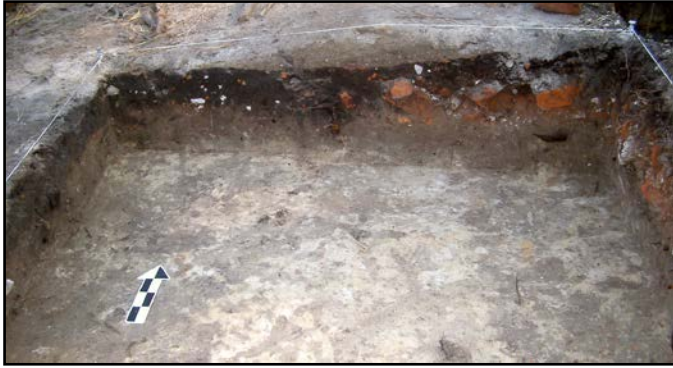
The site is visible as an oval mound located in a small wooded tract. The mound rises over 4' from the general ground surface. This appears to be the result of collapse of the structure following a fire, as the ground surface was littered with melted bottle glass. Three zones are present in the mound. Zone 1 is a dark gray-brown humus layer (10yr2/1 or 2/2) full of roots. This zone ranged from .2' to .5' in depth. The layer of brick and mortar rubble resulting from decay of the building was designated zone 2. This varied in thickness, depending on the location within the building mound, and ranged from .1' on the edges to 4.0' adjacent to portions of intact foundation. Moderate amounts of dark soil (10yr2/2) were present among the heavy brick rubble. Zone 3 was associated with the interface of finished and unfinished mortar joints in the foundation (indicating original grade), and consisted of a medium gray-brown sandy soil (10yr4/3). A moderate amount of 18th century material was recovered from zone 3. Sterile subsoil was present beneath

zone 3, and was characterized as a yellow to light brown sand (10yr5/4). Nine units were excavated to the base of zone 3, in order to expose builder's trenches and retrieve artifacts for dating construction and abandonment of the structure. The remaining seven units were excavated into zone 2, deep enough to expose architectural details.

Figure 7: Unit N520E285, north profile, showing zones 1-3

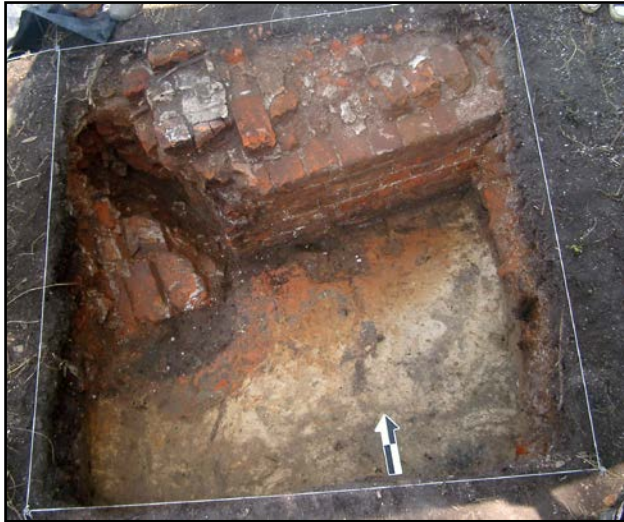
Figure 9: South wall (N505E300) and west wall (N510E295) showing cracks along the vent openings, and slumping of southwest corner of the structure.

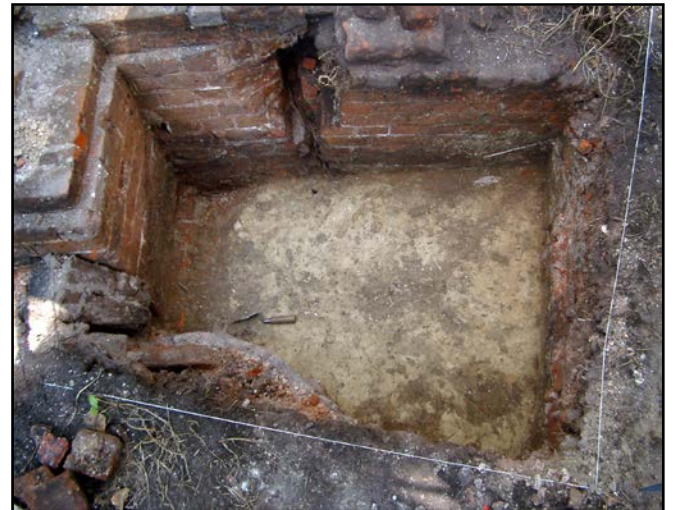
Figure 11: Unit N520E330, building exterior. Visible are feature 21 along the east wall, overlying feature 24 adjacent to the south wall of the chimney.

Identification and excavation of builder's trenches is an important step in dating construction of archaeological buildings. A narrow (.2') builders trench was identified along the foundation walls and designated feature 21. A wider (.8') but more ephemeral builders trench was identified along the east and west chimneys, and designated feature 24. These were sampled in N520E330, along the southern side of the east wall. In this unit, feature 21 appeared to truncate, and post-date, feature 24. While this sequence is uncertain, the evidence clearly does not show the opposite arrangement, which would indicate that the chimneys were a later addition. Feature 21 contained creamware, suggesting a fill date of 1760 to 1770. Feature 24 contained no datable materials. Additional features were present around the building foundations. Most interesting were amorphous concentrations of bright red clay, all designated feature 27. It is unclear if these represent natural unfired clay, clay fired at the time of construction, or results of the fire that destroyed the house. None were sampled.

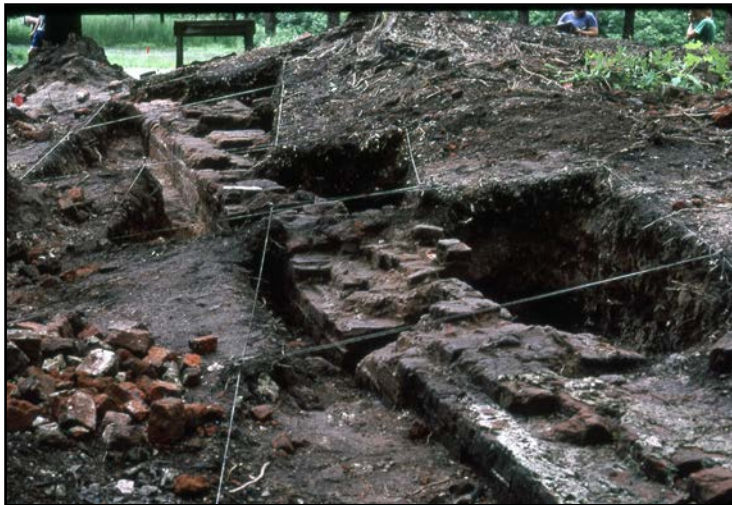
Figure 10: view of the south wall of the parsonage, facing west. Unit boundaries are marked with string. The possible brick threshold is visible in the fourth unit from the bottom of the image.

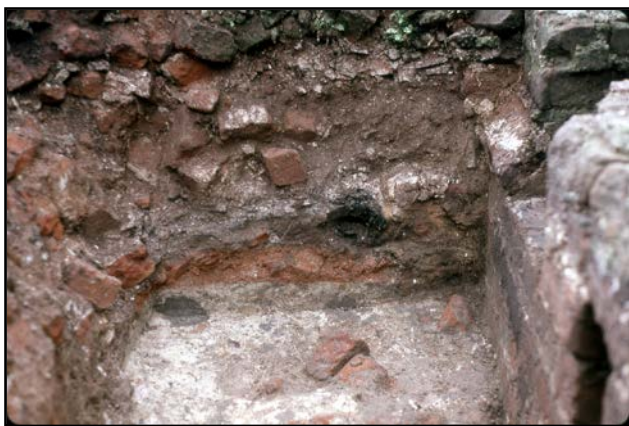
The interior fill was mostly rubble, and was three feet deep. A shallow soil and root mat (zone 1) overlay a thick layer of brick and mortar rubble. Beneath this was a layer of mortar and plaster, much of it blackened by fire. A second lens of brick rubble followed, this on top of a gray sand layer similar to zone 3 on the exterior.

Figure 12: profile of building interior, N515E325. Note the layer of soft red brick beneath lenses of rubble.

The interior of the building was explored in two test units. A 2.5' by 6' sample was excavated inside the northeast corner (units N530E325 and N535E325) and a smaller sample (2' by 5') was excavated along the south wall in N515E325. The two samples exhibited similar stratigraphy.

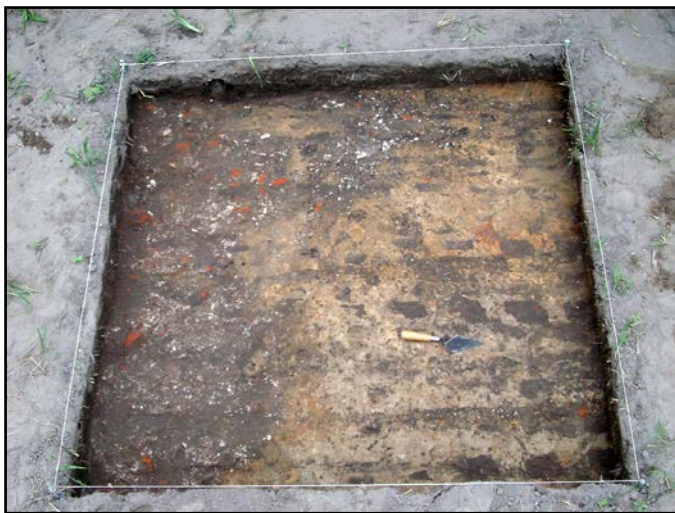
These include features 16-19 and features 22-23. The last unit excavated here, N300E350 revealed a concentration of brick and mortar rubble in the south half of the unit. The feature exhibited a fairly straight edge and was filled with large chunks of mortar and brick in a medium brown sand matrix. Due to time constraints, the feature was not sampled at this time. Additional excavation in this vicinity is warranted.

Figure 13: N300 E350, showing linear concentration of brick and mortar rubble. Note the shallow plowzone above sterile subsoil.

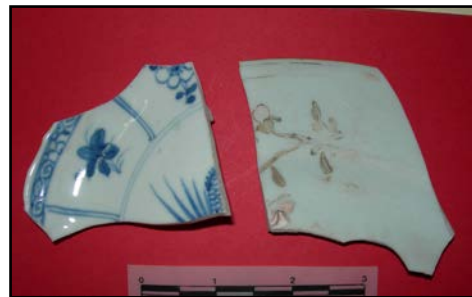
Figure 15: Chinese export porcelain, blue underglaze variety (left) and enameled (overglazed) saucer (right)

On the sites of wealthy residents, food service vessels were designed to display social status and the knowledge of use that went with ownership of such display pieces. Chinese export porcelain was the most expensive and most desired of all colonial ceramics. The soils around the parsonage house contained a moderate amount of porcelain, both the blue on white underglaze variety and the more elaborate overglaze decorated styles. Chinese porcelain was available to lowcountry residents throughout the 18th century.

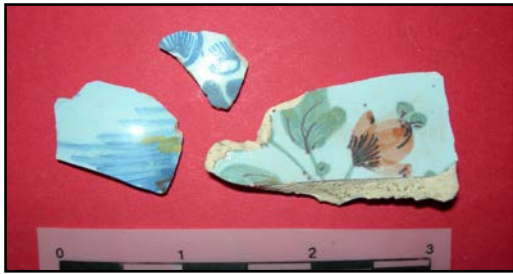
soft yellow to buff colored earthenware paste and an opaque, sometimes chalky-textured glaze consisting of tin oxide in a lead glaze. The glaze can be white, but often exhibits a light ‘robin’s egg’ blue background color. Individual vessels may be undecorated, or feature hand-painted decoration in blue or a range of colors, the latter classified as polychrome.

Figure 16: English delft in blue and polychrome

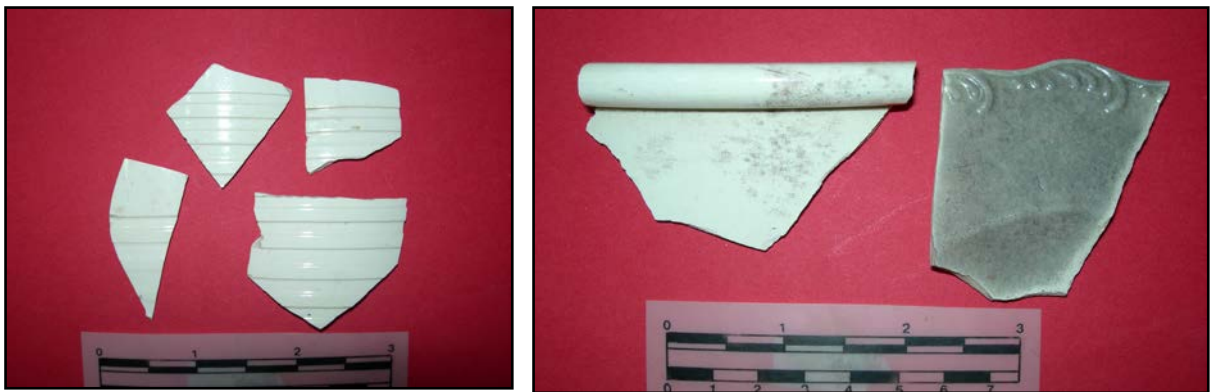
Figure 17: examples of creamware from the parsonage: left, fragments of a ridged bowl, c. 1800; right, bowl with rolled rim and plate with feather edge decoration.

Whieldon ware, after the potter Thomas Whieldon, this ceramic was manufactured from 1740 to 1775. It was often made in the same molds as the contemporary white saltglazed stoneware. Only a few fragments of this ware were recovered from the parsonage. Whieldon wares were rapidly replaced with cream-colored ware know as Creamware or Queens ware, and available by 1762. It is this ceramic that dominates the parsonage site assemblage. Like the Chinese porcelain, creamware came in highly decorated and expensive styles, as well as relatively plain and inexpensive forms. Creamware accounts for nearly a third of the parsonage ceramic assemblage.

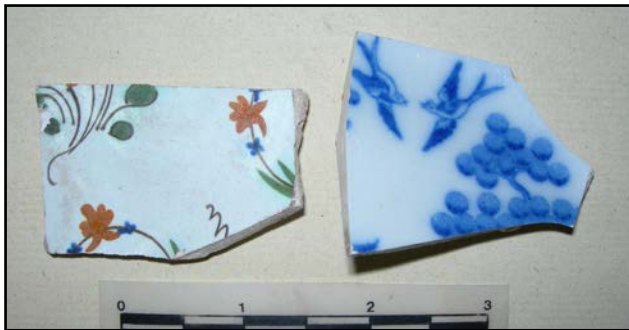
Figure 18: Hand painted (left) and transfer printed (right) pearlware

In their quest for an all-white ceramic, Wedgwood and his contemporaries altered the glaze formula with the addition of cobalt to produce a bluish-tinted ware. Known collectively as pearlwares, these came in a variety of decorative styles. Hand painted and shell edged wares appeared in 1780, while transfer-printed and annular striped wares were available in 1795. Creamware, with a yellowish tint, continued alongside the

pearlwares in popularity. Though not as common as creamware, the parsonage site contained a number of pearlware fragments, in each of the four decorative groups. The later styles were represented by only a few sherds, again supporting abandonment of the site shortly after these wares became available.

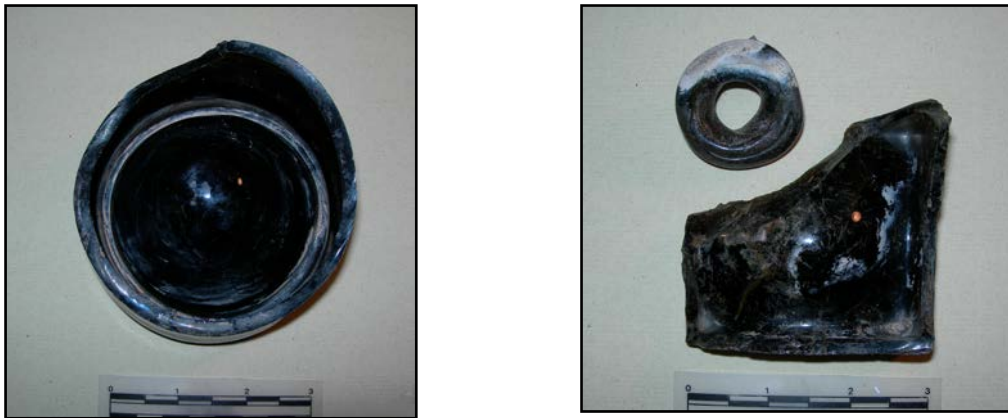
Figure 20: Olive green bottle glass. Left, base of hand-blown bottle; right, base and neck to square case bottle.

Another common component of the kitchen group, and of the parsonage assemblage, is olive green bottle glass. These were generally, though not exclusively, used to hold alcoholic beverages, and were often reused. The green glass bottles were hand blown, and exhibit a pontil scar on the base and irregularities throughout the glass. Seventeenth century examples are short and squat, known as ‘onion bottles’. They gradually get taller and narrower, until by the early 19th century green bottles exhibit the proportions found today (Noel Hume 1969). Fragments of olive green glass, many of them melted, are common at the parsonage site. Another variety of glass container are small vials for medicines or condiments. These are also hand-blown, and exhibit a pontil scar at the base. They are often aqua or light olive green, but can also be made of clear glass. A few fragments were recovered at the parsonage.

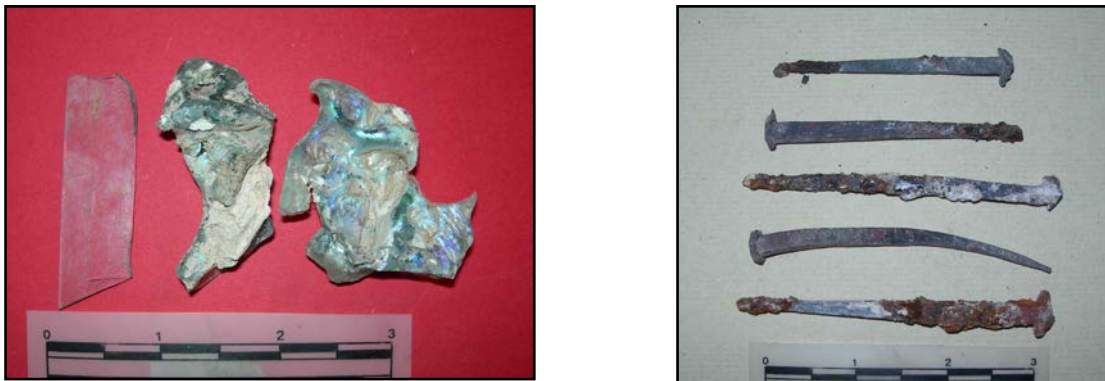
Figure 21: window glass, including melted examples, and nails from zone 2 deposits.

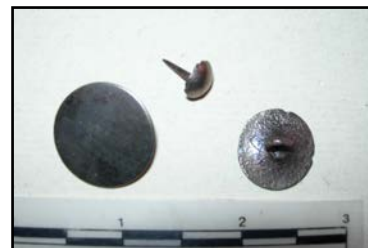
Figure 22: brass buttons, upholstery tack.

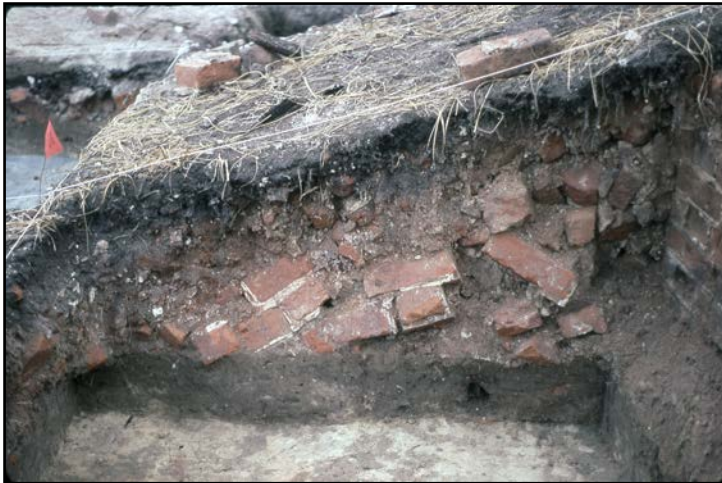
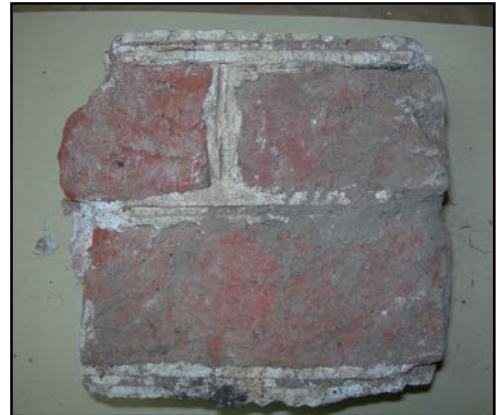
Figure 27: portions of intact brick showing struck mortar joint. Right is north profile of N510E290.

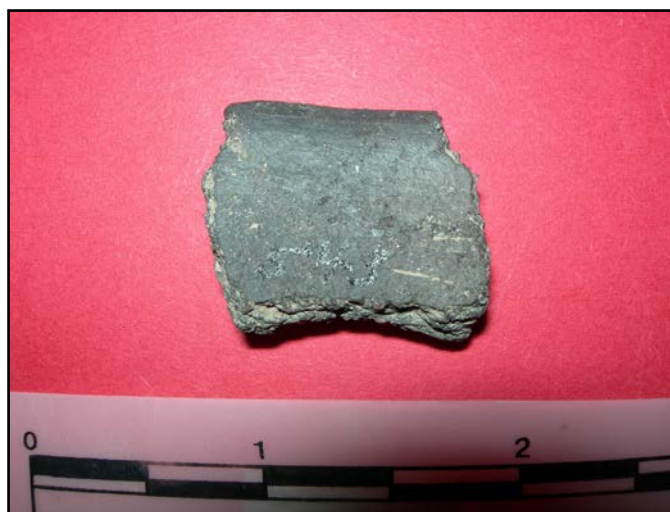
Figure 30: Yaughan colono ware

Yaughan colono ware is most often associated with African American residential occupation. It appears to be an “everyday” utilitarian ware used for cooking and serving. At several plantation sites investigated in the lowcountry, this variety comprised more than half of the artifacts recovered from African American slave residential areas (eg. Drucker and Anthony 1979; Wheaton et al. 1983; Zierden et al. 1986). Vessel forms dominating Yaughan assemblages include convex-sided, rounded to slightly flat-bottomed hemispherical bowls and both large and small globular jars with everted rims and gently rounded bottoms. Some Yaughan jars recovered from lowcountry sites are characterized by lug or strap handles which do not appear to have been attached by plug insertion (Wheaton et al. 1983; Anthony 1986, 2002). Lips of these ceramic vessels are most frequently rounded or flattened with a tool. Yaughan vessels usually exhibit crudely smoothed to rather well smoothed surfaces and, at times, burnished or rubbed finishes. Yaughan vessels that have been burnished can exhibit surfaces that have been incompletely or haphazardly rubbed. A notable number of Yaughan sherds recovered from the parsonage site indicate that several vessels were burnished in this way. Yaughan vessels often exhibit a clearly laminar paste and vessel walls which often are not uniform in thickness.

Yaughan bowls generally outnumber jars, at least 2 to 1, in many, if not most, rural colono ware assemblages. This seems to be the case at the Parsonage site as well (Tables 9 and 10). Other Yaughan vessel forms encountered, although usually in the minority, may include bottles, cups, plates, and lidded vessels, possibly serving a function similar to a Dutch oven (Anthony 2002). No vessels of this sort were recovered from the Parsonage site during the present project. At times, Yaughan smoking pipe fragments and gaming pieces, such as marbles, have been recovered from 18th and early 19th century contexts. A single colono ware pipe bowl fragment was recovered from excavation unit N505 E300 at the parsonage site.

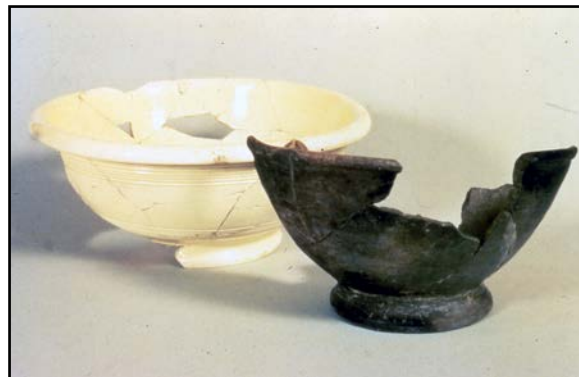
Figure 31: Lesesne lustered and creamware bowls from Charleston sites.

Lesesne Lustered colono ware (Anthony 1986), believed to have been a *market* ware rather than a *utilitarian* ware (Anthony 1986; Hamby and Joseph 2004), often accounts for the majority of colono wares associated with rural planter/landowner residences (Anthony 1986, 2002). Likely used routinely in 18th century planter households, Lesesne can exhibit physical attributes similar to some European and European American ceramics. This occurrence supports the notion that much of this pottery was

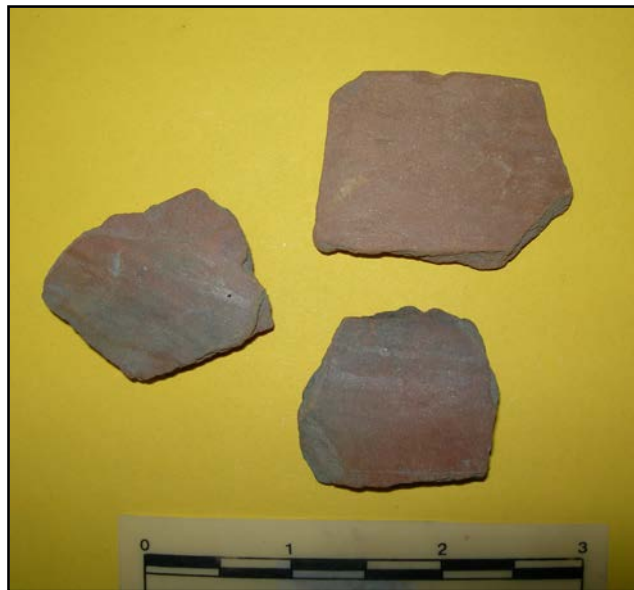
Figure 32: Lesesne lustered colono ware

Lesesne colono ware from the Parsonage Site presently is limited to only bowls and jars. Usually exhibiting a fine to medium paste, at times almost temperless, Lesesne colono ware can evidence a laminar paste, although the laminar “look” is often not as pronounced as found in the somewhat less well fired Yaughan pottery. A laminar paste is evidently one signature of hand modeling vessel construction, as opposed to a coil method. Perhaps the most readily visible morphological feature of Lesesne colono ware is its surface treatment. Lesesne pottery is characterized by relatively well-burnished surfaces (Anthony 1986, 2002).

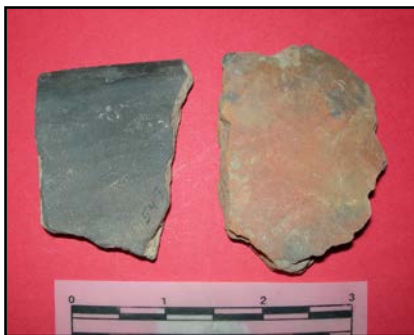
Figure 33: Lesesne lustered sherds, from reducing (left) and oxidizing (right) firing conductions

Although not as evenly or completely burnished as a variety of colono ware known as River Burnished (Ferguson 1989), Lesesne colono ware is burnished to a degree which often results in a “waxy” feel to the vessel surface. Another distinguishing characteristic of Lesesne, relative to Yaughan pottery, is uniformity in vessel wall thickness. Lesesne vessels also tend to be somewhat thinner walled than Yaughan vessels. Both

Lesesne and Yaughan ceramics were primarily hand modeled and both can be incompletely oxidized or incompletely reduced. At times, Lesesne colono ware can be completely oxidized or reduced. No River Burnished colono ware has been identified at the parsonage site.
