# Willtown's Second Presbyterian Church, 1767-1807: Archaeological Study of the Parsonage (38Ch1660)

Martha A. Zierden  
and  
Ronald W. Anthony

Archaeological Contributions 44  
The Charleston Museum

Prepared for  
The Seymour H. Knox Foundation  
September 2010

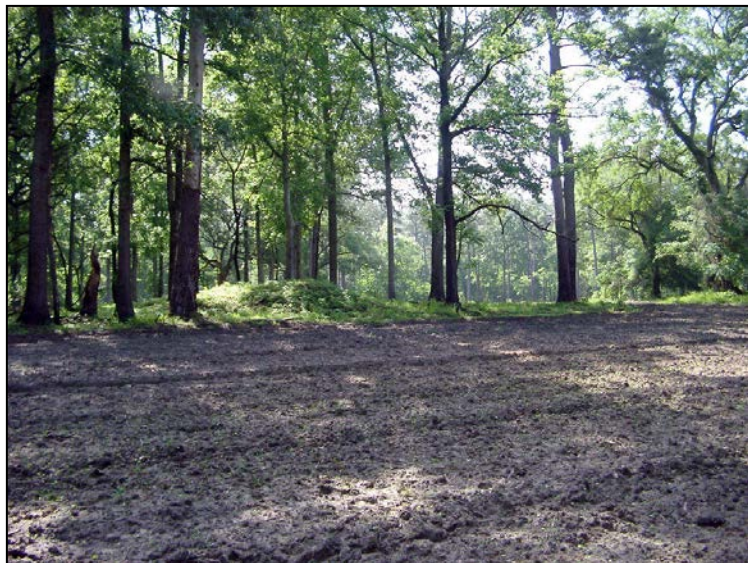
Figure 1: The ‘mound’ formed by the foundation in 2003, with plowed area visible in the foreground, facing southeast.

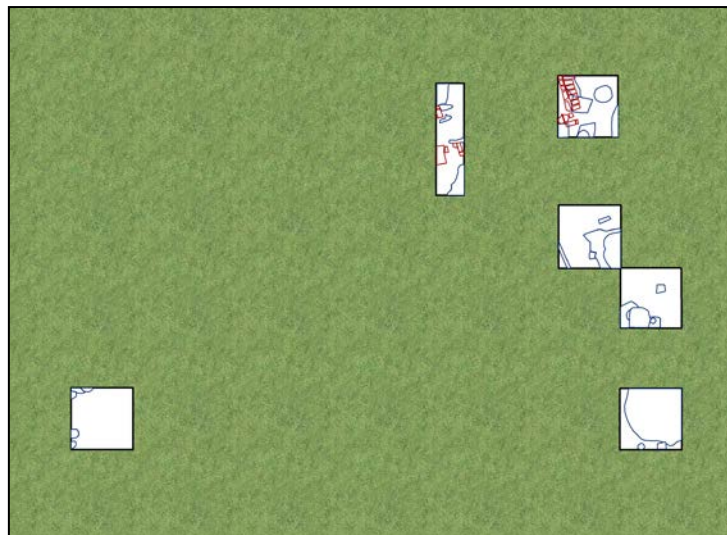
Figure 34: Composite map of test units in the kitchen area, showing features at the base of the ash layer, Feature 1. Brick foundations are shown in red.

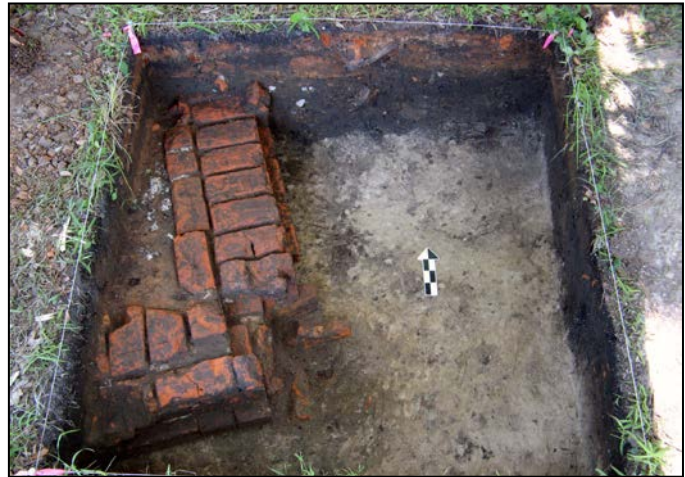
Figure 38: N535 E400, brick foundation at base of zone 3

Unit N535 E400 revealed different stratigraphy and proved to be the location of the kitchen structure. The ground surface sloped upward to the north. Zone 1 was a thin lens of black soil, overlying moist red/orange clay. The clay wedge and dark soil were excavated as zone 1 to the lowest point of the unit. Zone 2 as defined elsewhere was present beneath the clay, but here contained higher concentrations of brick. A pocket of zone 1/zone 2 soil in the southeast corner was excavated separately, and contained a concentration of artifacts, including nails. Zone 2 was .4' deep, and was excavated in two levels.

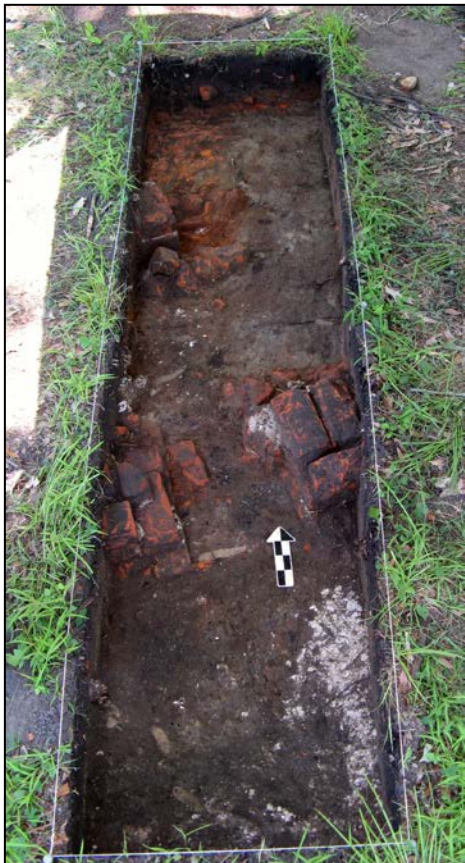
Figure 39: Features 37, 51, 52 in N530 E390

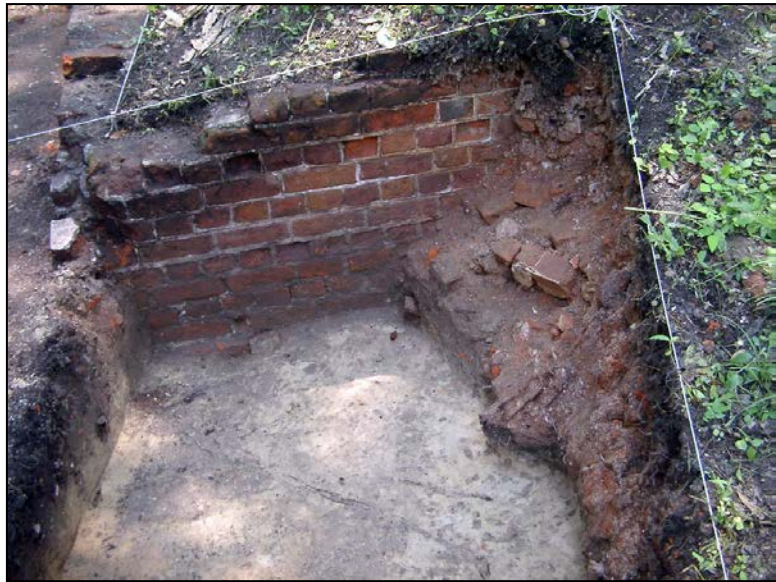
Figure 50: NW corner of dwelling, excavated to sterile subsoil

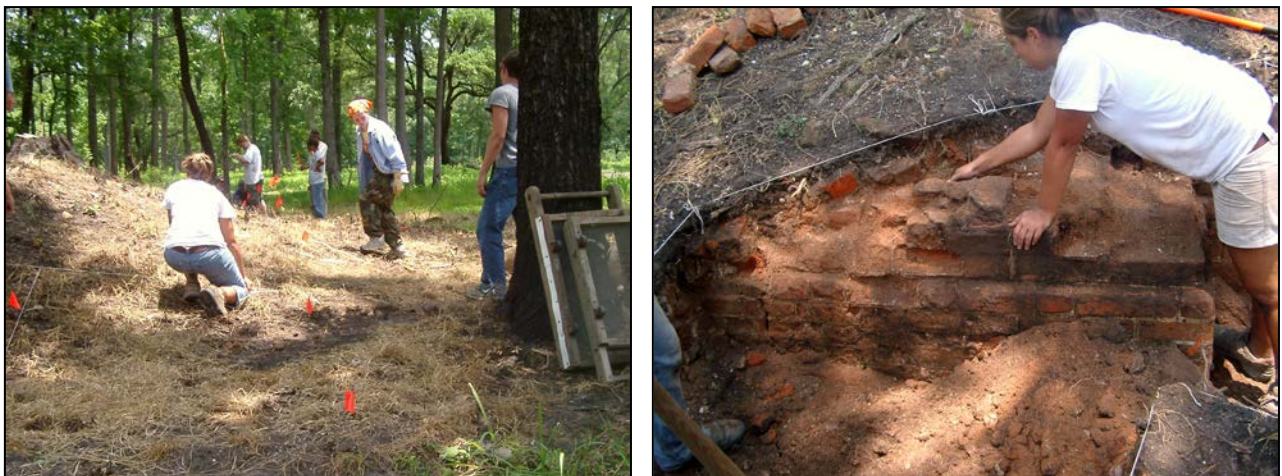
Figure 53 a-b: Laying in excavation units on south side of foundation (facing east); Exposure of chimney on western wall, revealing the shallow nature of topsoil (zone 1) over brick rubble (zone 2).

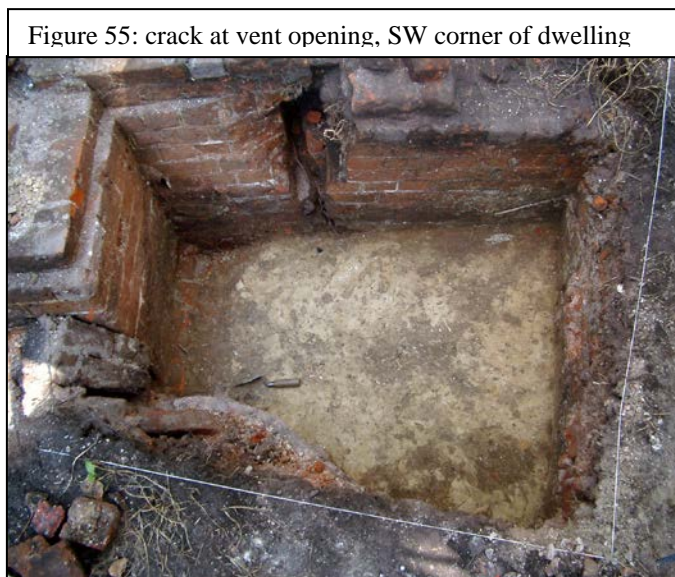
Figure 55: crack at vent opening, SW corner of dwelling

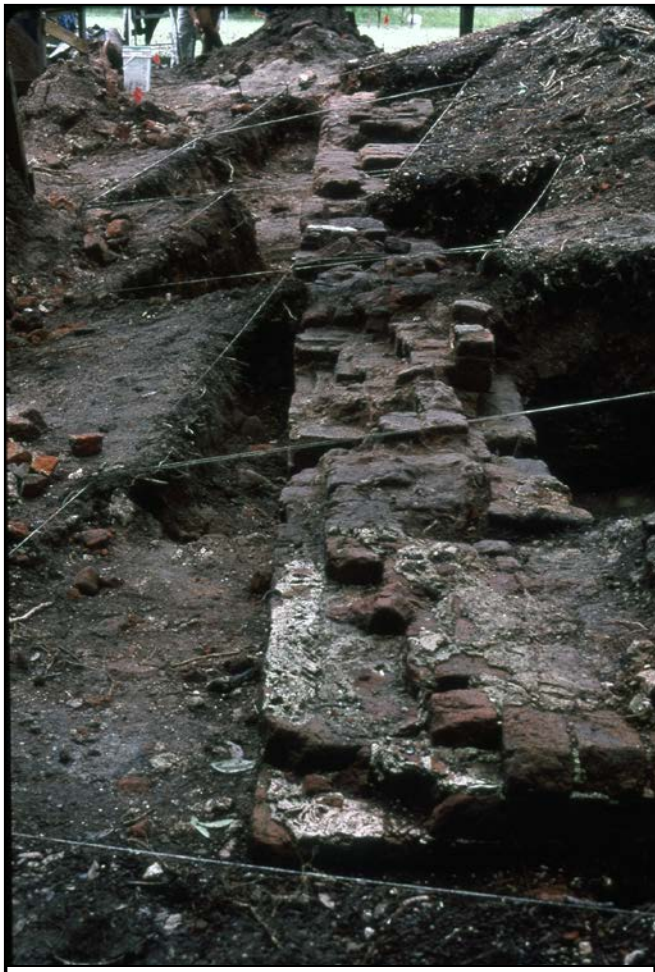
Figure 57: Southern wall of structure, facing west

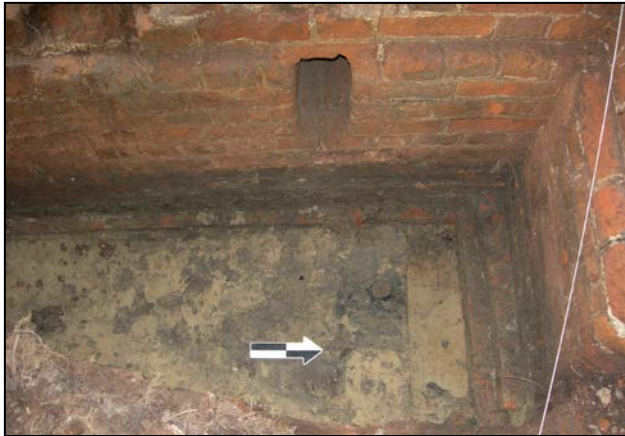
Figure 58: builders trench for east chimney; note vent opening

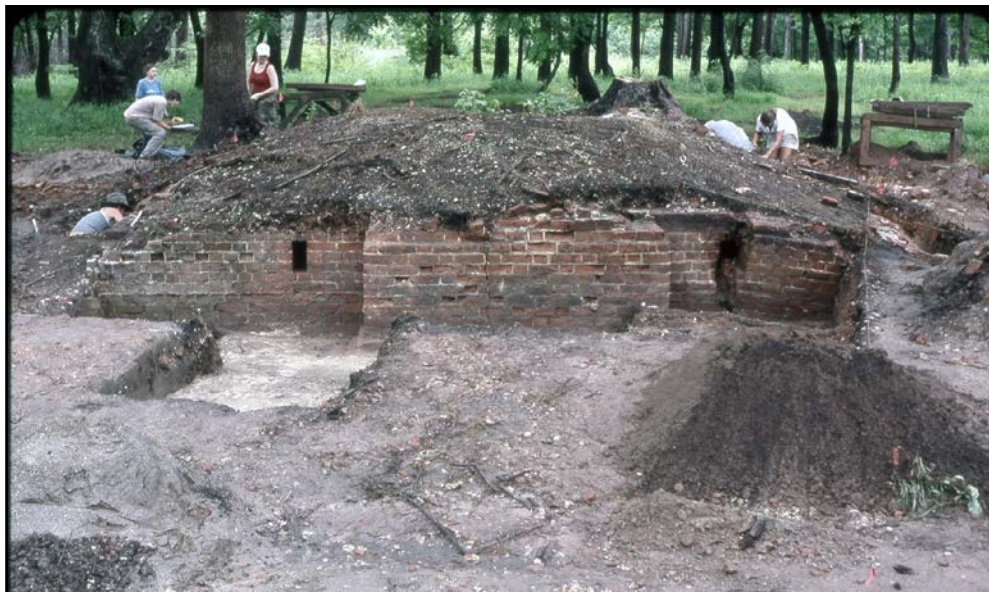
Figure 59: Completed excavations, 2005, facing the west side of the structure; note displacement of SW corner due to cracking along vent opening.

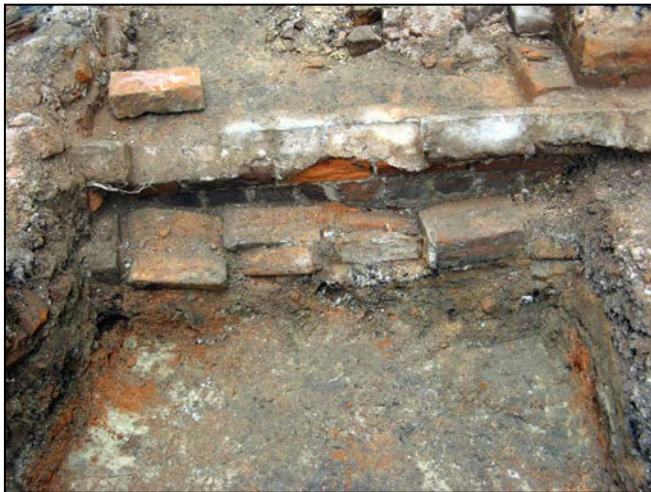
Figure 63 (left): curved brick foundation abutting hearth; pavers on top of zone 7.  
Figure 64 (above): ruler in feature 61

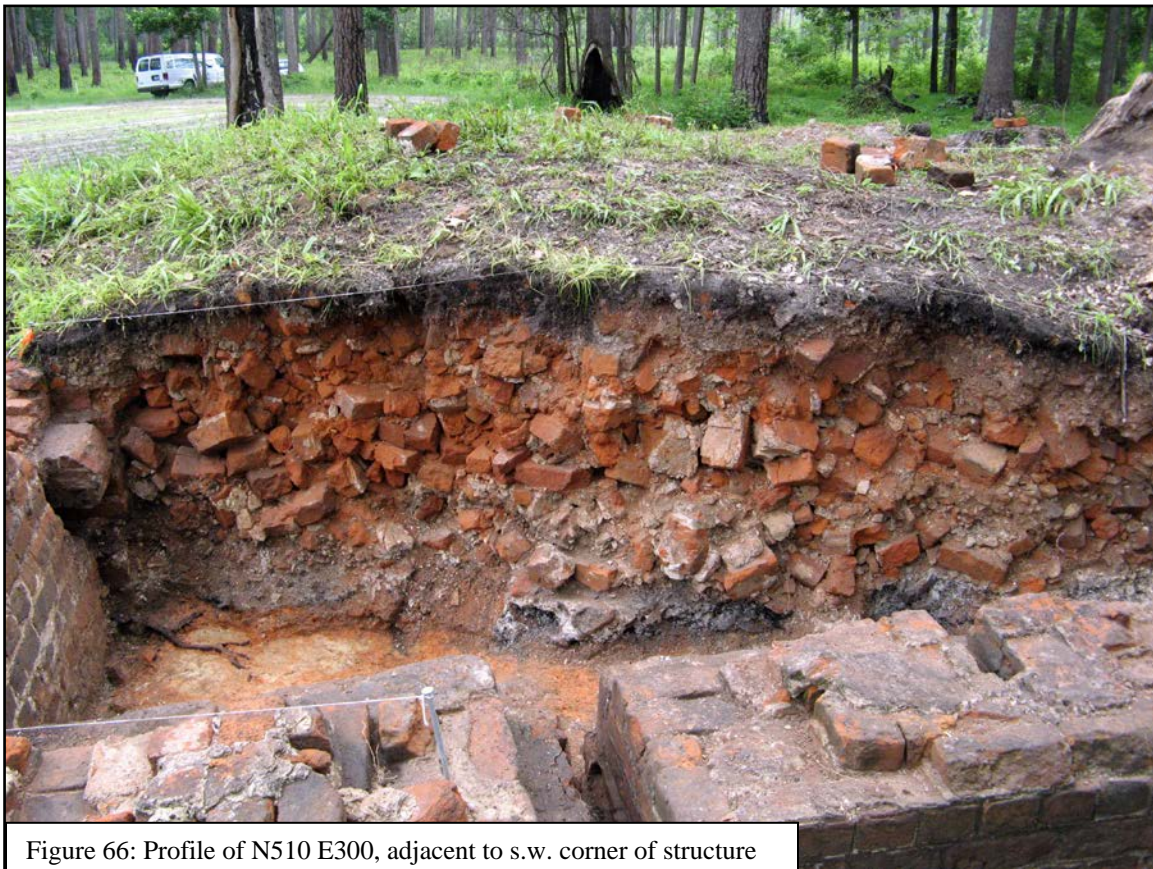
Figure 66: Profile of N510 E300, adjacent to s.w. corner of structure

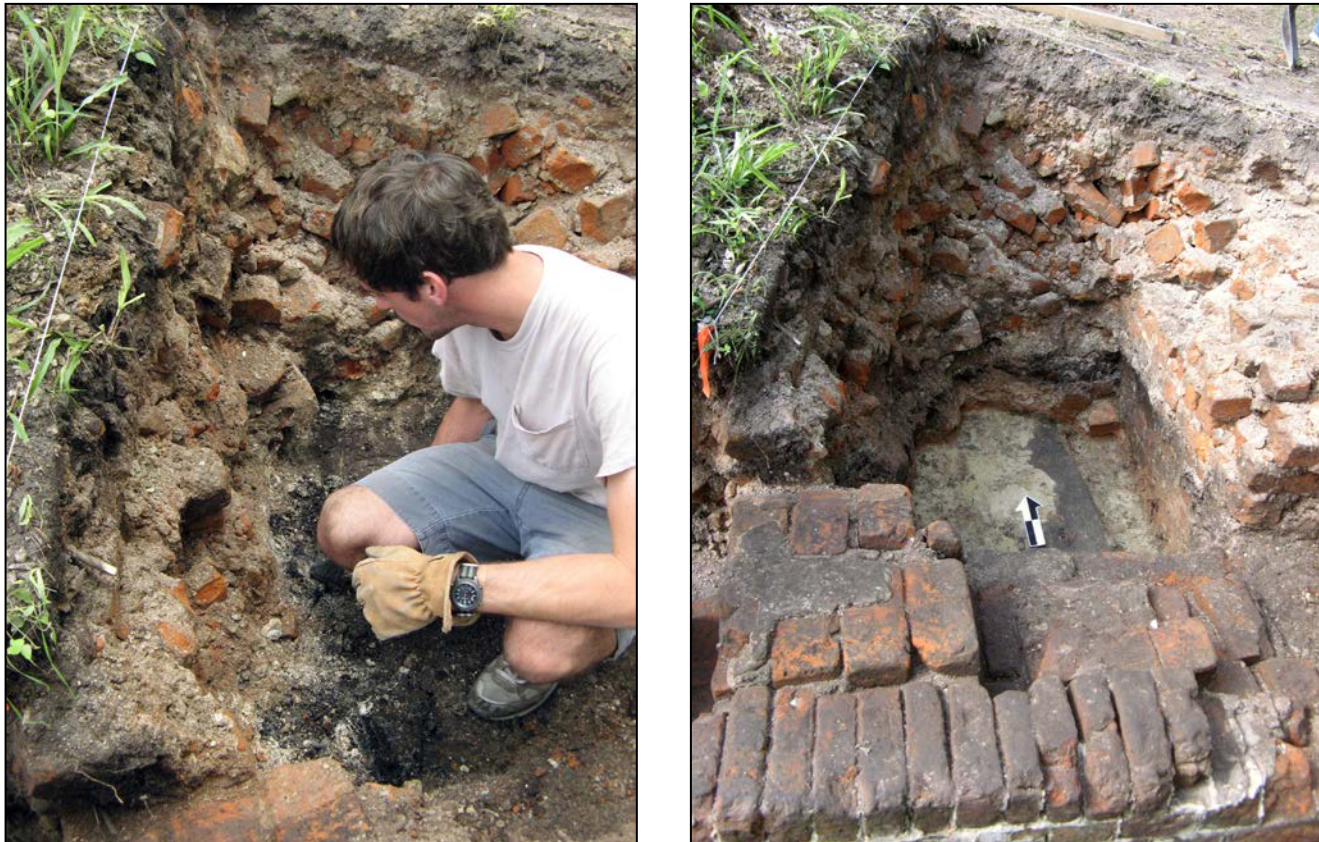
Figure 67a-b: N515 E315, excavating zone 6/feature 64; excavations completed, showing threshold and interior wall

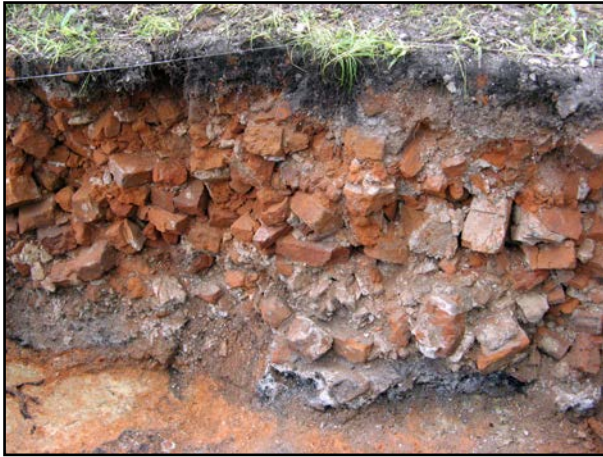
Figure 68: Photo and profile, strata along southern wall of dwelling, facing north. Shown in the photo is a section from E305 – E310.

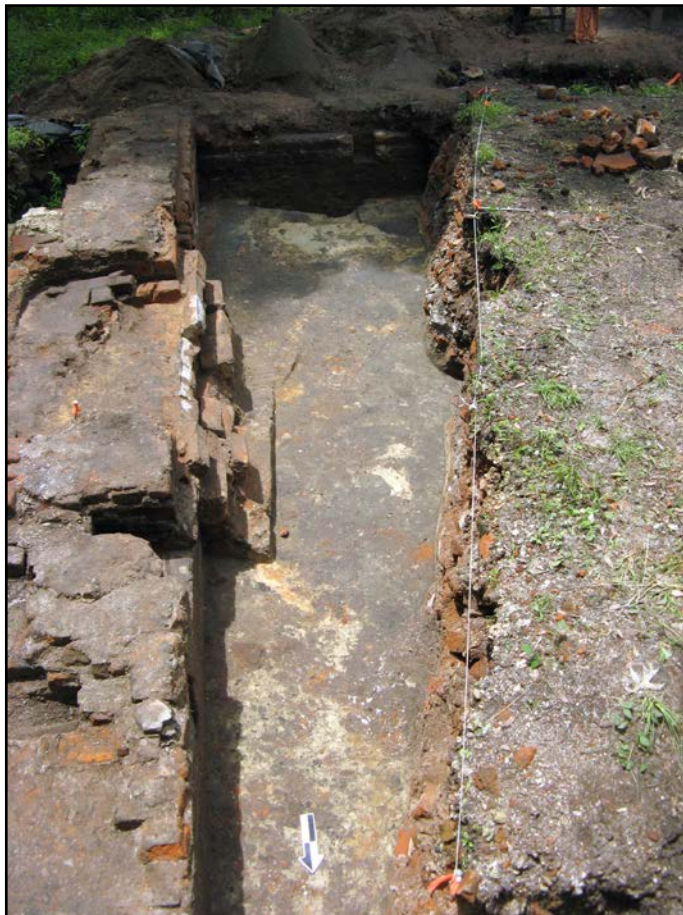
Figure 69: completed interior excavations along east wall, facing south. Chimney and hearth visible on left.

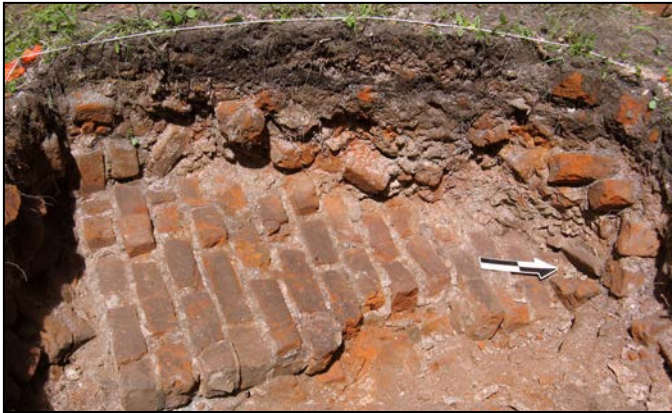
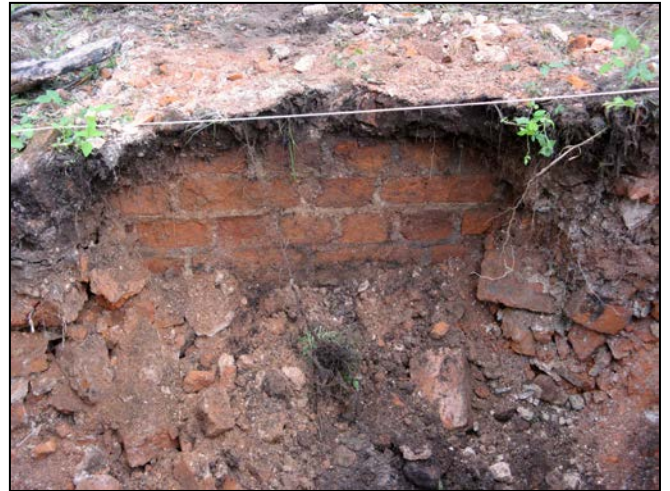
Figure 70a-b: N525 E310, intact wall in zone 2; exposure of feature 59 in the east profile

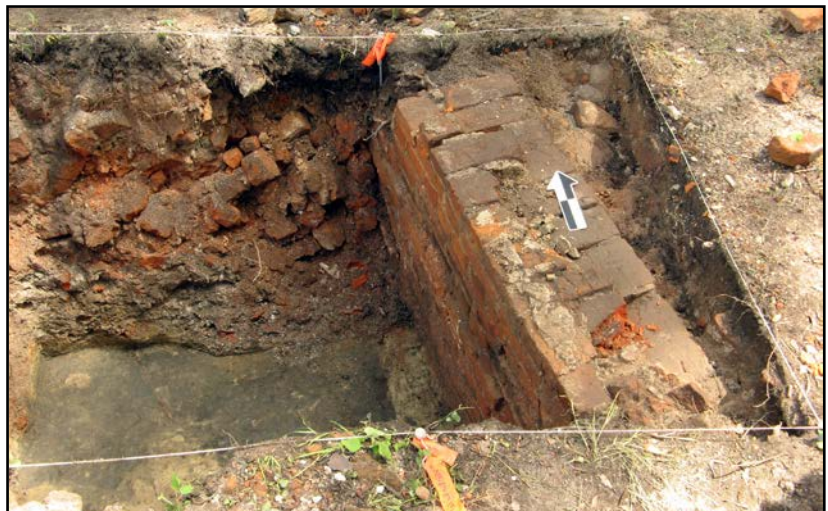
Figure 71: N525 E310; colono ware in zone 5; base of excavation, showing feature 59 (internal wall) and feature 61 (associated builders trench)

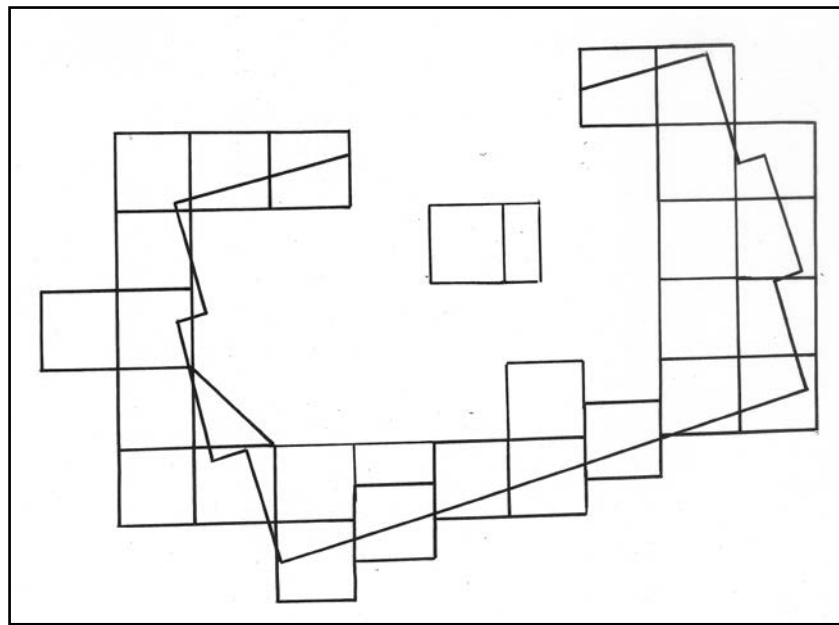
Figure 72: schematic of completed block excavations of dwelling foundation

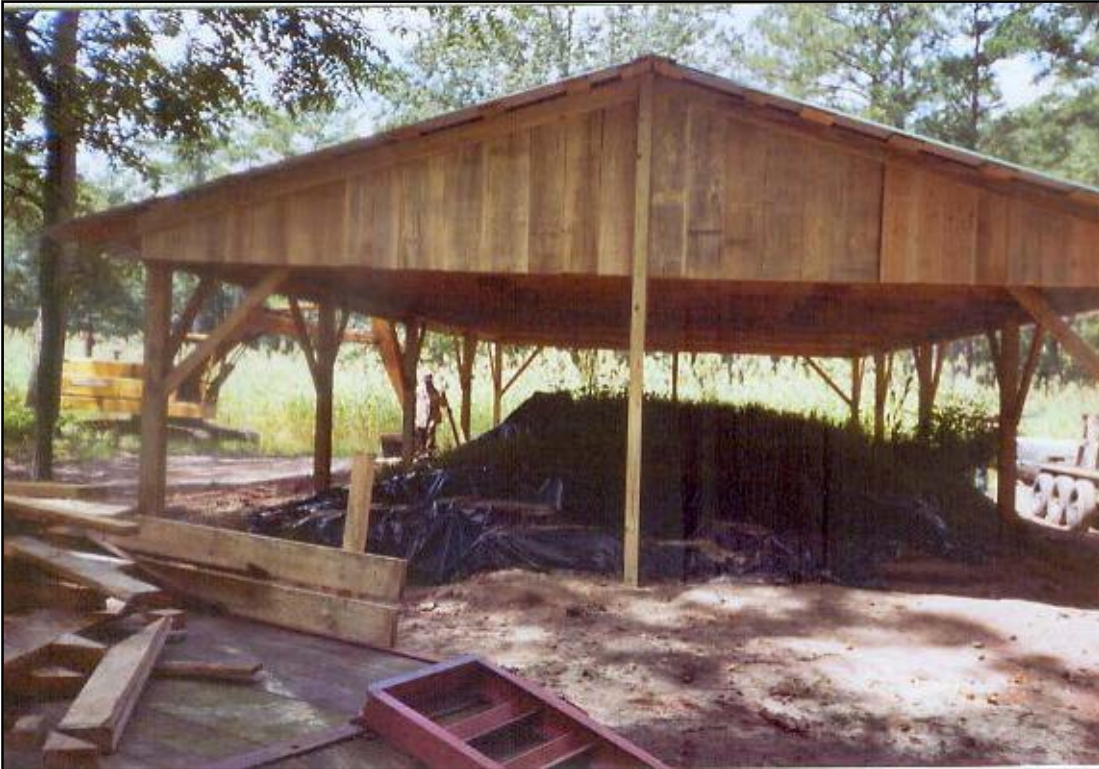
Figure 73: protective shed over the parsonage foundation, after completed excavations

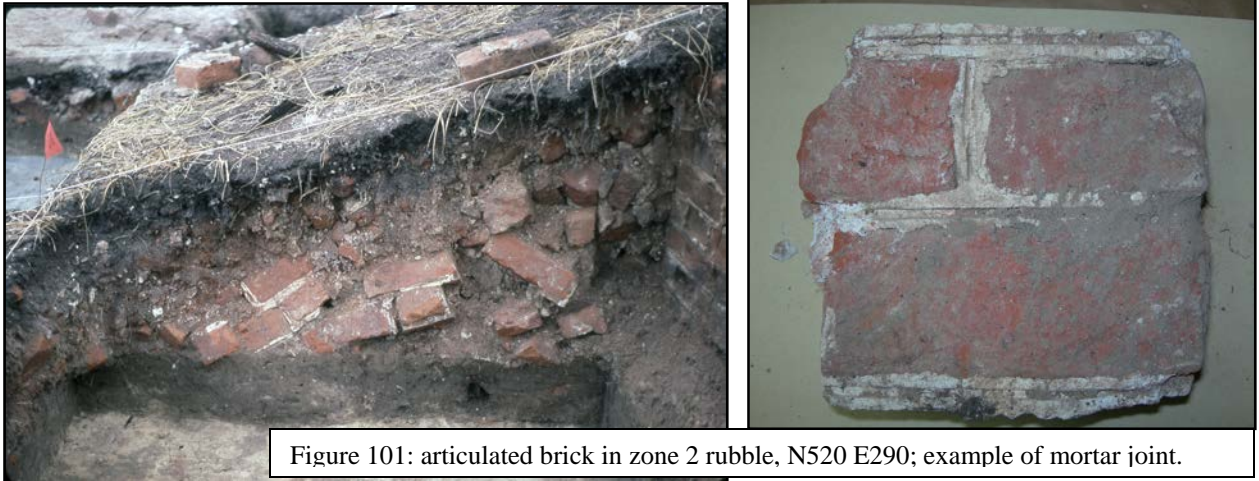
Figure 101: articulated brick in zone 2 rubble, N520 E290; example of mortar joint.

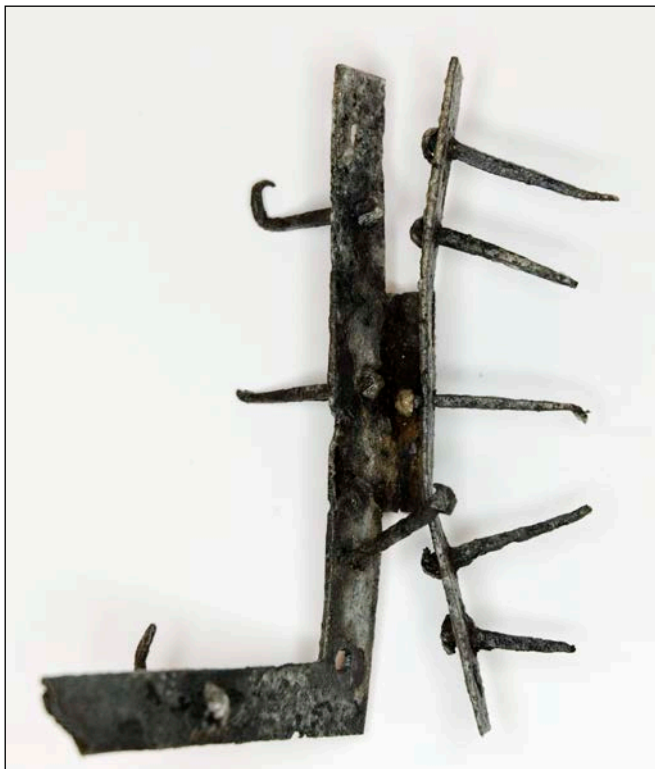
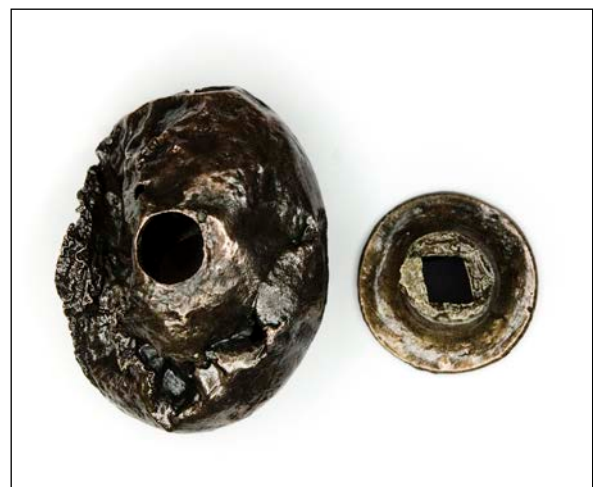
Figure 103: Hardware from the parsonage door: H-L hinge, with clinched nails; oval door pull and stem of brass
